Assessment Check List

Parcel ID#	Damage Address	City	Zip Code
EF-165-AQ	997 Pacific St.	Lindenhurst	11757

NOTE: IMMEDIATE ATTENTION REQUIRED- DANGEROUS STRUCTURE

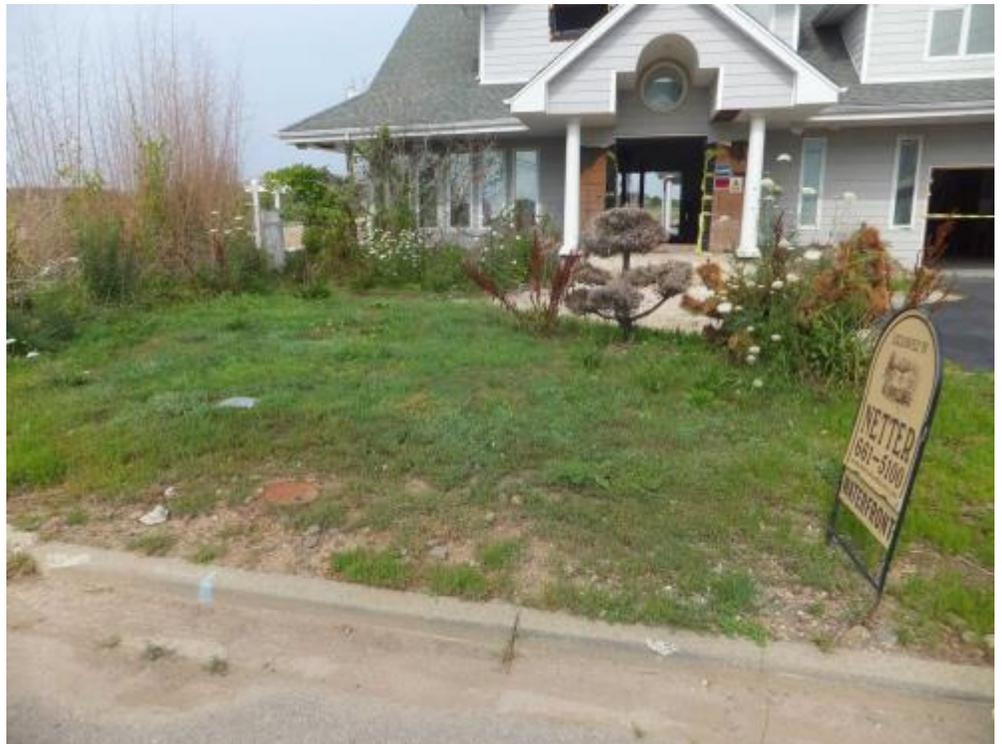
6 Front-Elevation
Date Taken: 7/14/2014
Taken By: MGREEN
Overgrown and upkept yard.

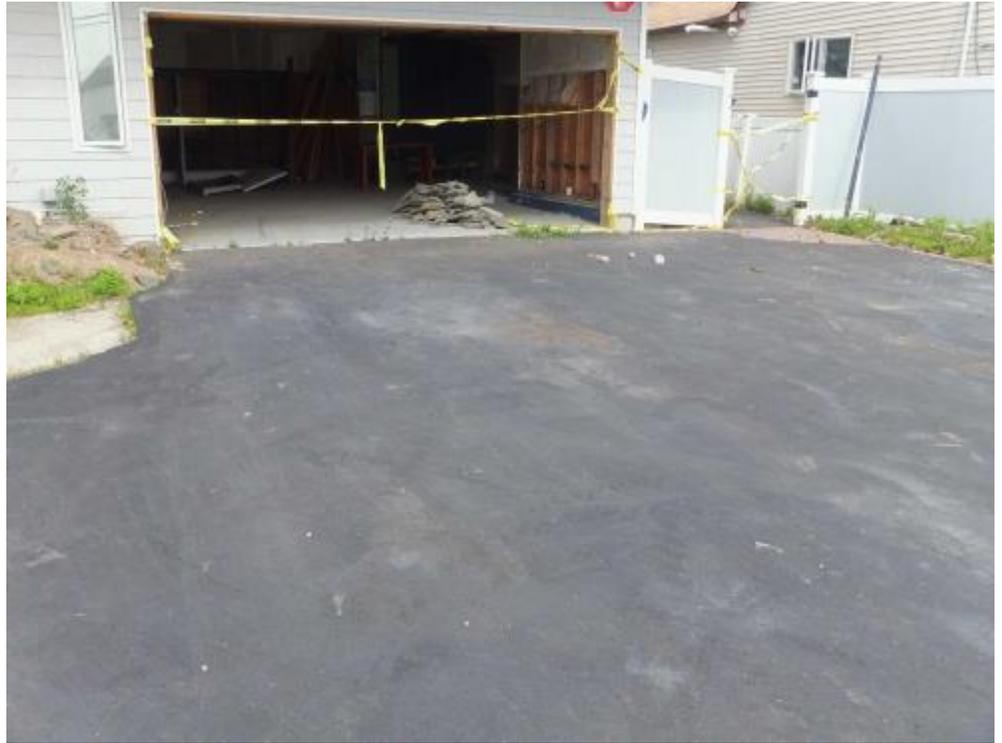
9 Front-Elevation
Date Taken: 7/14/2014
Taken By: MGREEN
No damage to driveway.

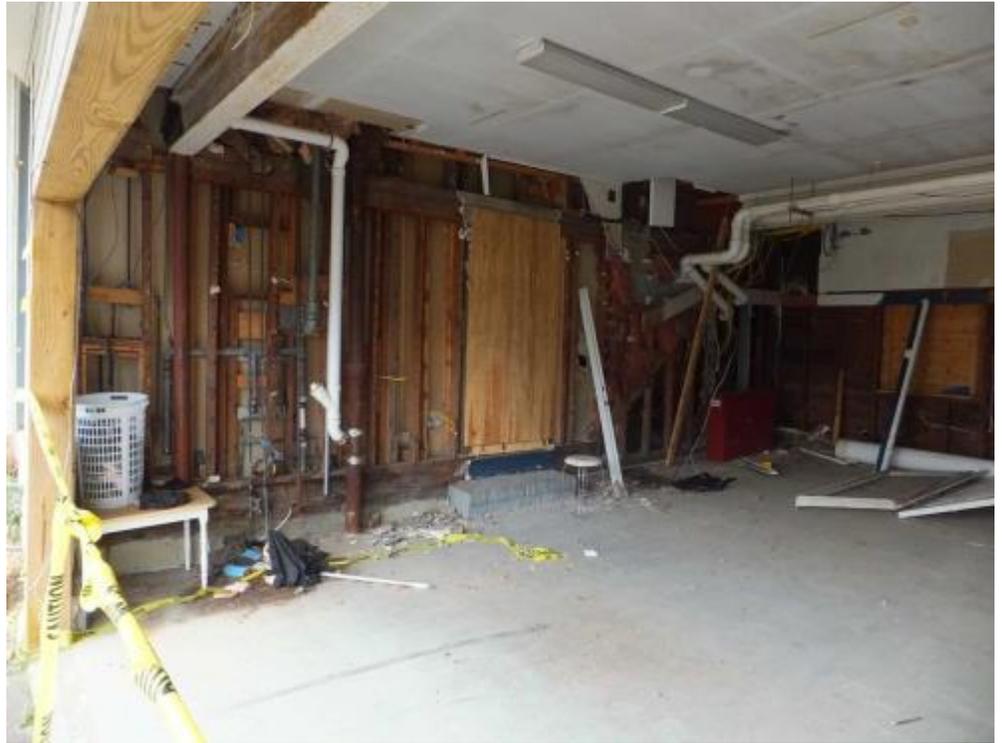
11 Front-Elevation
Date Taken: 7/14/2014
Taken By: MGREEN

Interior of garage. Parts have been gutted and no repairs have started.

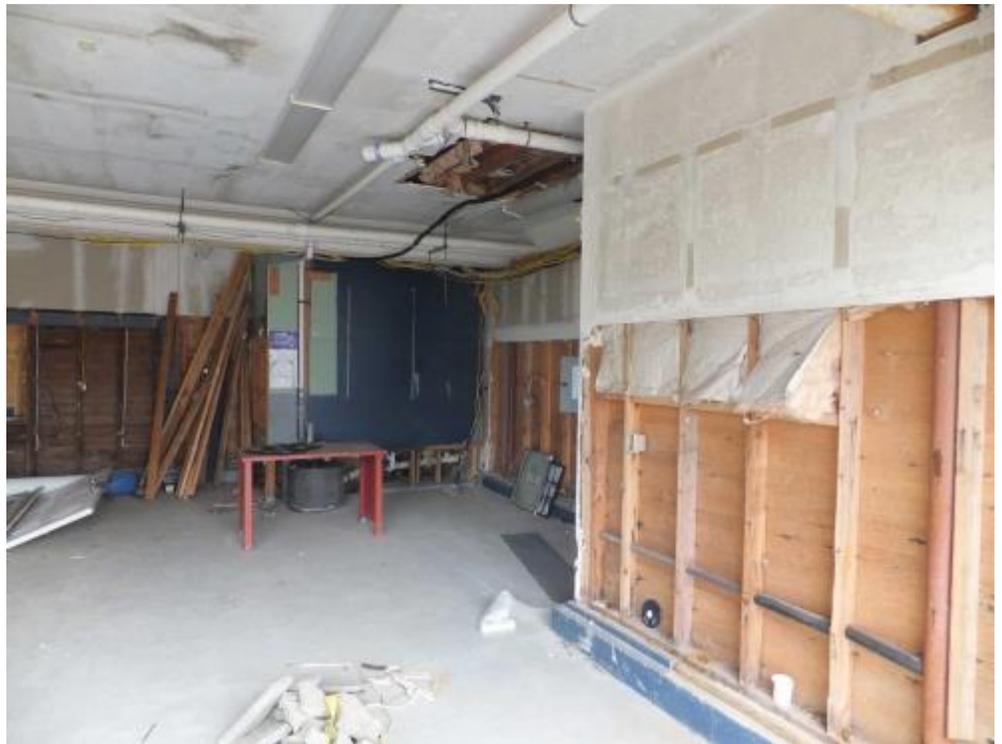
12 Front-Elevation
Date Taken: 7/14/2014
Taken By: MGREEN

Interior of garage. Parts have been gutted and no repairs have started.

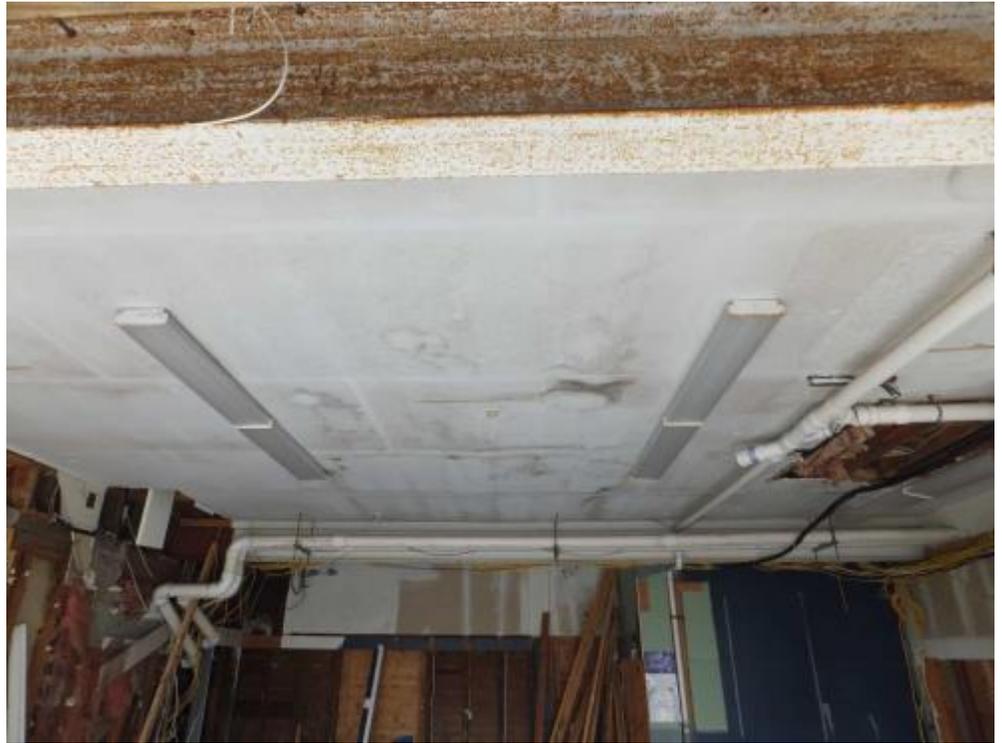
13 Front-Elevation
Date Taken: 7/14/2014
Taken By: MGREEN

There appears to be mold and leaking coming from the second story.

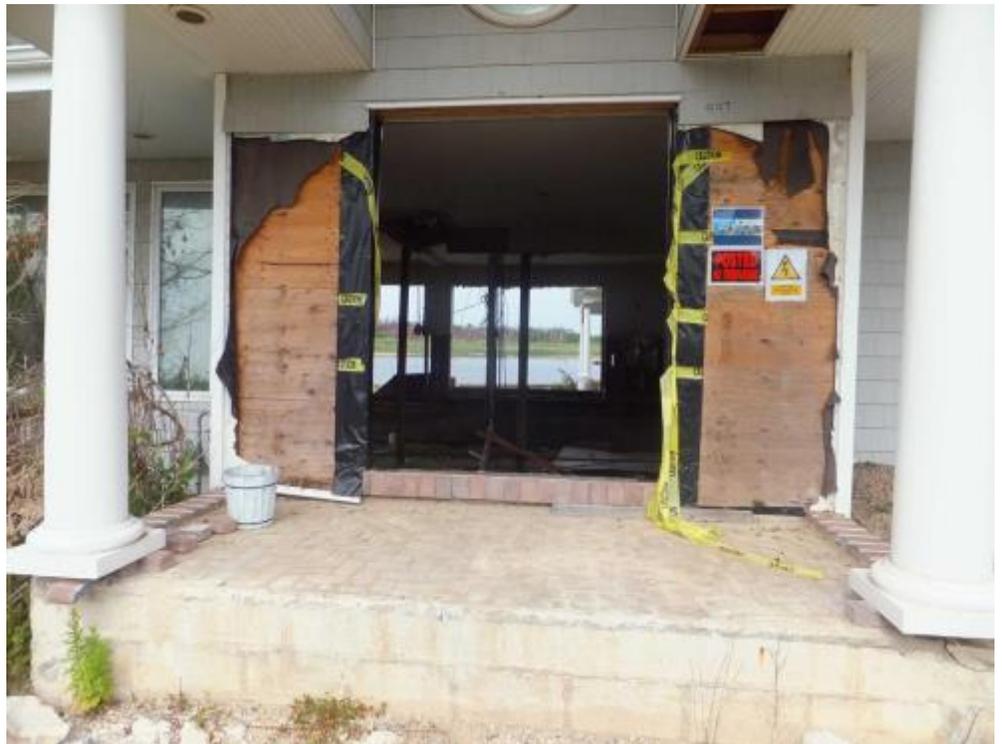
14 Front-Elevation
Date Taken: 7/14/2014
Taken By: MGREEN

Front entrance. This needs to be boarded up for liability. Columns on either side of the entrance are not secure.

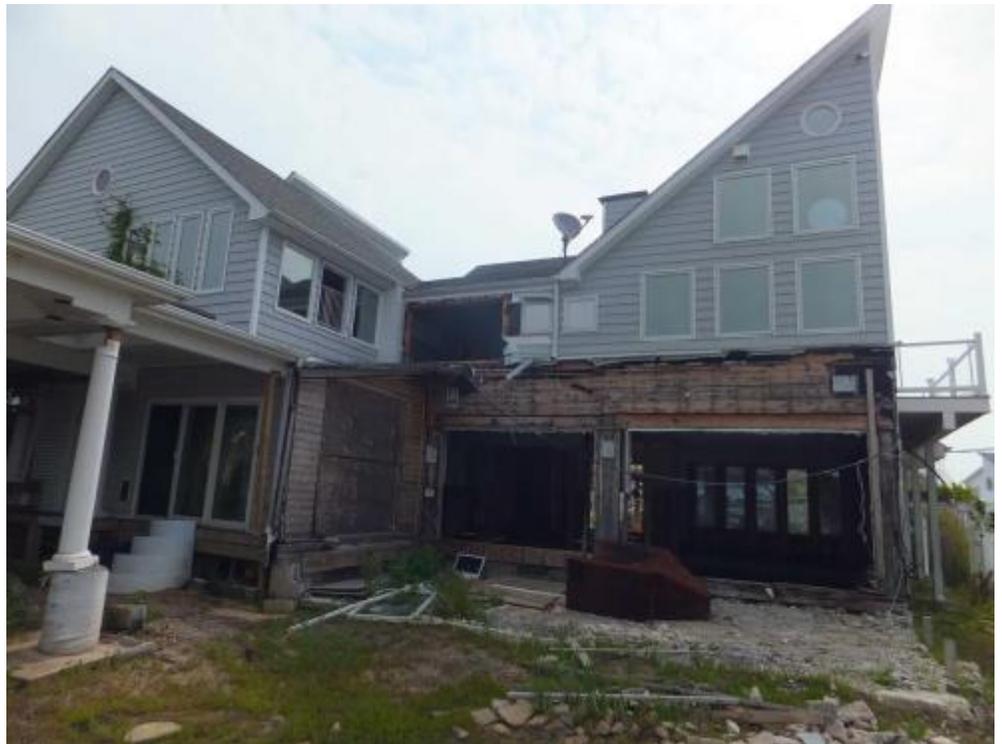
20 Rear-Elevation
Date Taken: 7/14/2014
Taken By: MGREEN

Overall view of the rear elevation.
This property must be slated for
demolition.

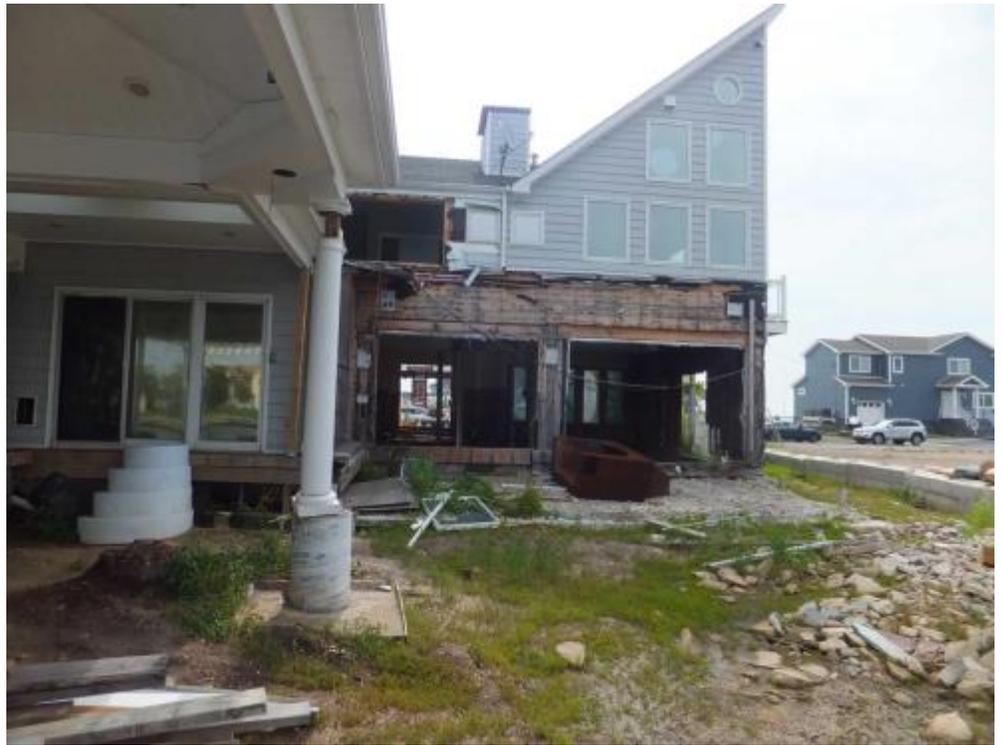
21 Rear-Elevation

Overall view of the rear elevation.
This property must be slated for
demolition.

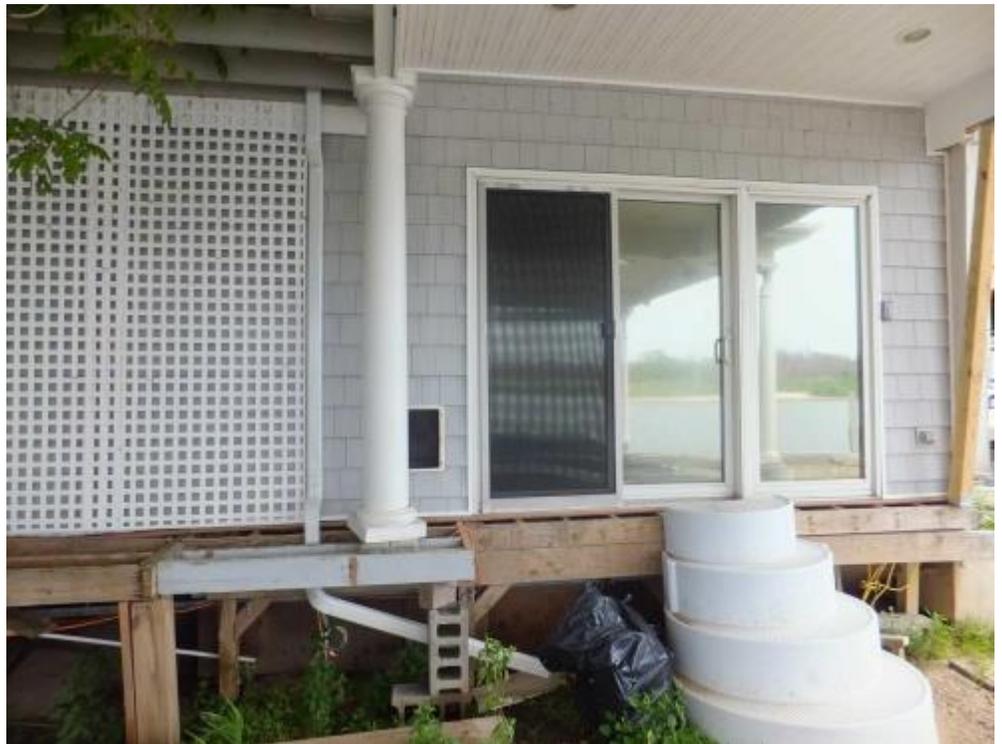
22 Rear-Elevation

Sliding glass doors need to be
secured. All decking under the Lanai
has been removed.

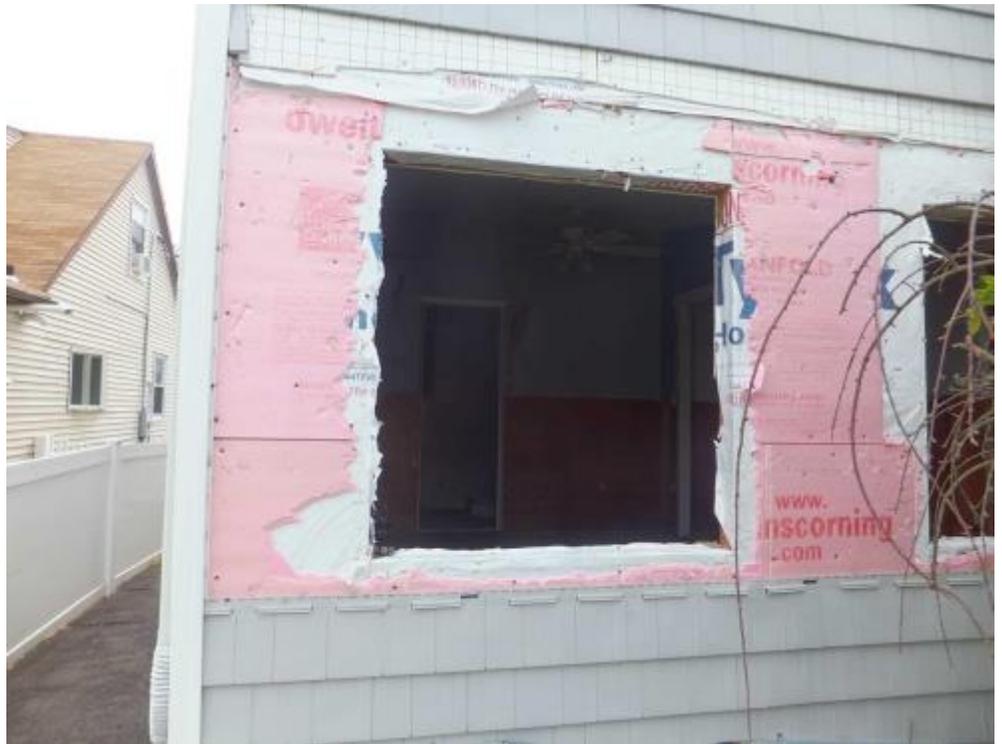
24 Rear-Elevation
Date Taken: 7/14/2014
Taken By: MGREEN
Windows need to be boarded up.

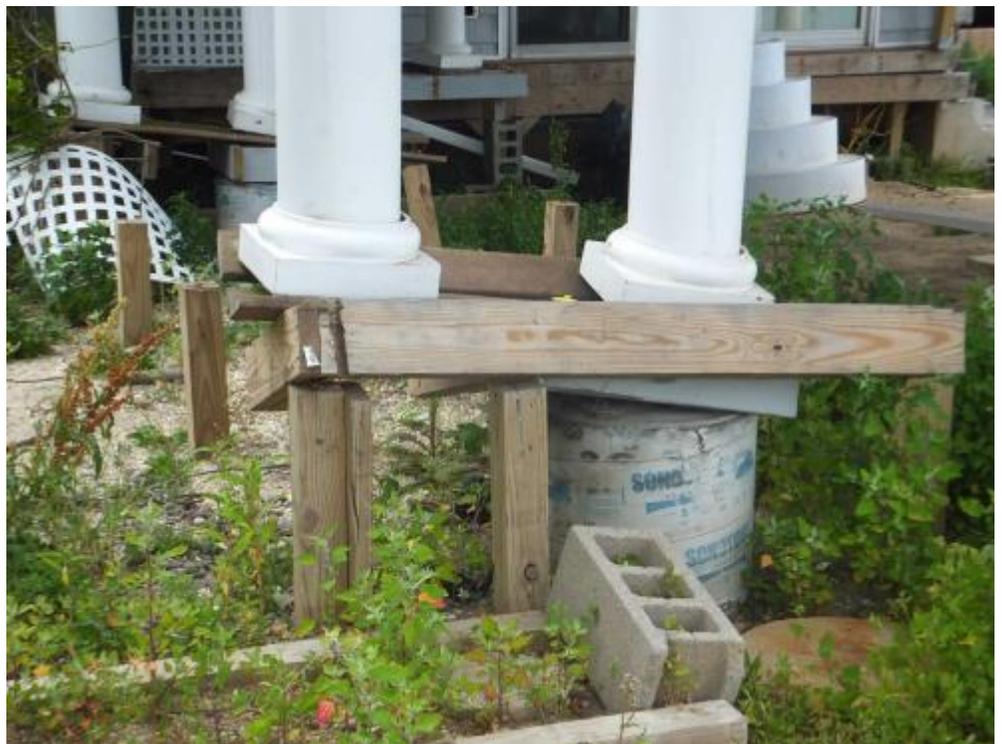
<input type="checkbox"/>	<input type="checkbox"/>	<input checked="" type="checkbox"/>						
Habitable with Minor Clean up	Yes	No							
	<input type="checkbox"/>	<input checked="" type="checkbox"/>							
Hazardous/ Environmental Material Abatement	Notes:	There is a large fire place frame in the rear yard. Rust has accumulated on it and is a possible danger to passers by.							
Verify Status of Bulkheads	Yes	No							
	<input checked="" type="checkbox"/>	<input type="checkbox"/>	Bulkheads are damaged with rotten and damaged timbers.						
Provide Security Personnel	Yes	No							
	<input checked="" type="checkbox"/>	<input type="checkbox"/>							
Notes:	This site appears to be extremely dangerous to enter due to only 4 ea. 4x4 post holding up the second floor and the perilous condition of the lanai column supports.

28 Rear-Lanai
Date Taken: 7/14/2014
Taken By: MGREEN
Lanai supports are unstable and hazardous.

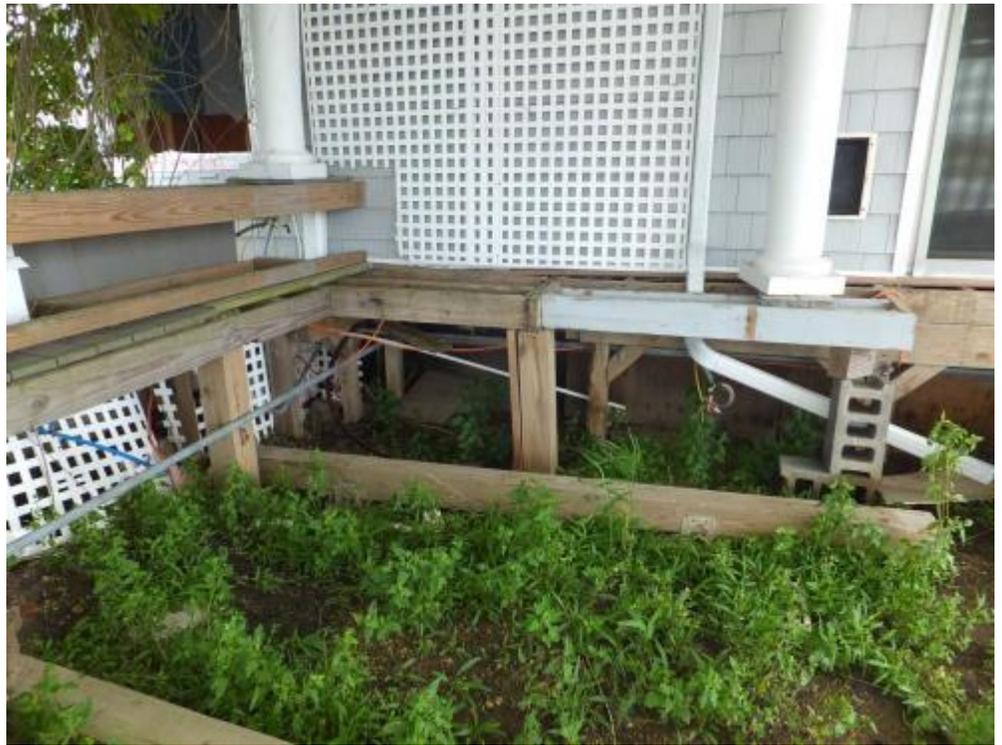
29 Rear-Lanai
Date Taken: 7/14/2014
Taken By: MGREEN
Lanai decking has been removed.

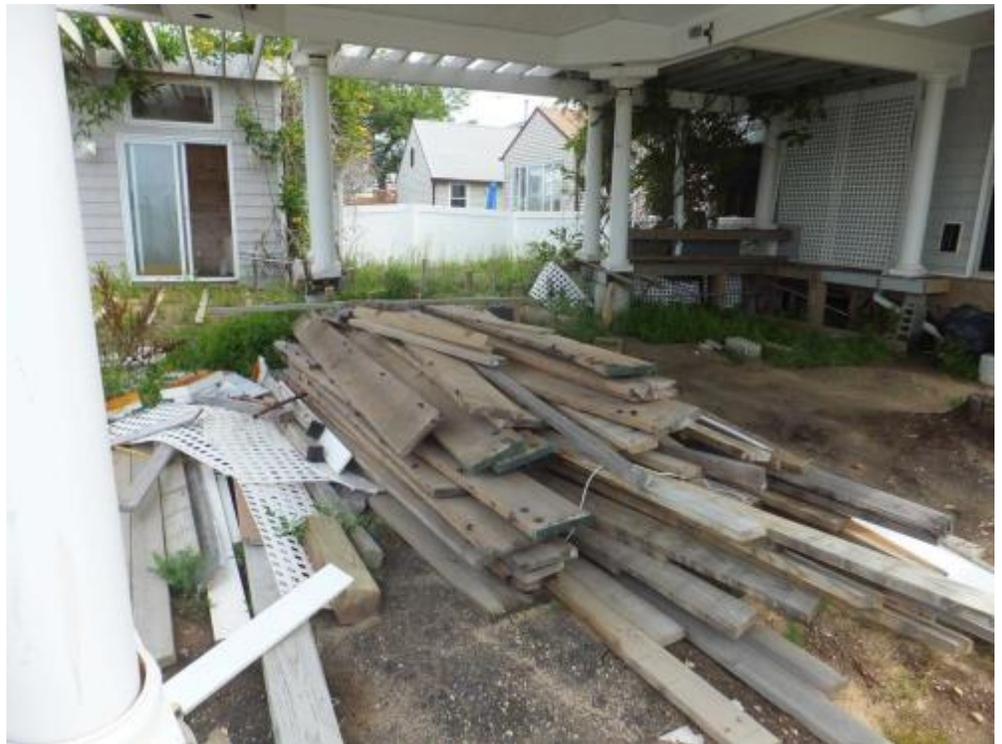
32 Rear-Lanai
Date Taken: 7/14/2014
Taken By: MGREEN

Debris most likely from the interior
floor joist and decking from the lanai
flooring.

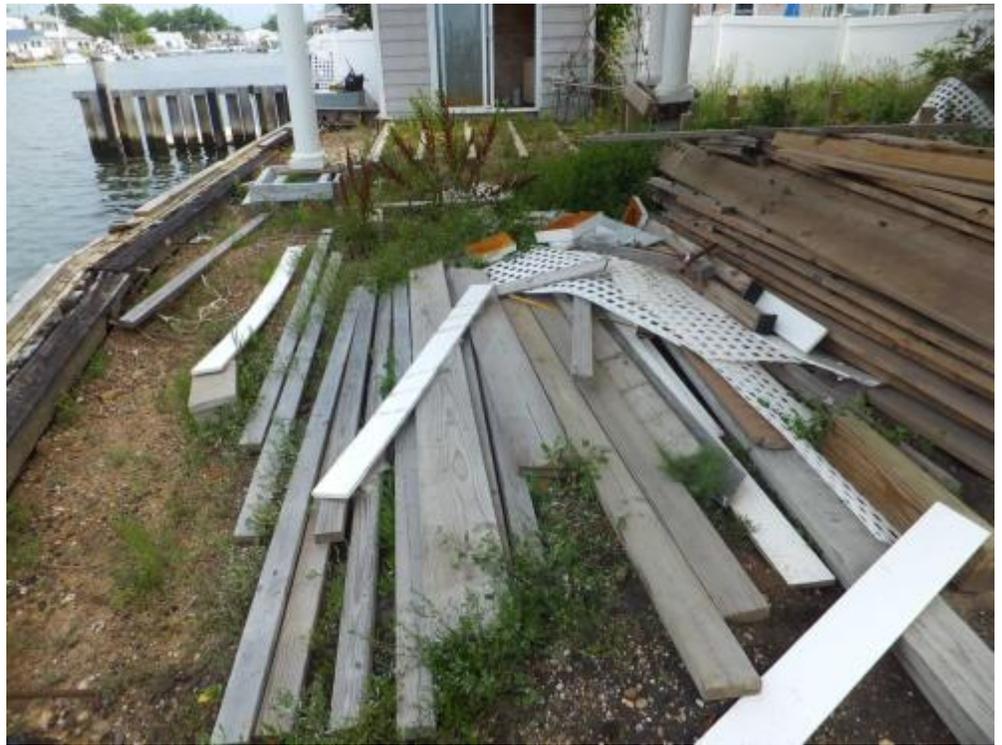
33 Rear-Lanai

Debris most likely from the interior floor joist and lanai decking.

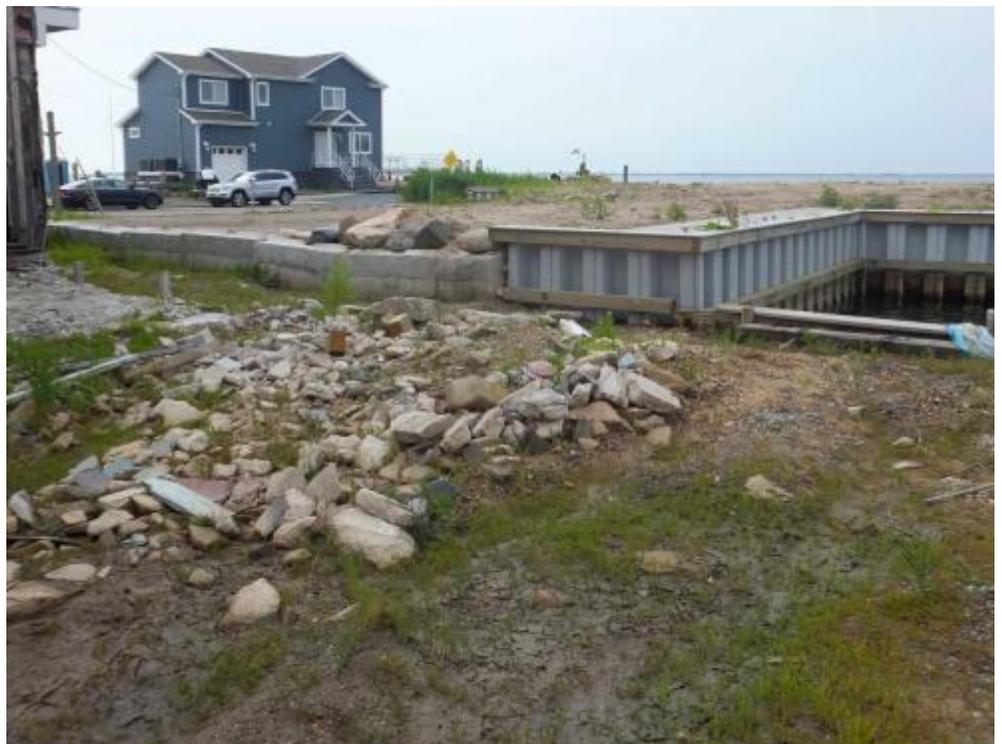
40 Rear-Yard

Right to left view of the rear of the property. Heavy debris shown.

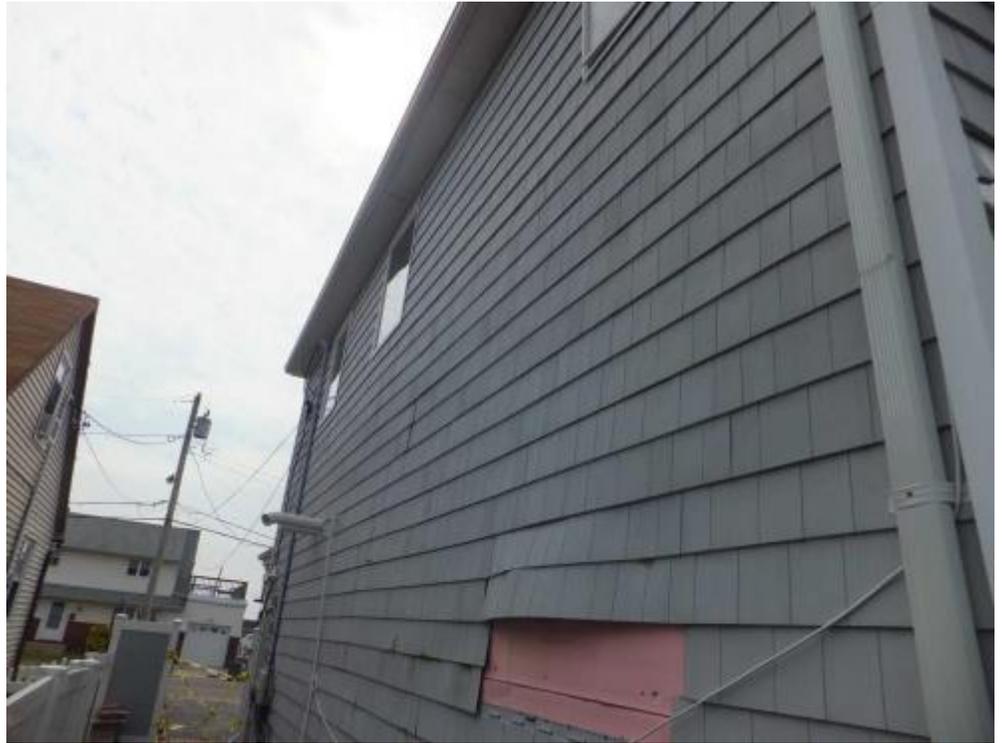
43 Right-Elevation
Date Taken: 7/14/2014
Taken By: MGREEN

Shows missing and damaged siding.

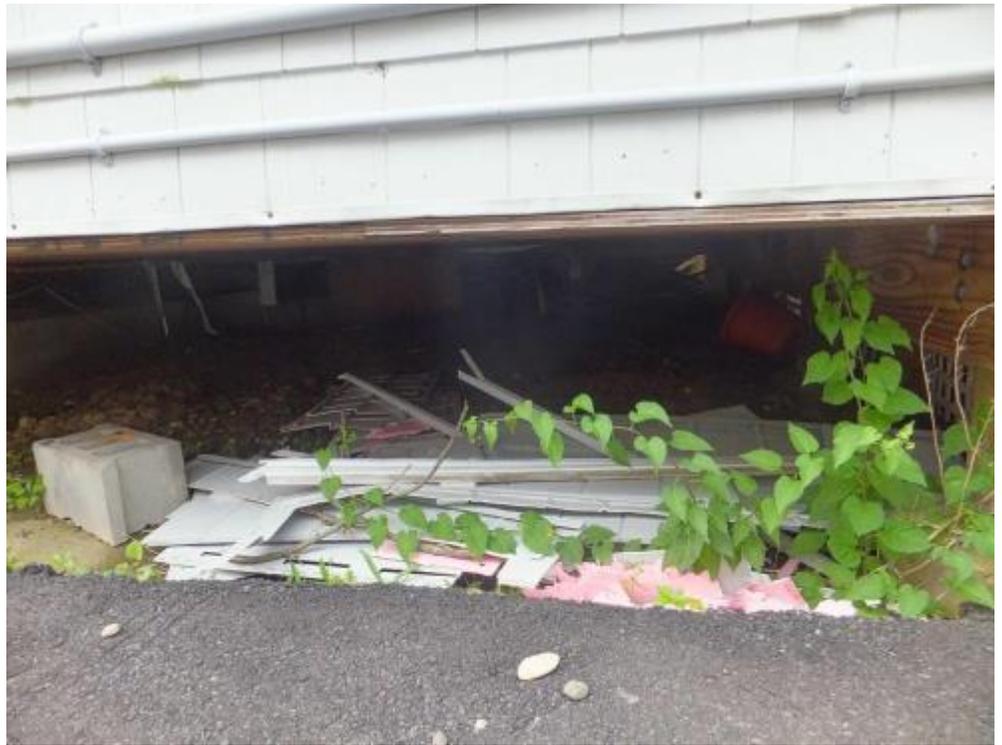
45 Right-Elevation
Date Taken: 7/14/2014
Taken By: MGREEN
Shows debris in crawlspace.

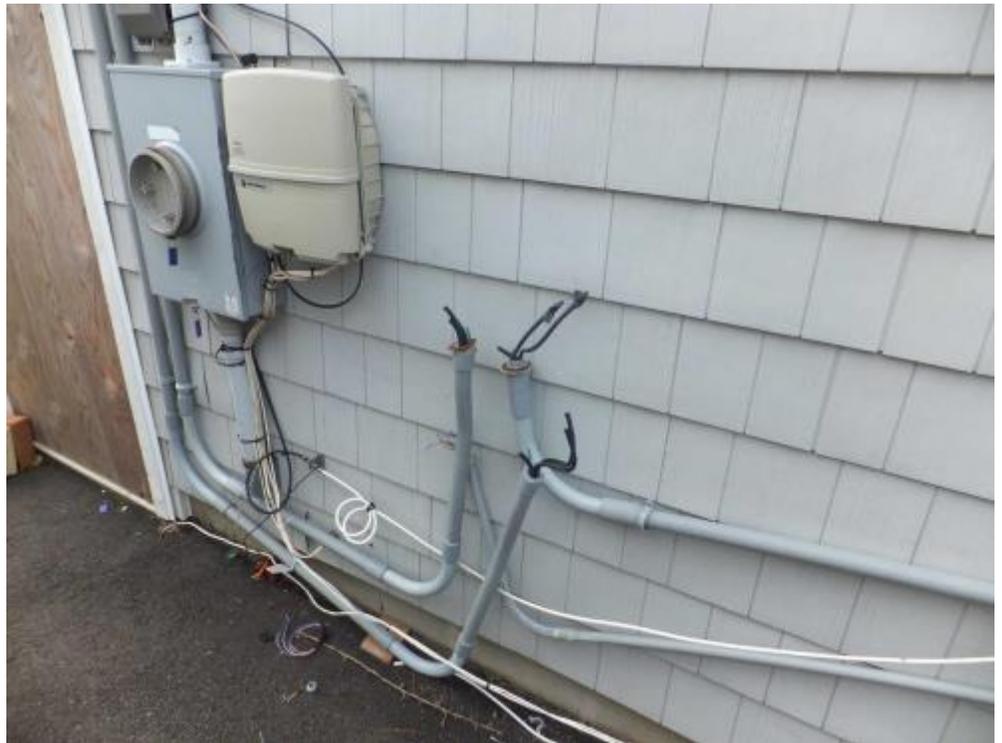
49 Right-Elevation
Date Taken: 7/14/2014
Taken By: MGREEN

Shows disconnected electrical service.

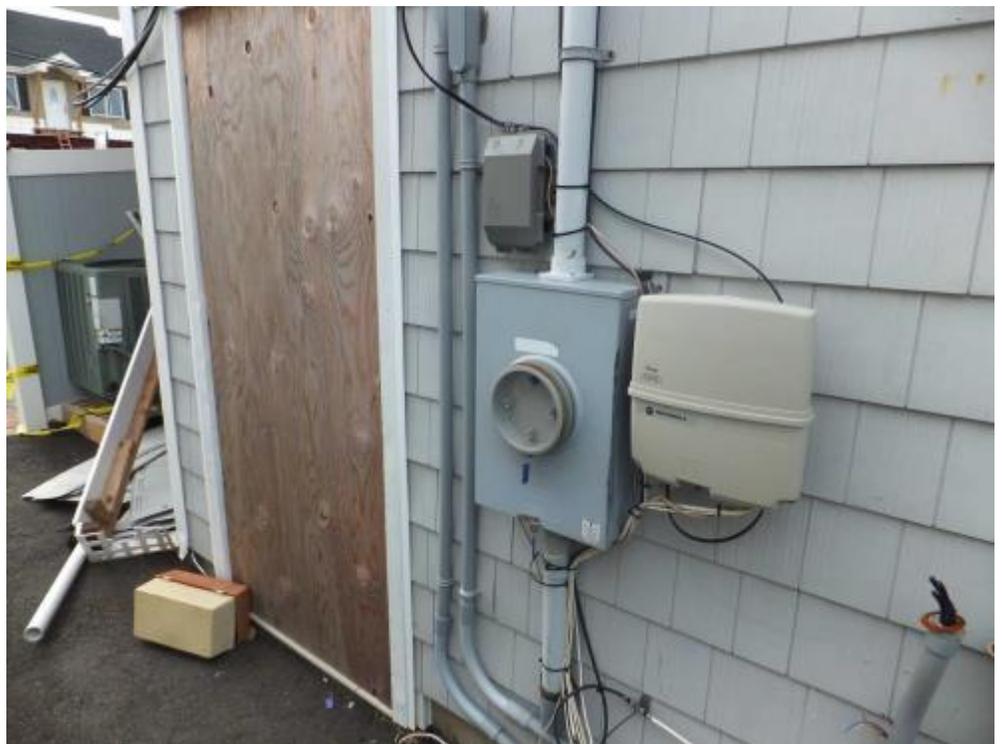
50 Right-Elevation
Date Taken: 7/14/2014
Taken By: MGREEN

Shows boarded up side entrance into the boiler room.

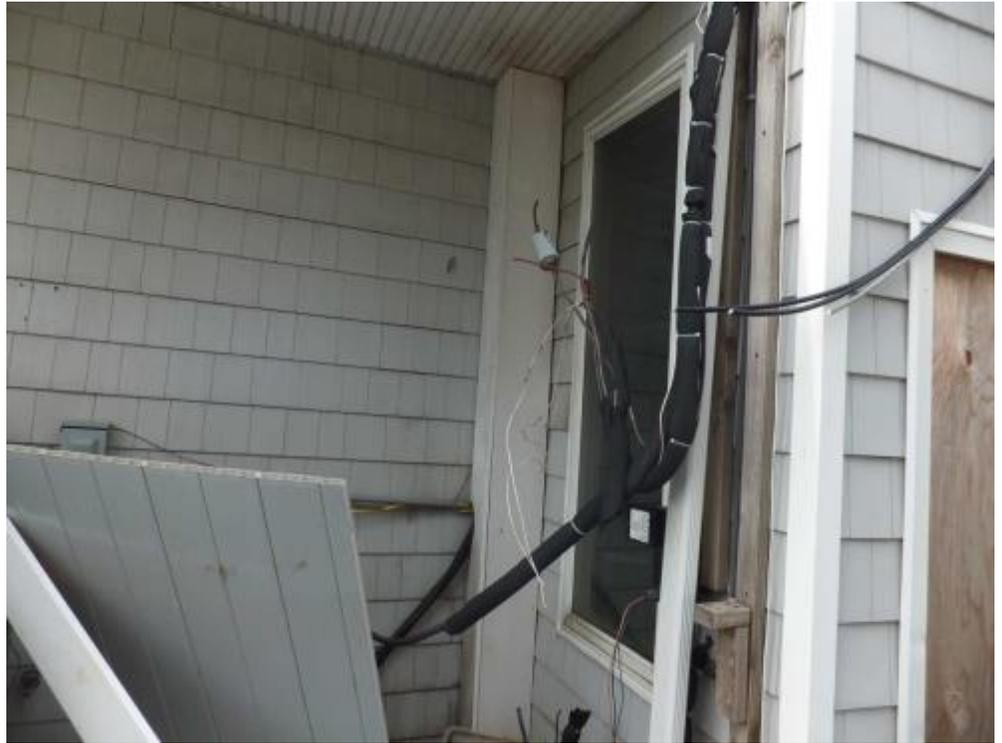
51 Right-Elevation
Date Taken: 7/14/2014
Taken By: MGREEN

Shows disconnected and missing AC unit.

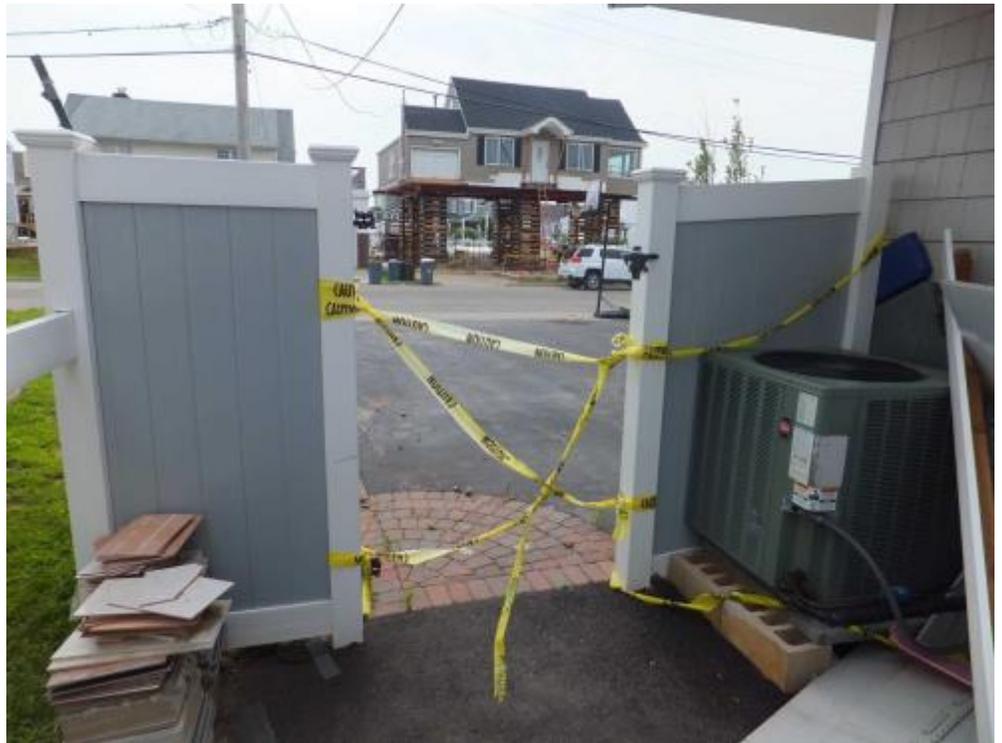
55 Right-Elevation
Date Taken: 7/14/2014
Taken By: MGREEN
Missing gate to back yard.

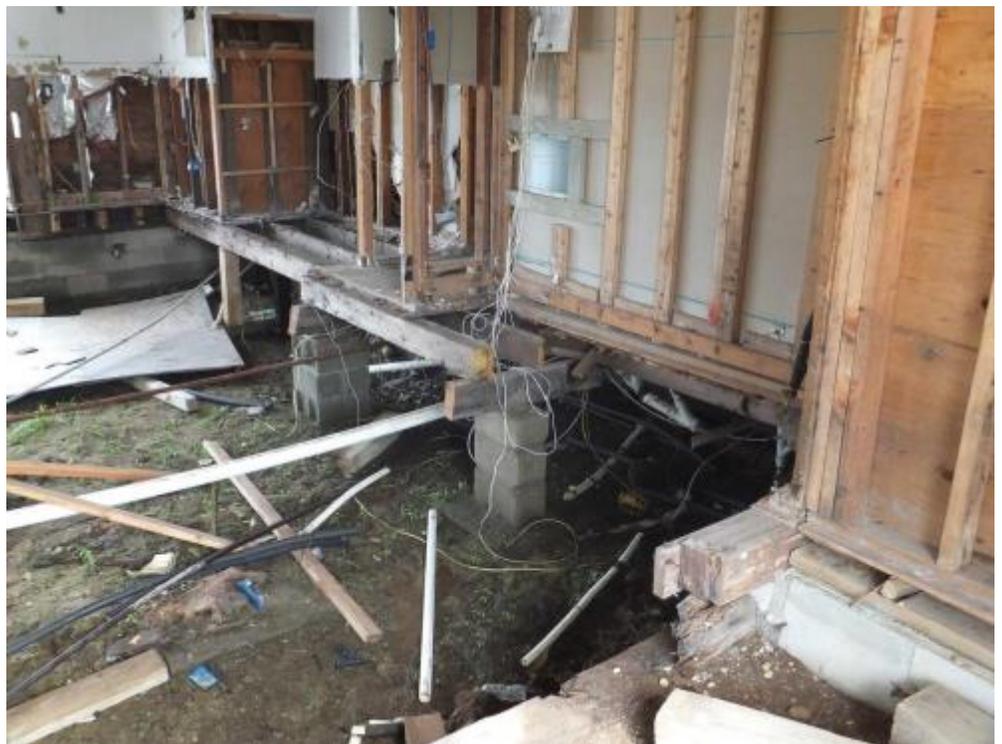
56 Interior
Date Taken: 7/14/2014
Taken By: MGREEN
Crawlspace is visible from front door.
All supporting joist, subfloor and
flooring have been removed.

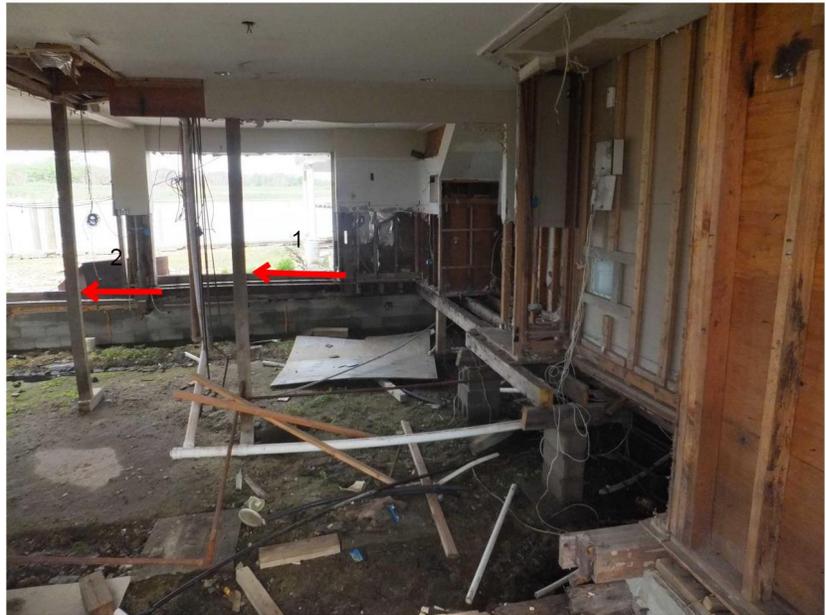
57 Interior

Interior appears to have been gutted with no repairs. The second floor is being held up by 4x4 beams.

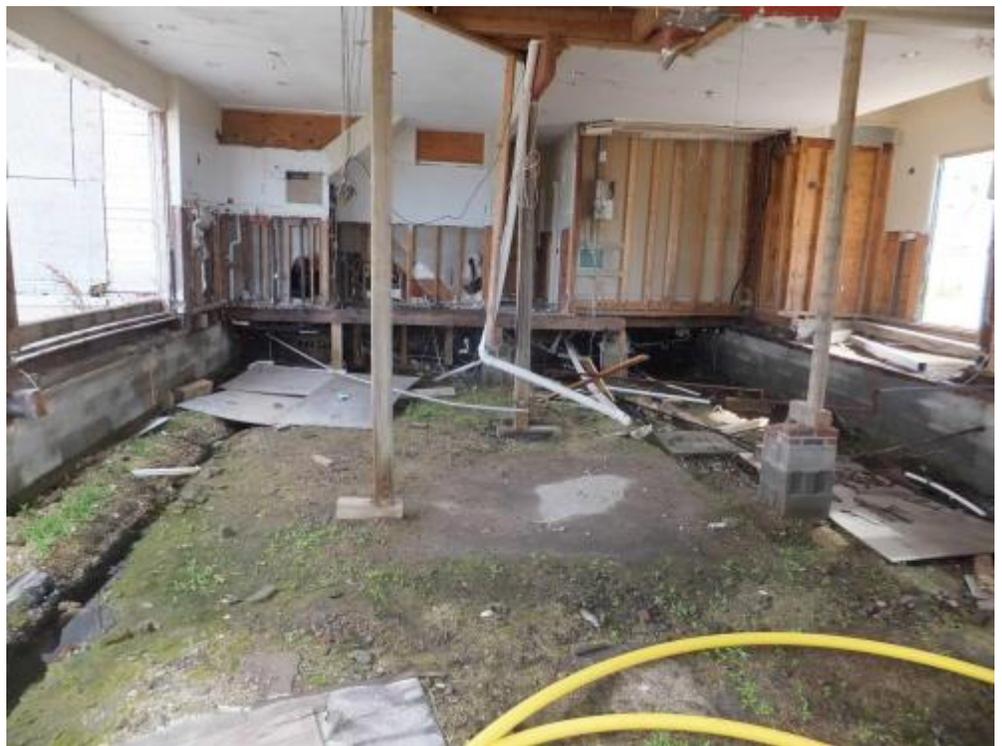
60 Interior
Date Taken: 7/14/2014
Taken By: MGREEN
Left view into the house. Shows supports holding up the 2nd floor. No flooring supports, subfloor or flooring.

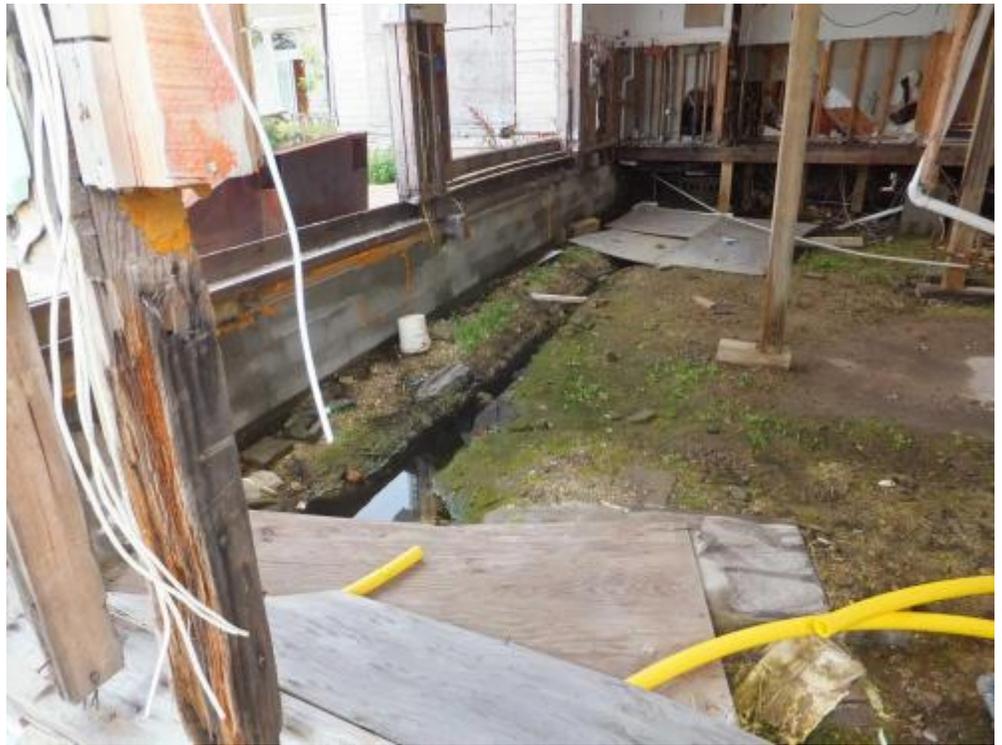
61 Interior

Standing water on the inside of the house.

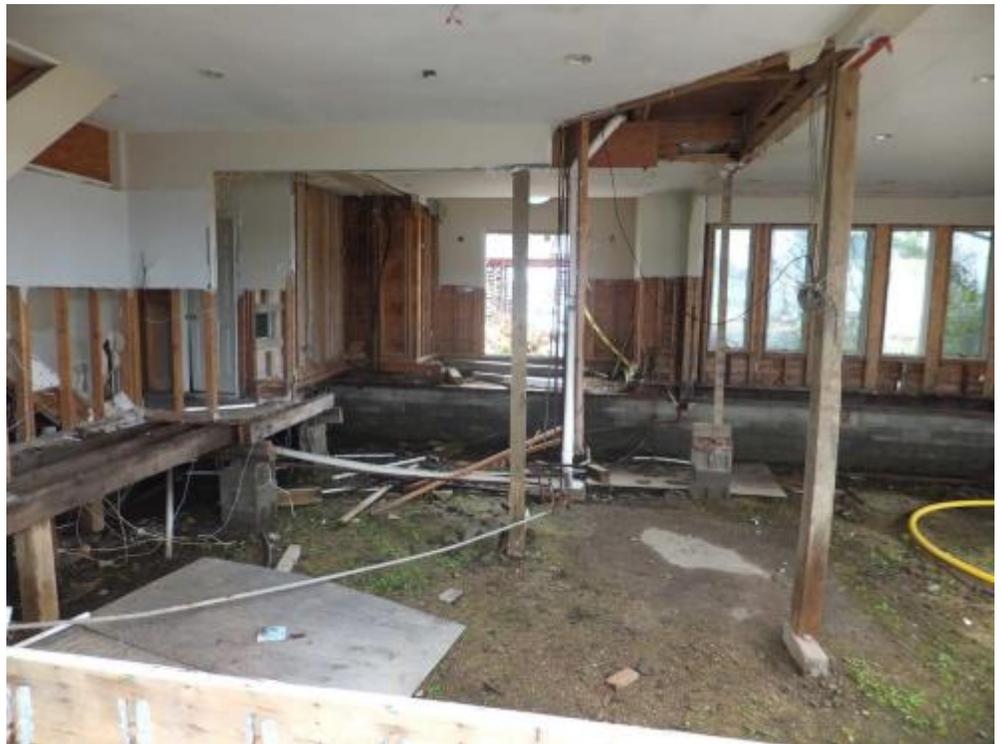
64 Interior
Date Taken: 7/14/2014
Taken By: MGREEN
Rear view into the house. Shows supports holding up the 2nd floor. No flooring supports, subfloor or flooring.

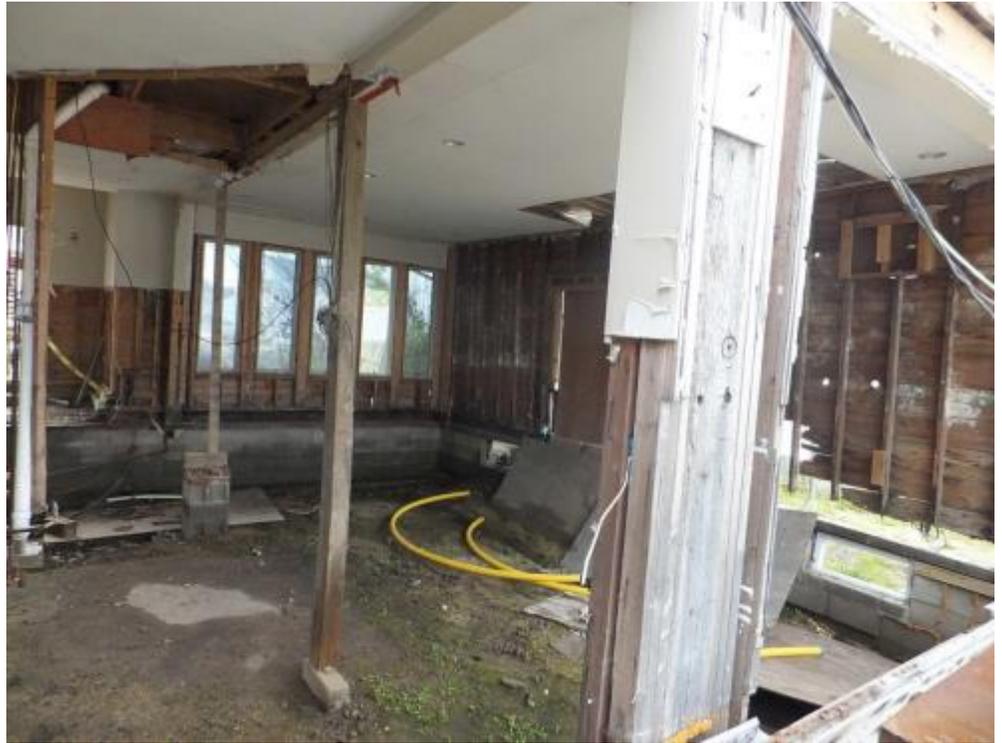
65 Interior

Left view into the house. Shows supports holding up the 2nd floor. No flooring supports, subfloor or flooring.
