Assessment Check List

Parcel ID#	Damage Address	City	Zip Code
LH-128	854 Atlantic St.	Lindenhurst	11757

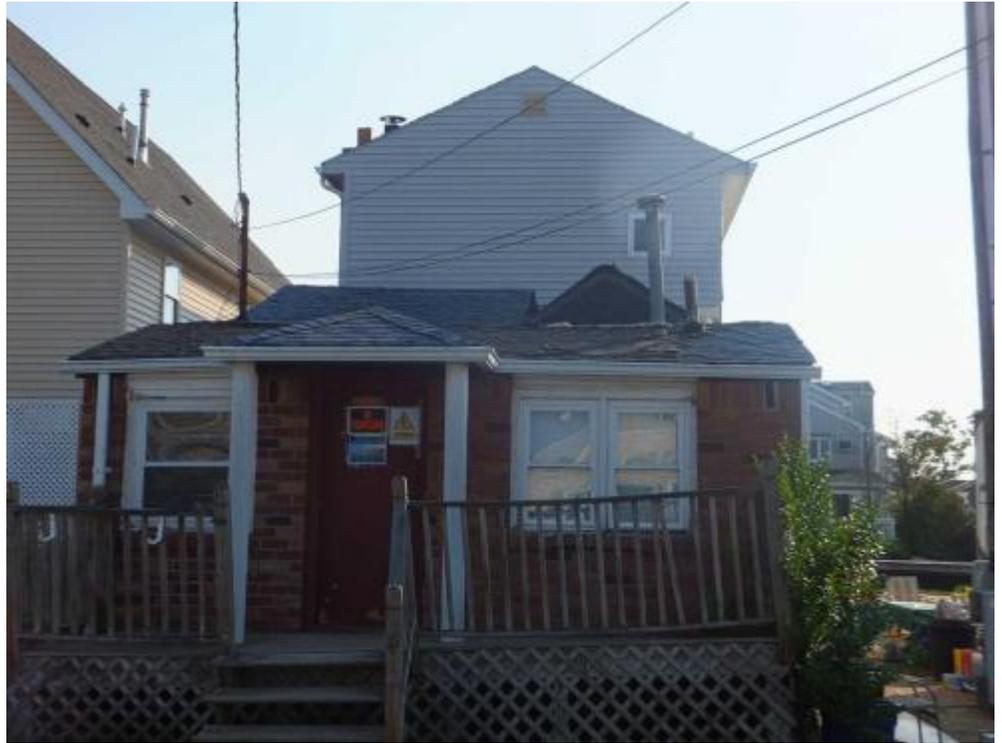
5 Front-Elevation
Date Taken: 7/14/2014
Taken By: MGREEN

Front porch railings appear to be unstable.

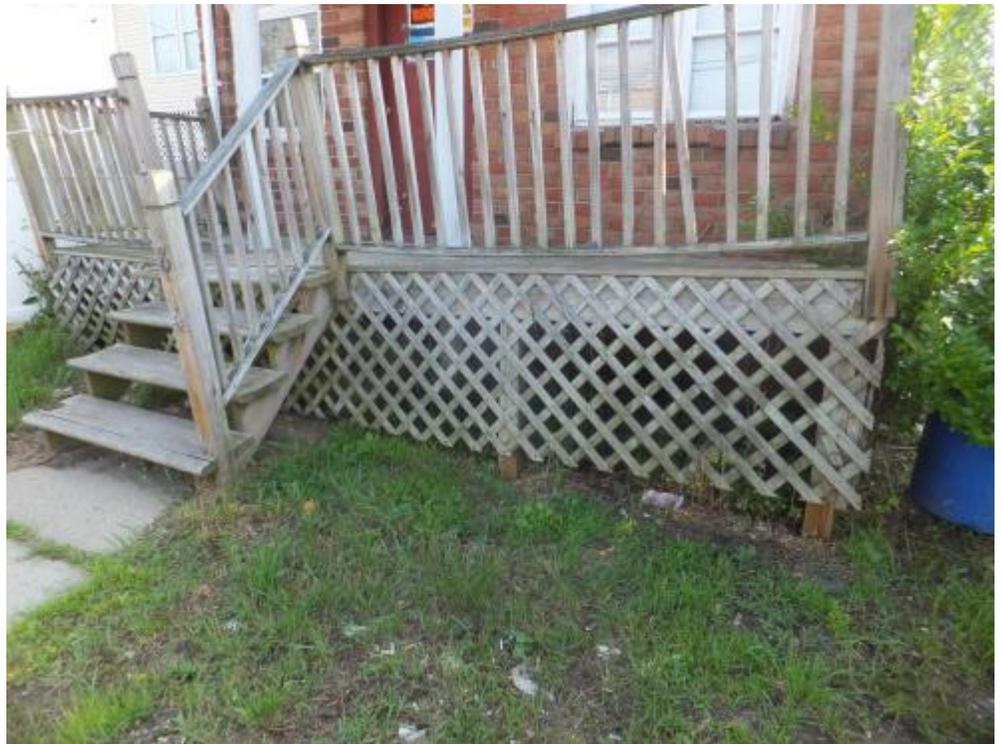
6 Front-Elevation
Date Taken: 7/14/2014
Taken By: MGREEN

Front porch pylons appear to be stable.

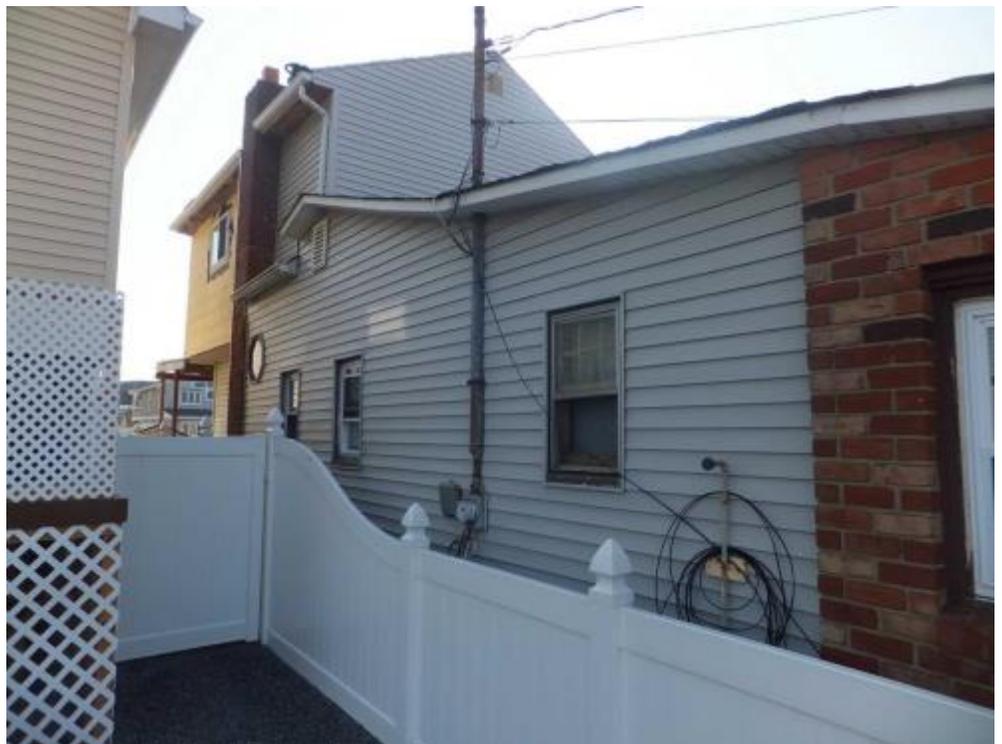
8 Left-Elevation
Date Taken: 7/14/2014
Taken By: MGREEN
Close up view of left elevation. Siding appears to be in condition. Windows need to be boarded up.

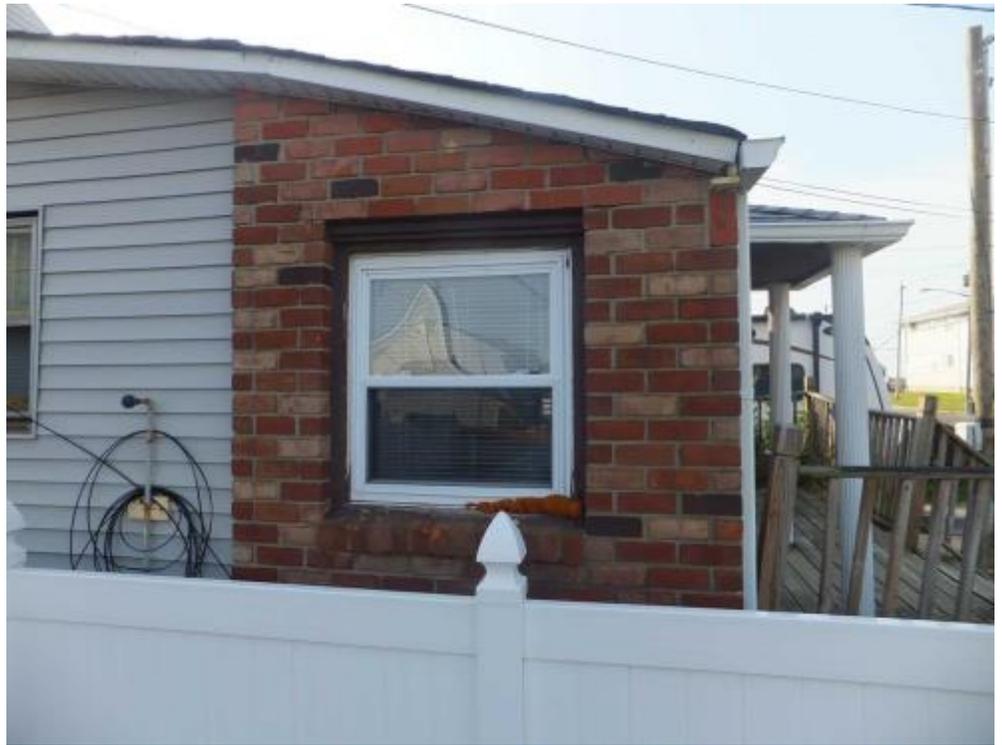
9 Left-Elevation
Date Taken: 7/14/2014
Taken By: MGREEN
Windows need to be boarded up.

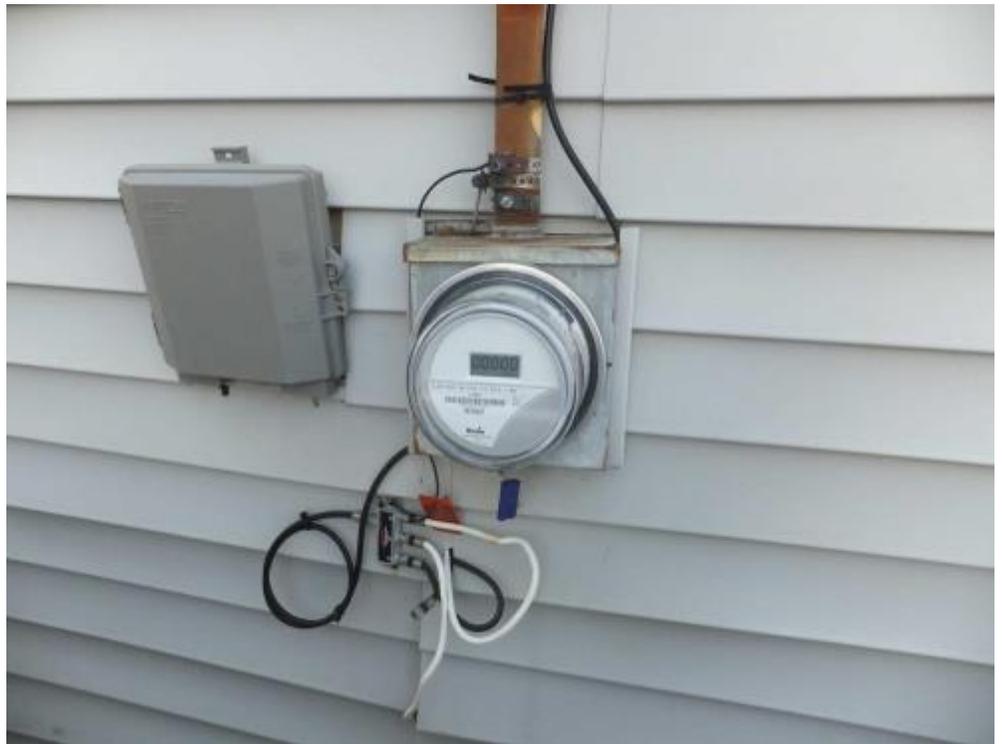
10 Left-Elevation
Date Taken: 7/14/2014
Taken By: MGREEN
Utilities appear to be disconnected.

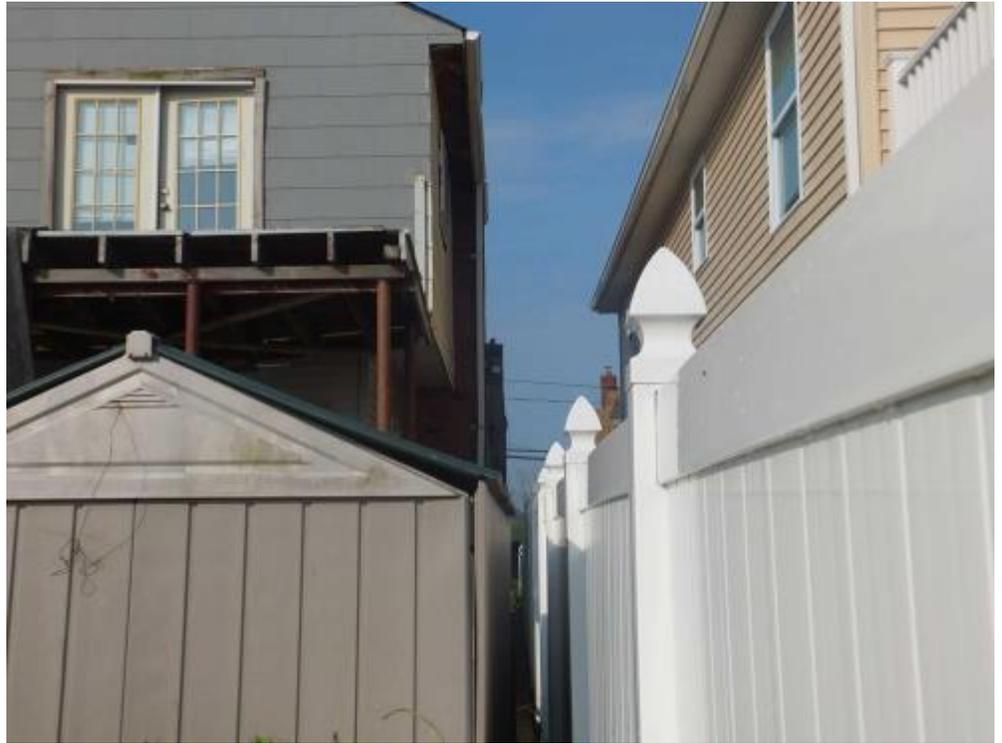
11 Left-Elevation

Back to front view. The storage shed appears to have damage on the left side of the roof.

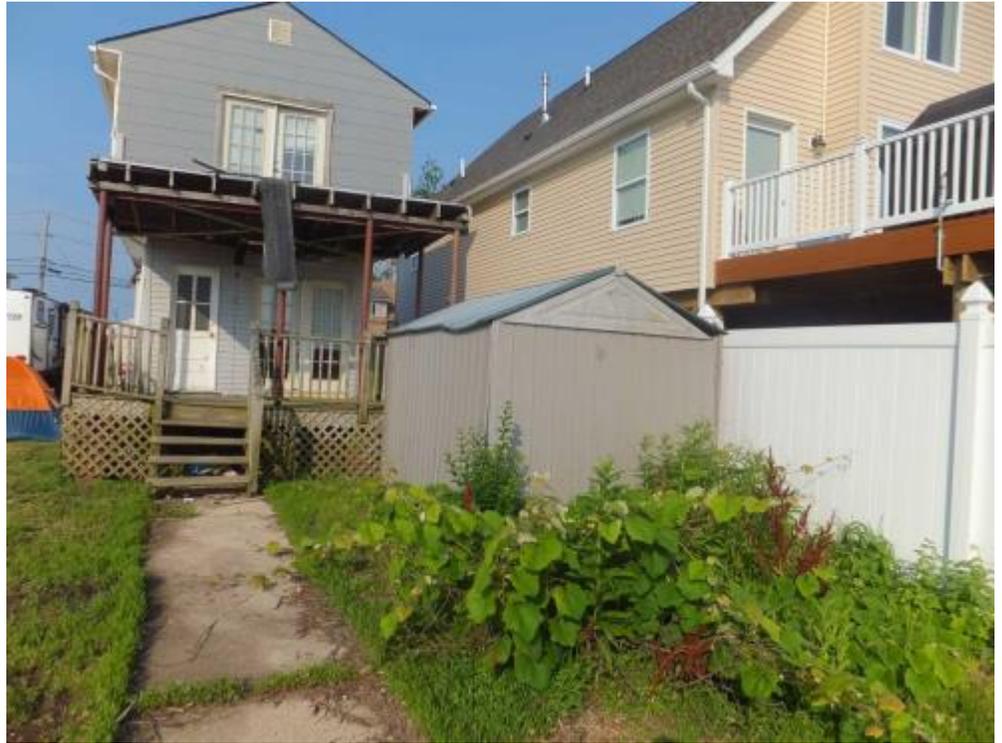
13 Rear-Elevation

Storage shed at the rear of the home along with overgrown vegetation.

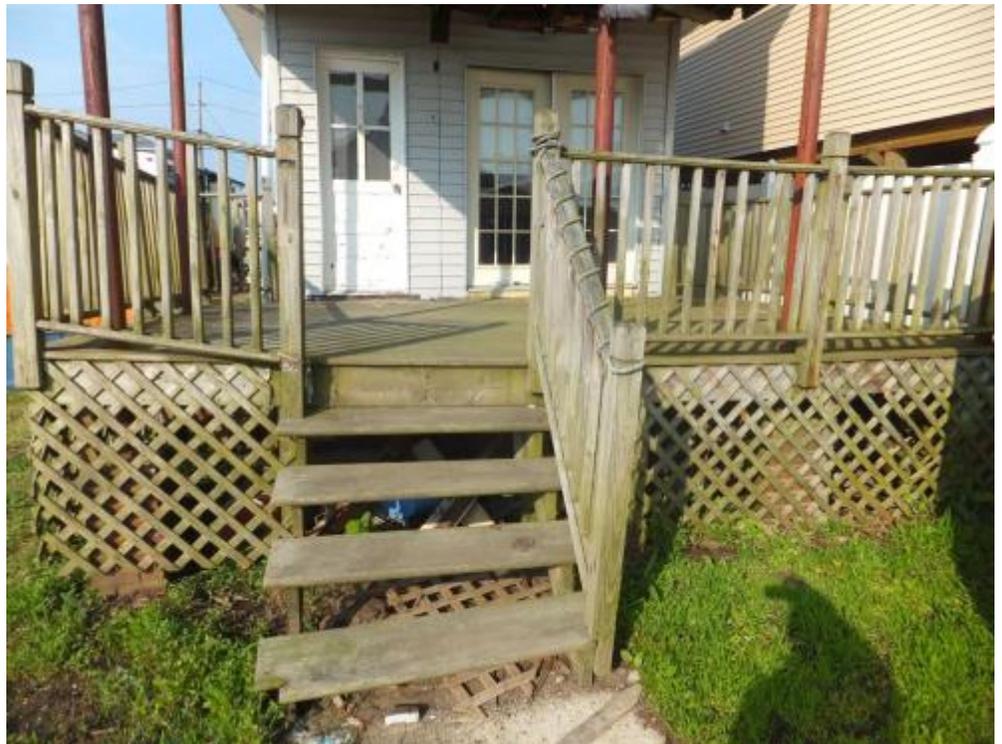
14 Rear-Elevation

Foundation appears to be in good condition. Decking is in bad shape.

Stairs and decking appear to be damaged.

Notes: Reinforce or tear down rear decking. This is a major hazard and could collapse with a high wind or by deterioration.

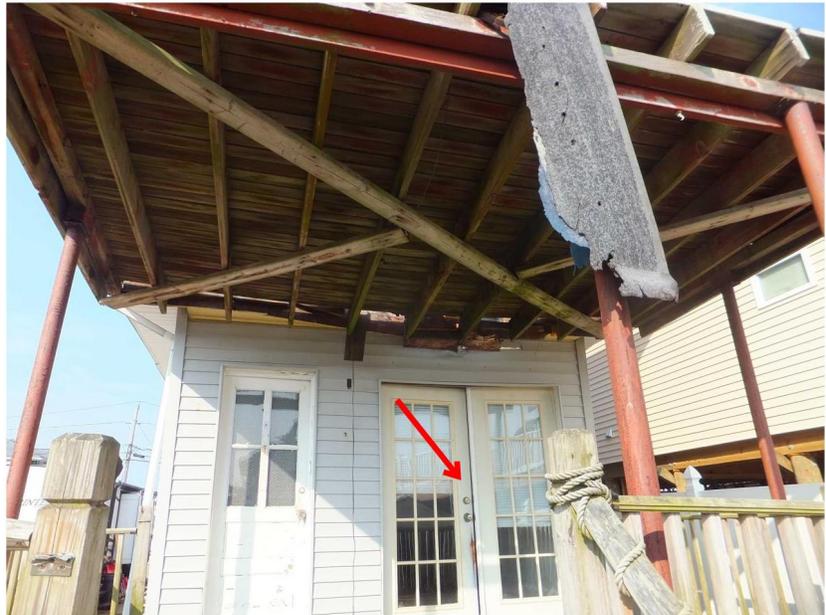
15 Rear-Elevation

Rear door appears to be ajar.
Boarding up to prevent further
intrusion is necessary.

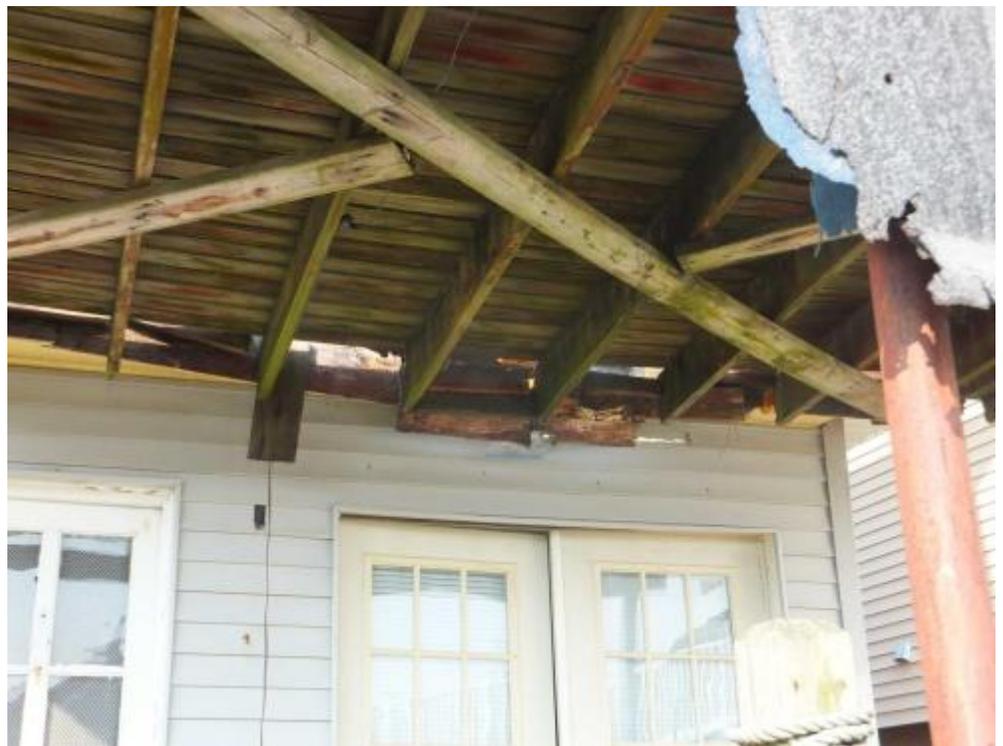
16 Rear-Elevation

Further damage of second floor
decking. This is a potential hazard.

Remove oil tank in the drive way. Secure all doors and windows. Reinforce rear second floor decking or demolish second floor decking, it is a major hazard due to it's deterioration and instability.

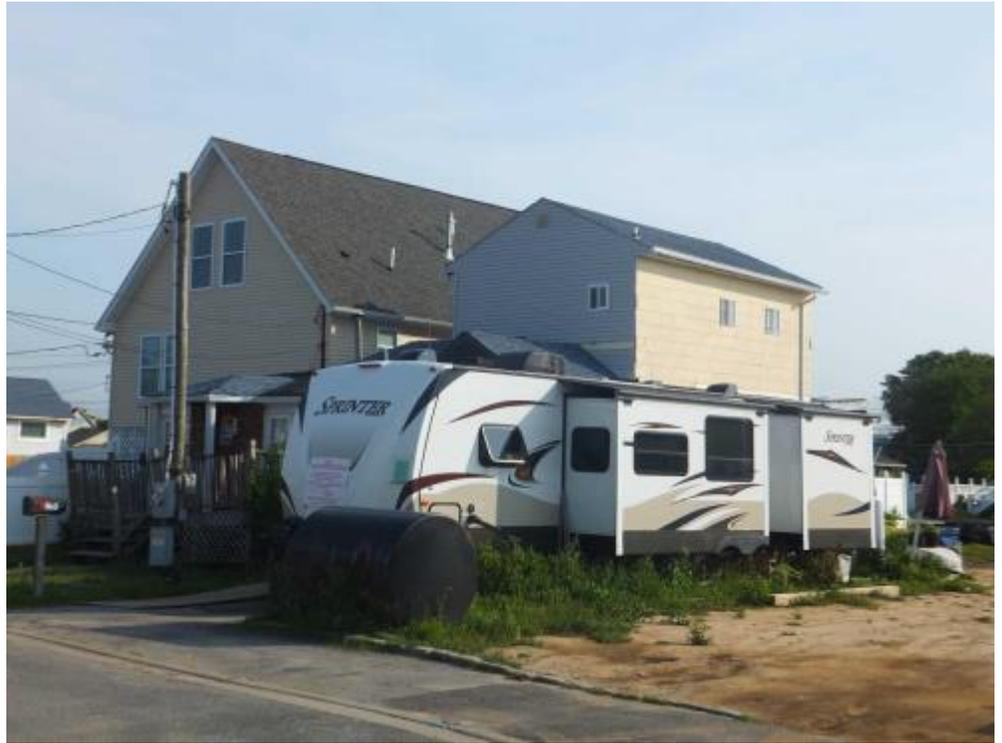
17 Right-Elevation

Notes: Oil storage tank in the driveway in front of 5th wheel is a potential hazard and needs to be removed.

Front to back view of right elevation with 5th wheel travel trailer in driveway.

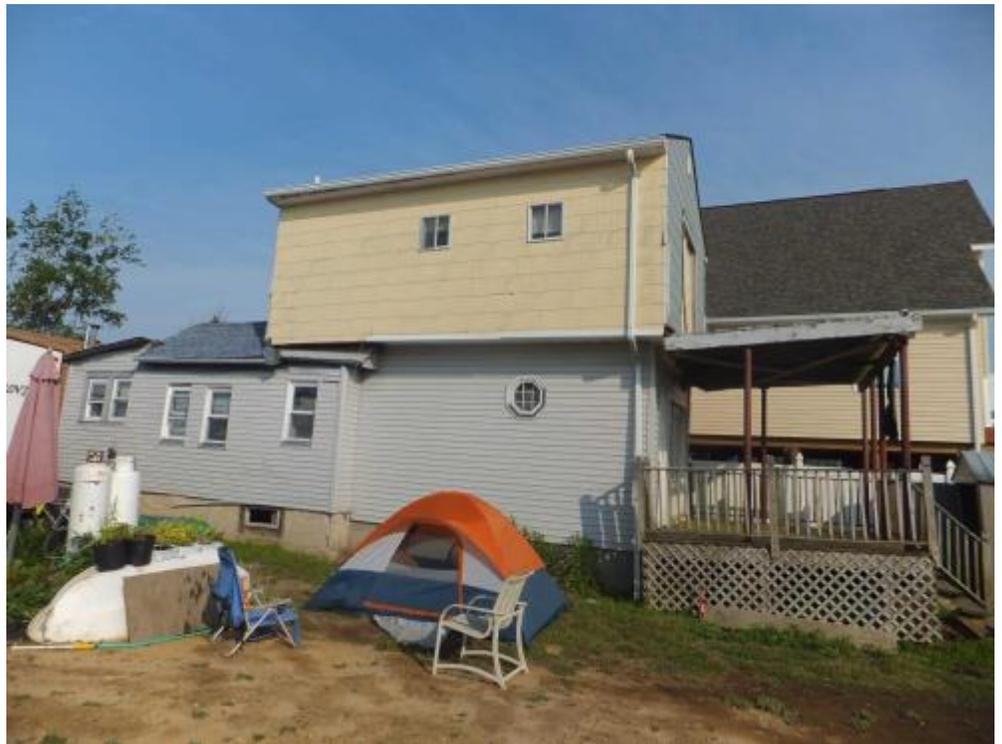
18 Right-Elevation

Overall view of right elevation. There is a 5th wheel travel trailer next to the home and the tent appears to belong to the occupants of the travel trailer.

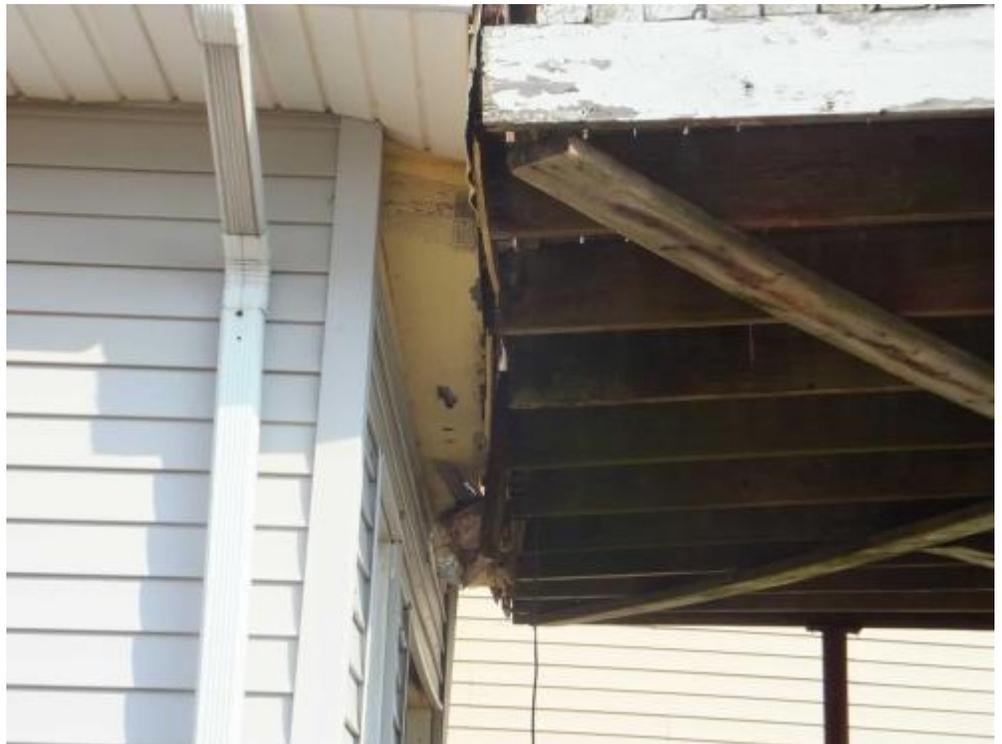
20 Right-Elevation
Date Taken: 7/14/2014
Taken By: MGREEN
Rear second floor decking appears to be separating from the main structure.

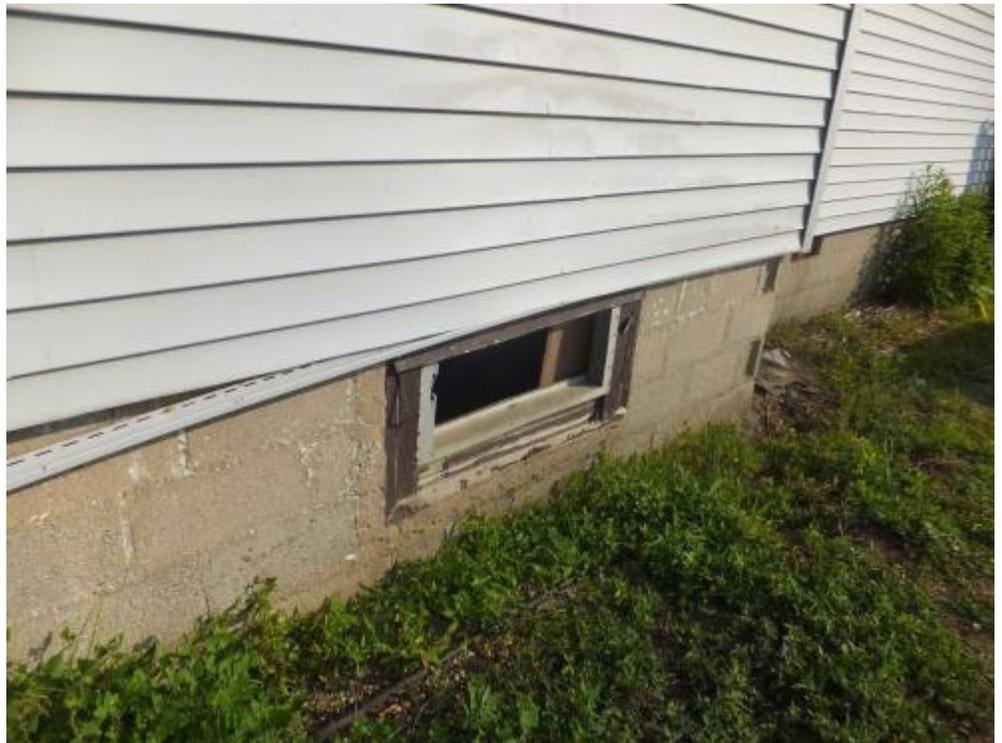
21 Right-Elevation

Slight siding damage with windows leading to crawlspace shown as broken. Possible vermin infestation.

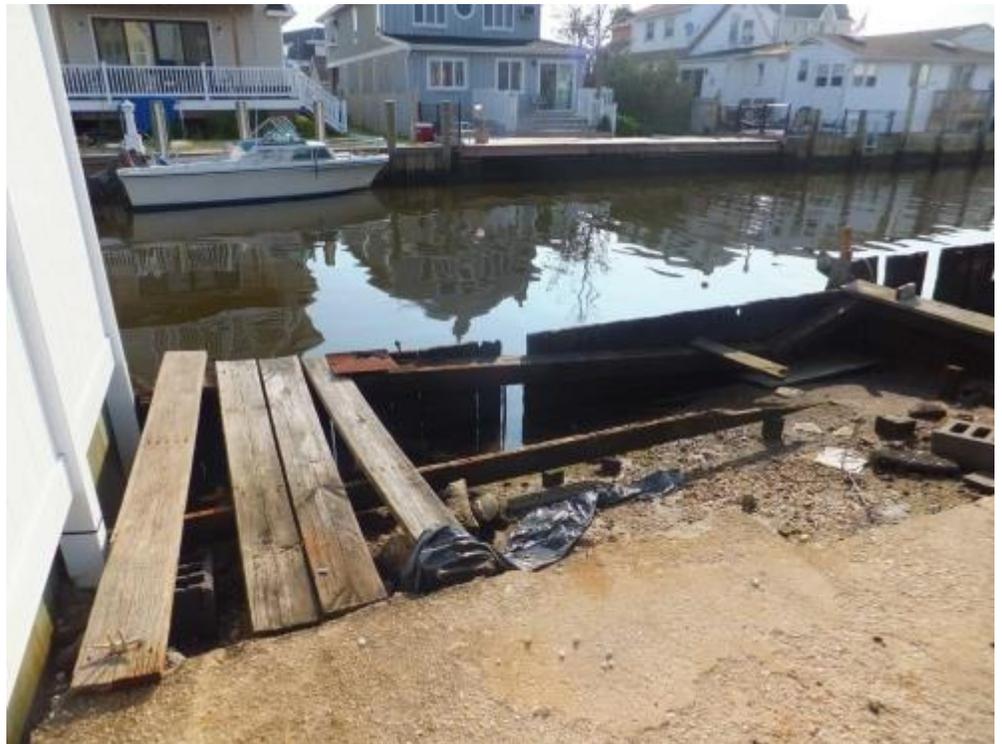
Bulkheads are damaged and the decking has been removed.

24 Bulkhead
Date Taken: 7/14/2014
Taken By: MGREEN
Bulkhead decking is severely
damaged with soil erosion.

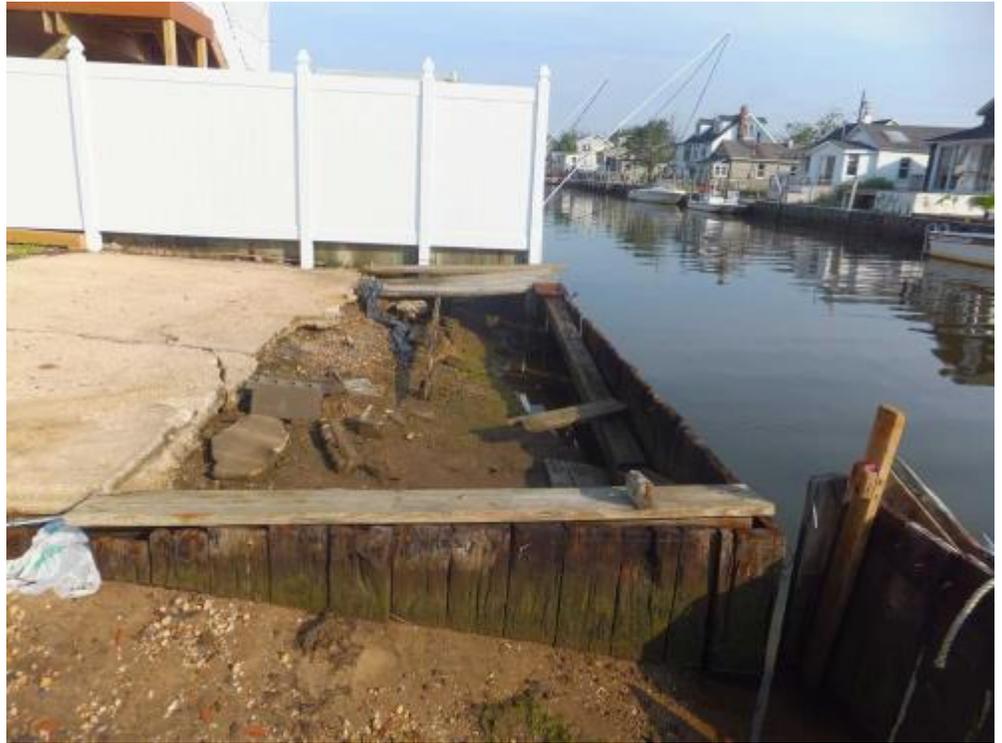
25 Bulkhead

Right to left view of Bulkhead with decking severely damaged along with soil erosion.

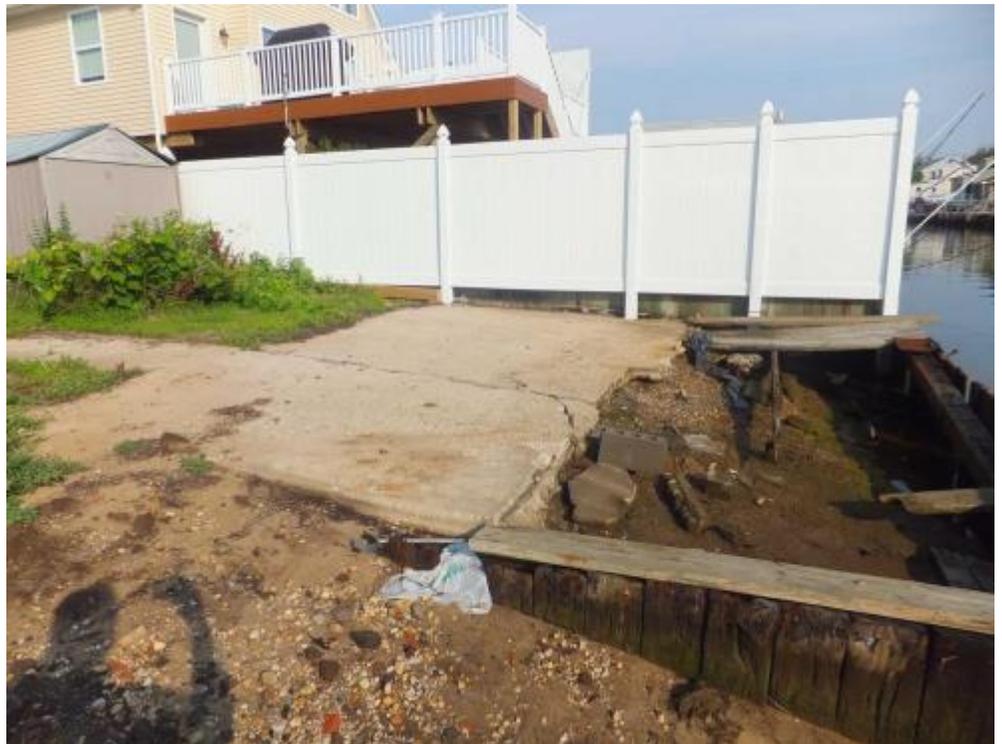
26 Bulkhead

Concrete platform leading to bulkhead is cracked and damaged.

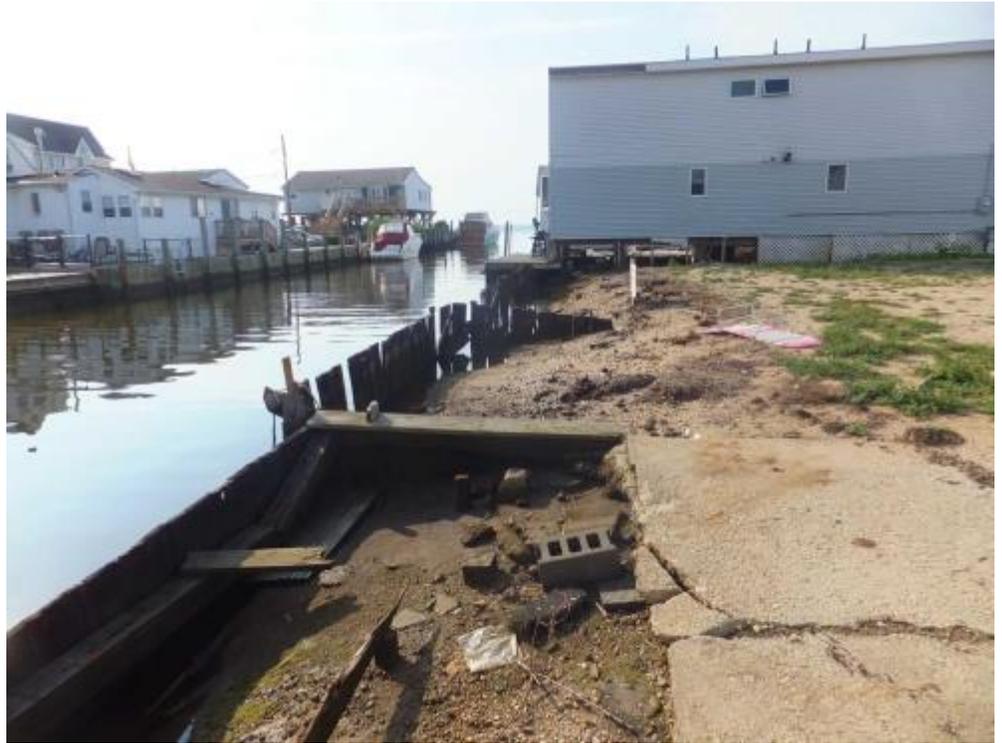
27 Bulkhead

Bulkhead is severely damaged with soil erosion. Overall view shows the condition is continuous to the other properties.
