Assessment Check List

Parcel ID#	Damage Address	City	Zip Code
OBBO-025	106 Fox Lane	Staten Is.

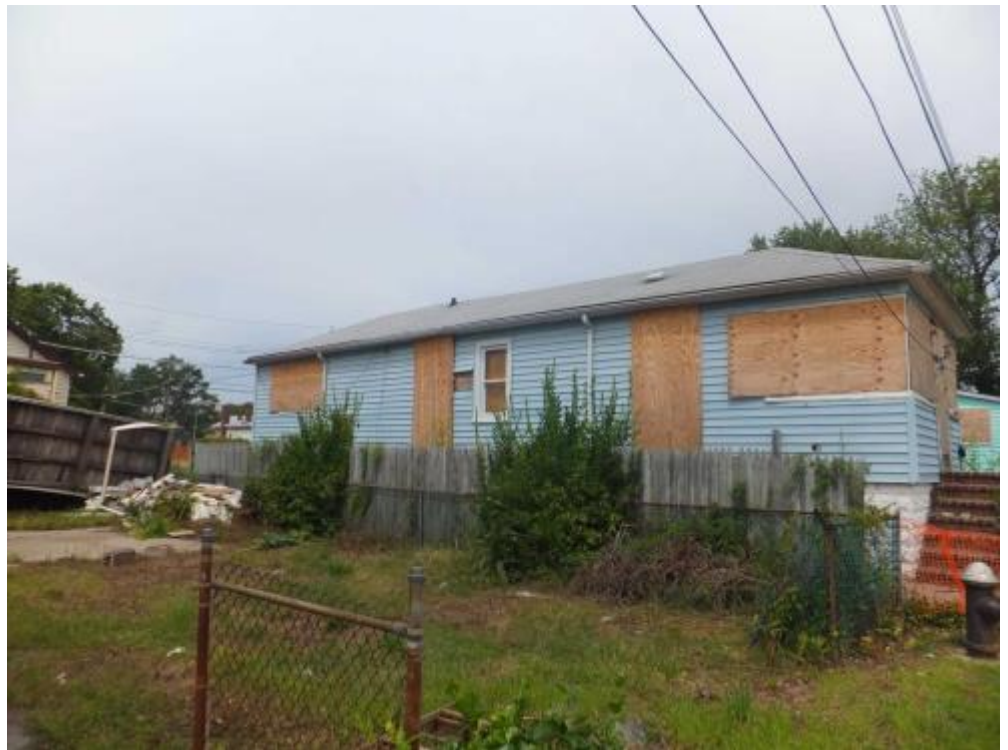
6 Left-Elevation
Date Taken: 7/19/2014
Taken By: MGREEN
Overall view of the left side of house.
The fence is blocking the lower
portion home.

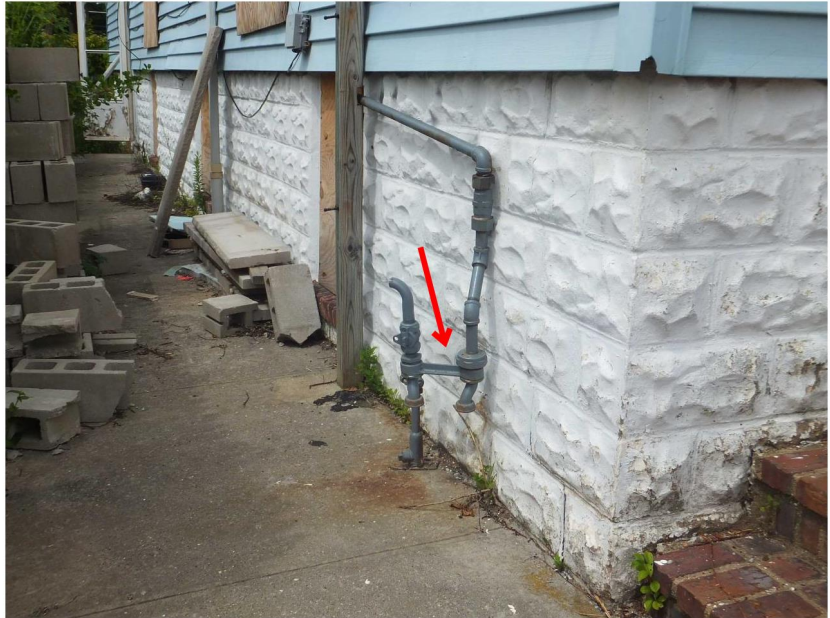
7 Left-Elevation
Date Taken: 7/19/2014
Taken By: MGREEN
Disconnected gas meter.

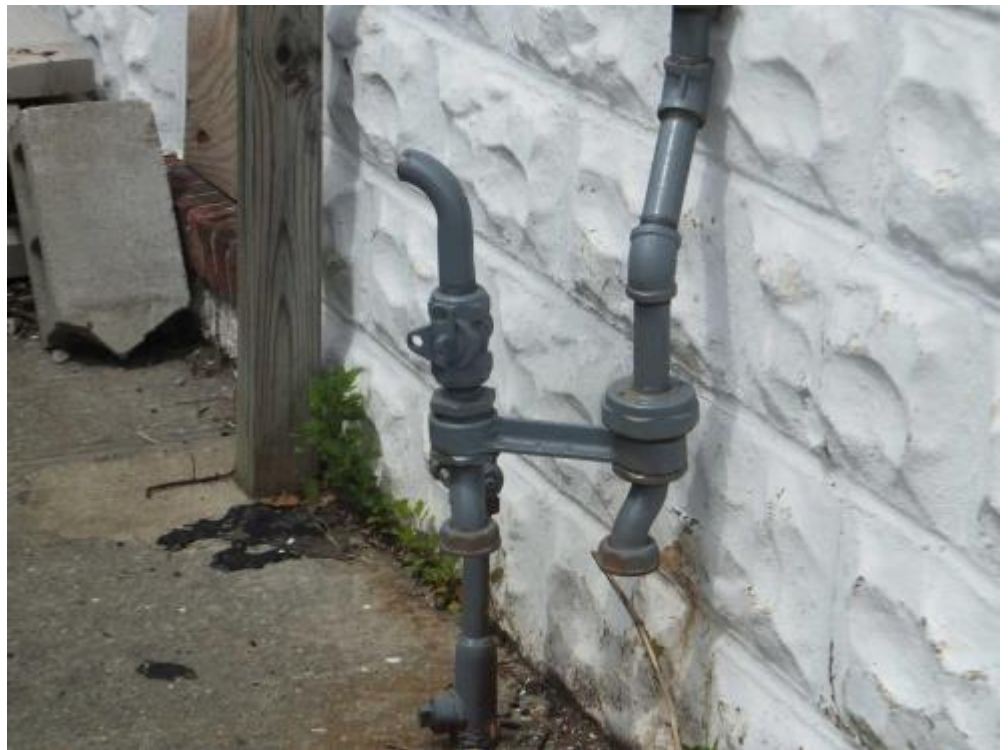
8 Left-Elevation
Date Taken: 7/19/2014
Taken By: MGREEN
Disconnected gas meter.

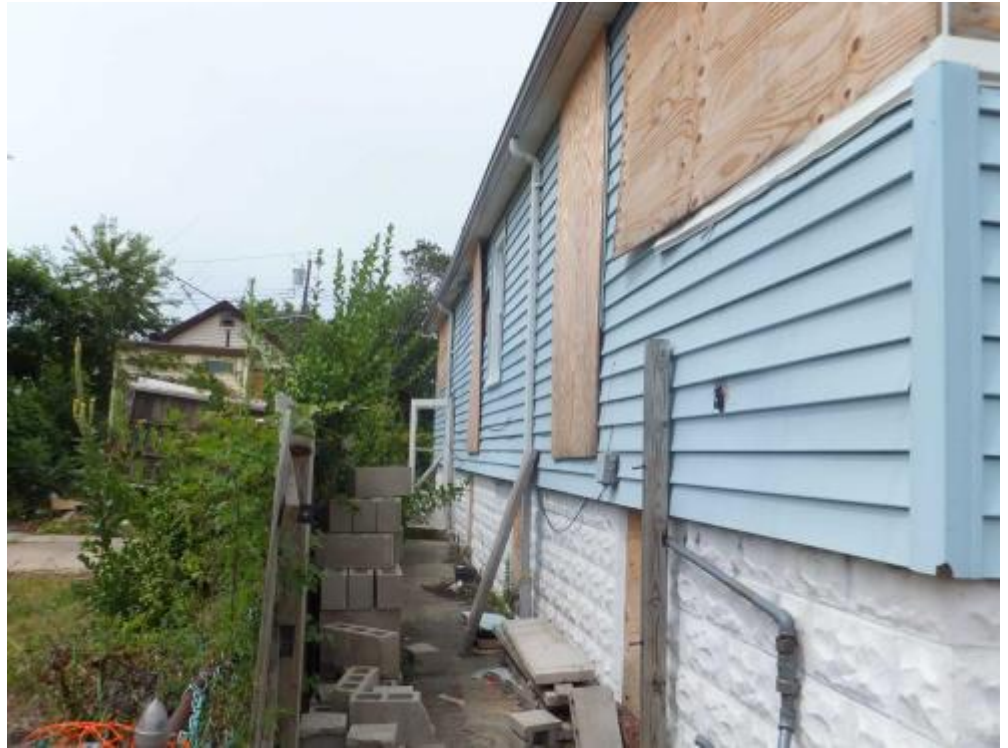
9 Left-Elevation

Side view of left elevation with cement blocks and other debris. Boarded up windows. Screen door appears to be ajar.

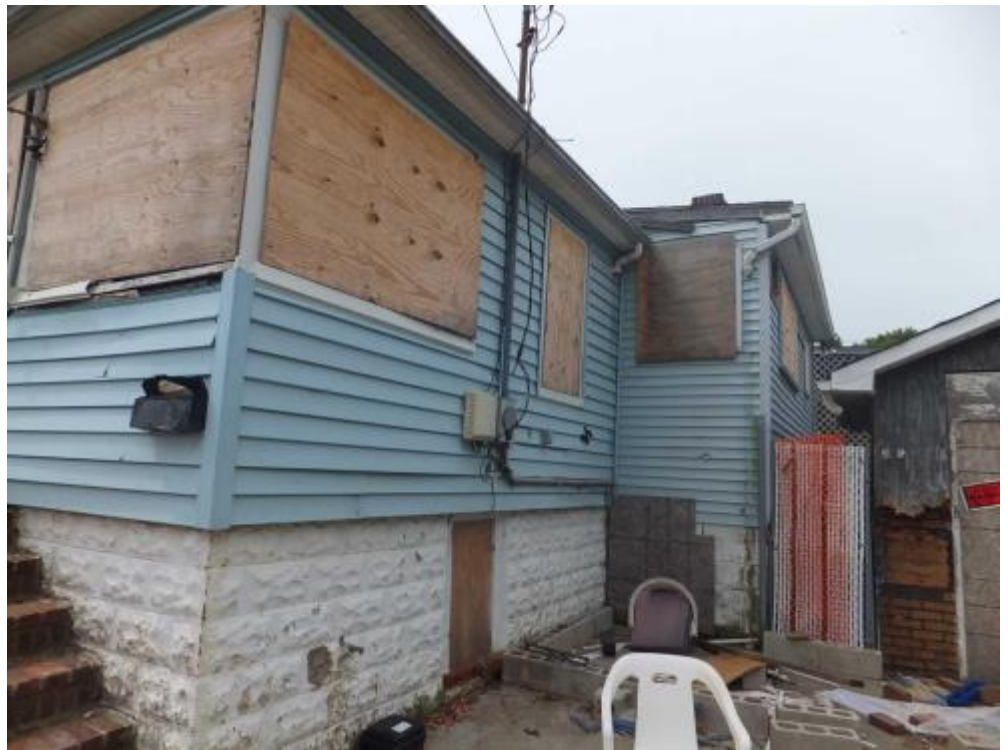
10 Right-Elevation

Overall view of right elevation with boarded up windows and debris.

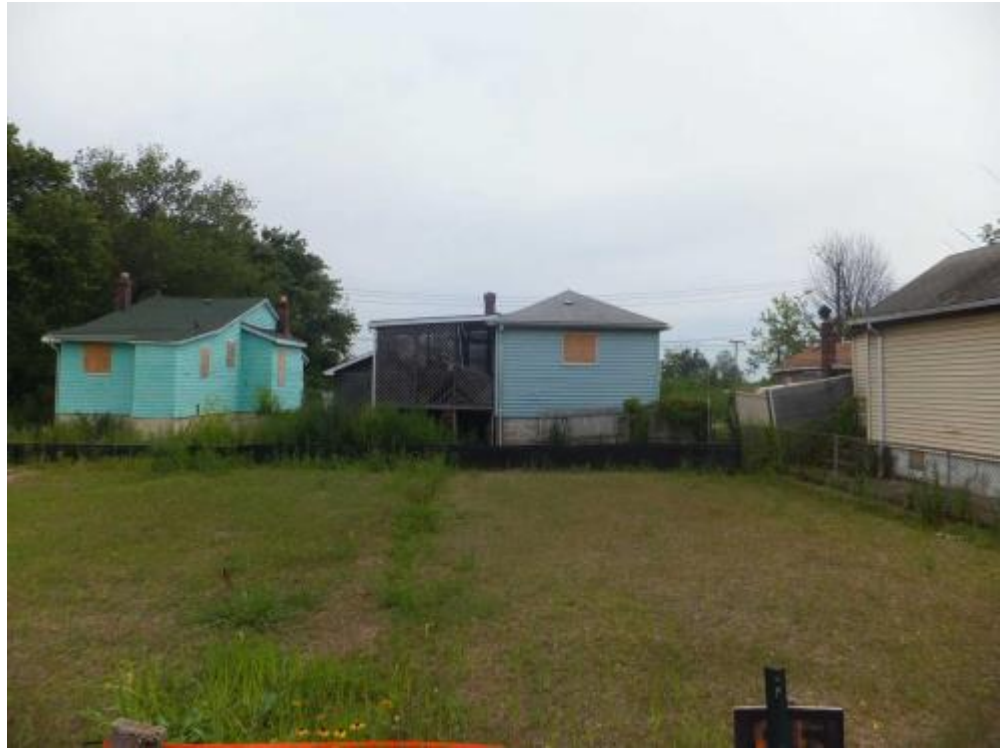
15 Rear-Elevation

Photo taken from the vacant lot behind the house. There is damage to the lattice screen porch.

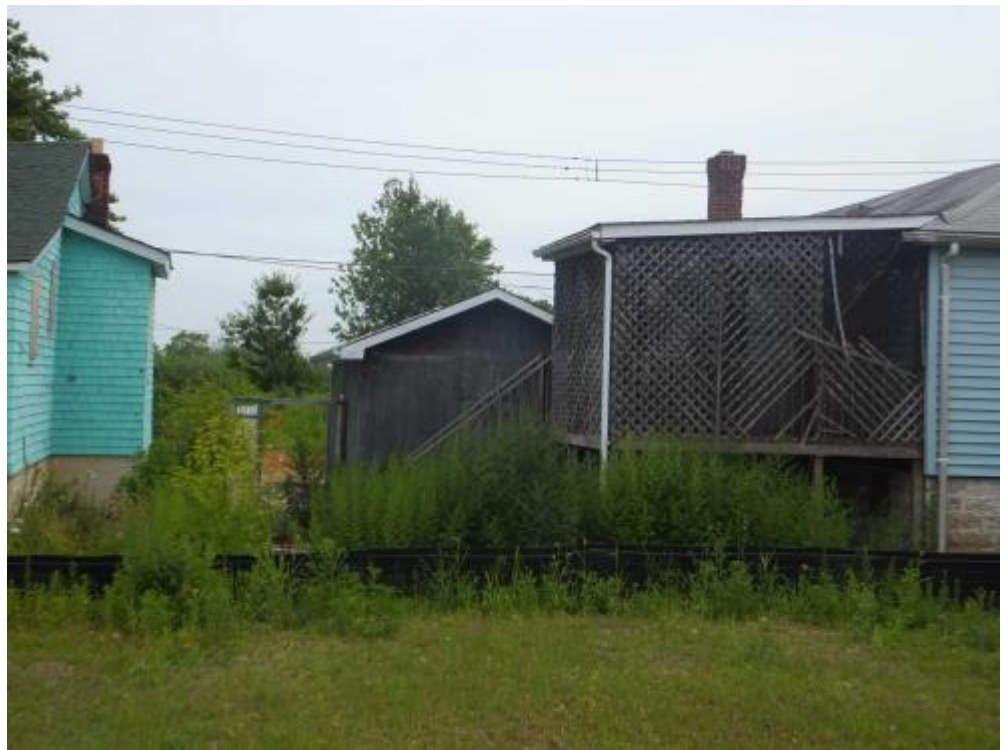
18 Rear-Elevation
Date Taken: 7/19/2014
Taken By: MGREEN
Rear view of the detached garage and side porch.
