Assessment Check List

Parcel ID#	Damage Address	City	Zip Code
OBBO-026a	51 Kissam Ave	Staten Is.

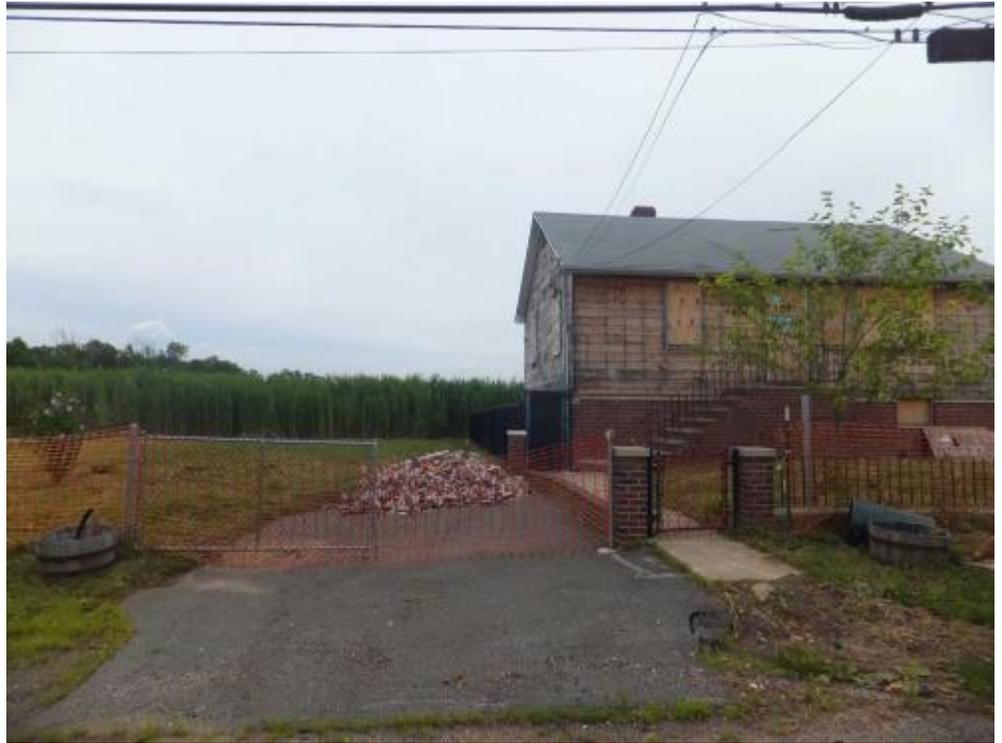
1 Front

This site appears to be two lots.
Landscaping has been maintained.
There is heavy debris on the side of
the house.

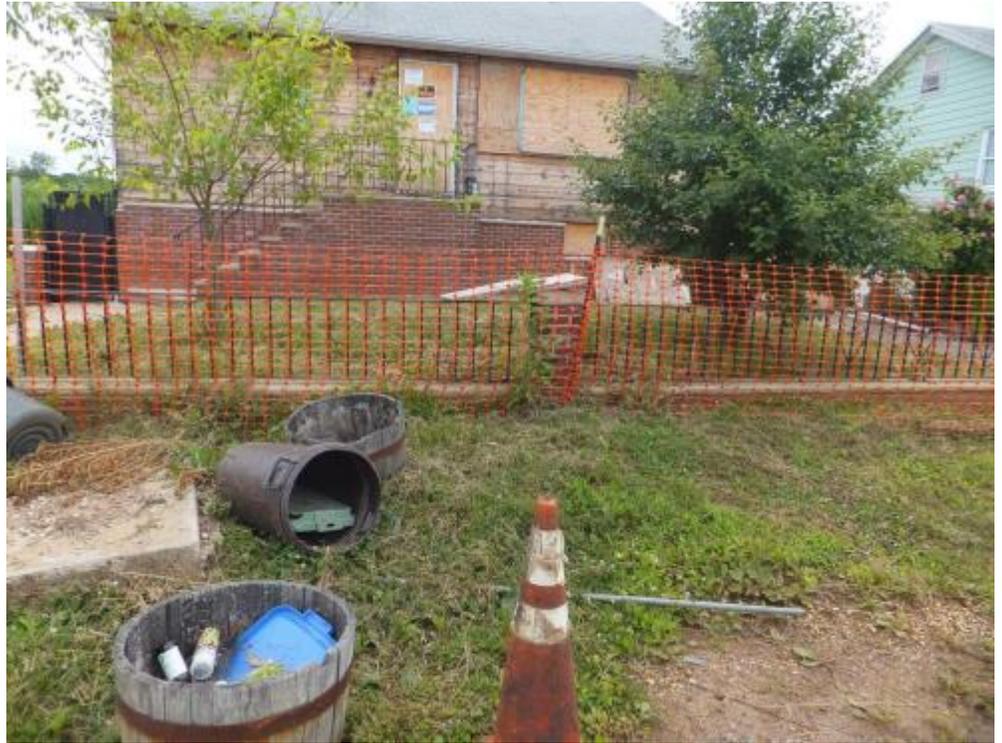
5 Front
Date Taken: 7/19/2014
Taken By: MGREEN

Front elevation shows debris in the front area and beyond the fence line.

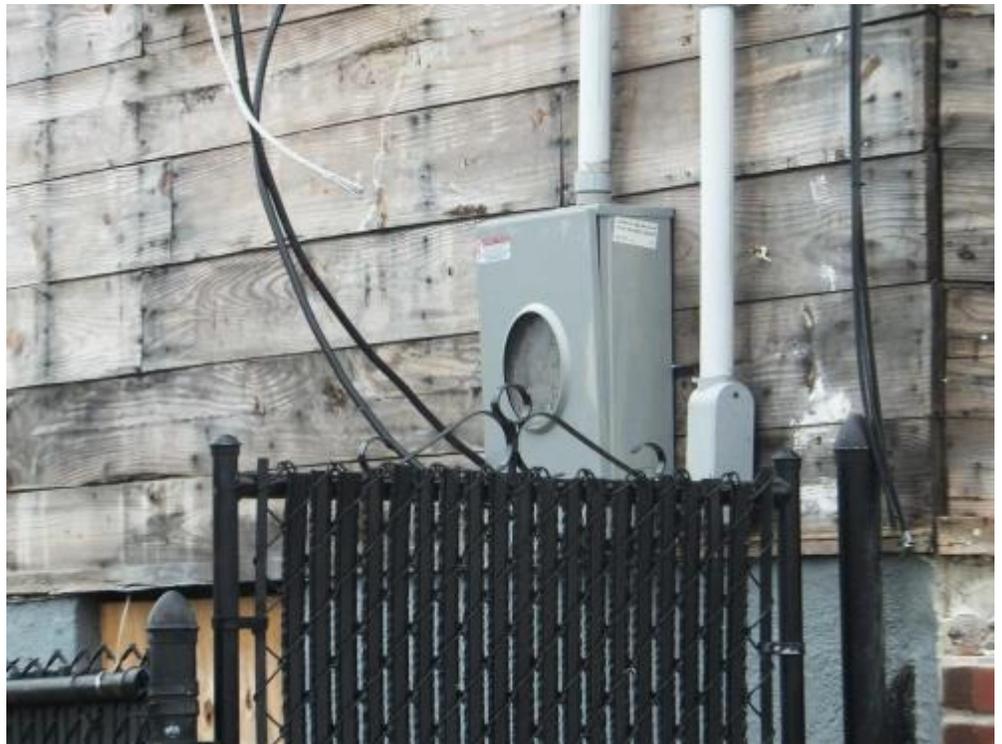
8 Right-Elevation
Date Taken: 7/19/2014
Taken By: MGREEN
Utilities have been disconnected.

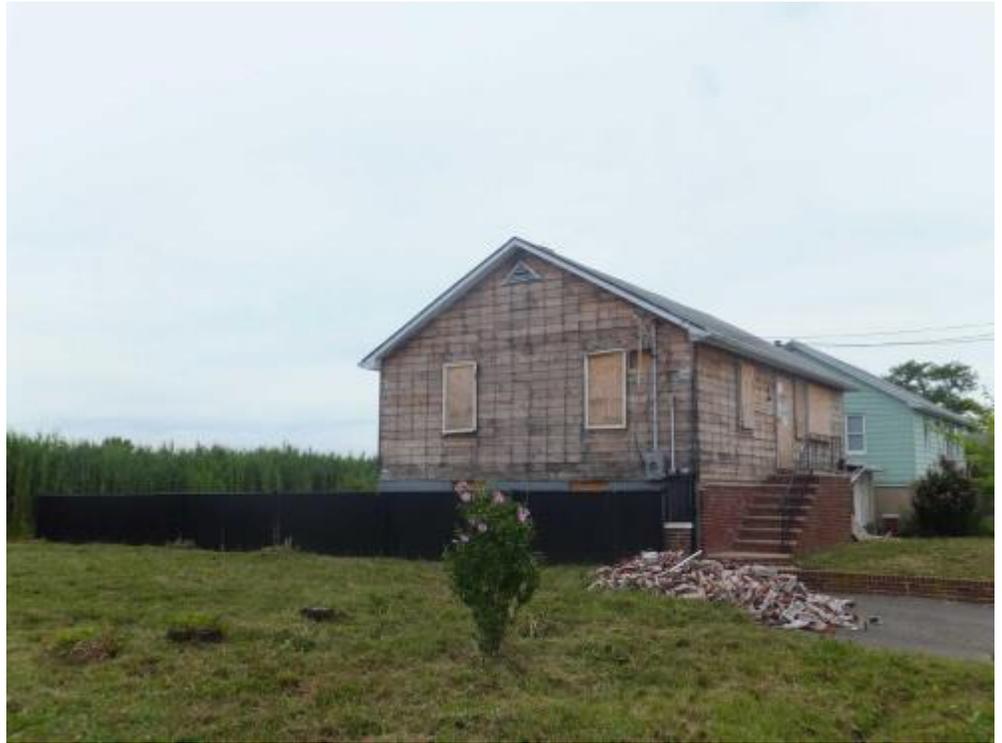
9 Right-Elevation
Date Taken: 7/19/2014
Taken By: MGREEN

Overall view of the left elevation of the site. Heavy brick debris at the side of the house.

Notes: Remove heavy brick debris from site. It appears to be the brick from the siding of the house.

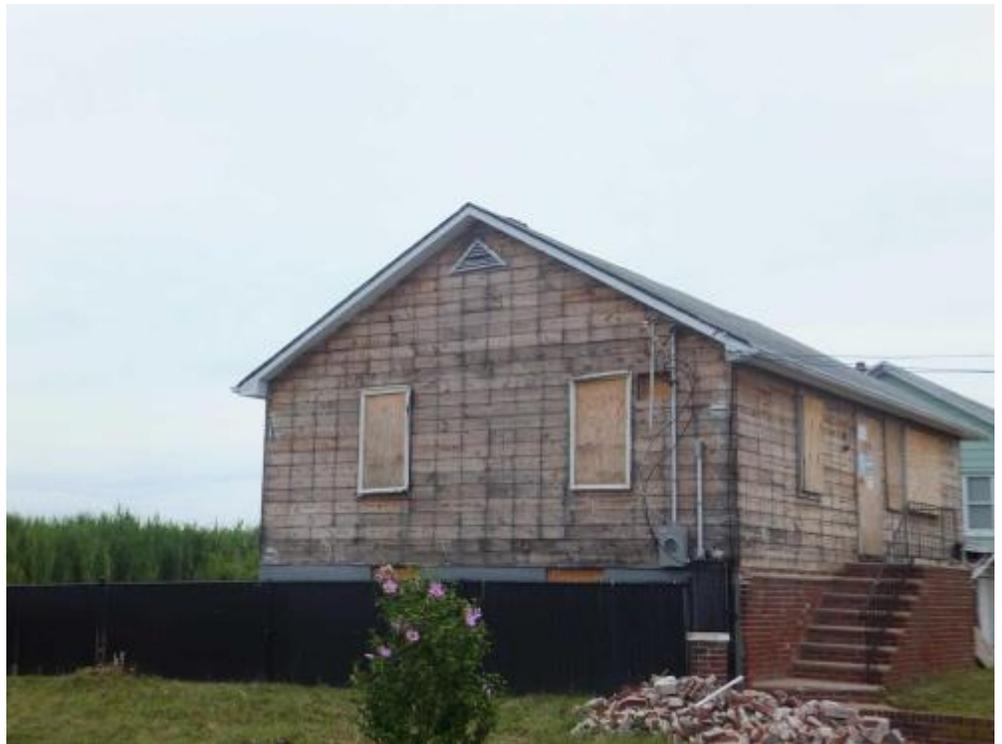
10 Right-Elevation
Date Taken: 7/19/2014
Taken By: MGREEN

Overall view of the right elevation. House no apparent siding.

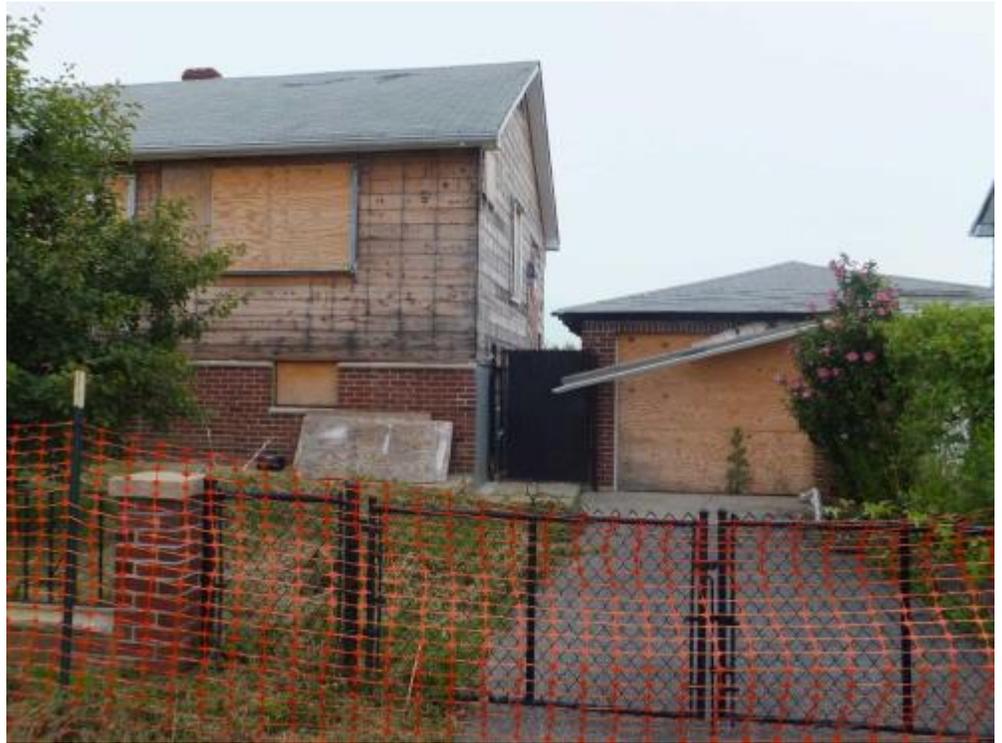
11 Front-Elevation

Detached garage is boarded up with damaged gutters and roofing.

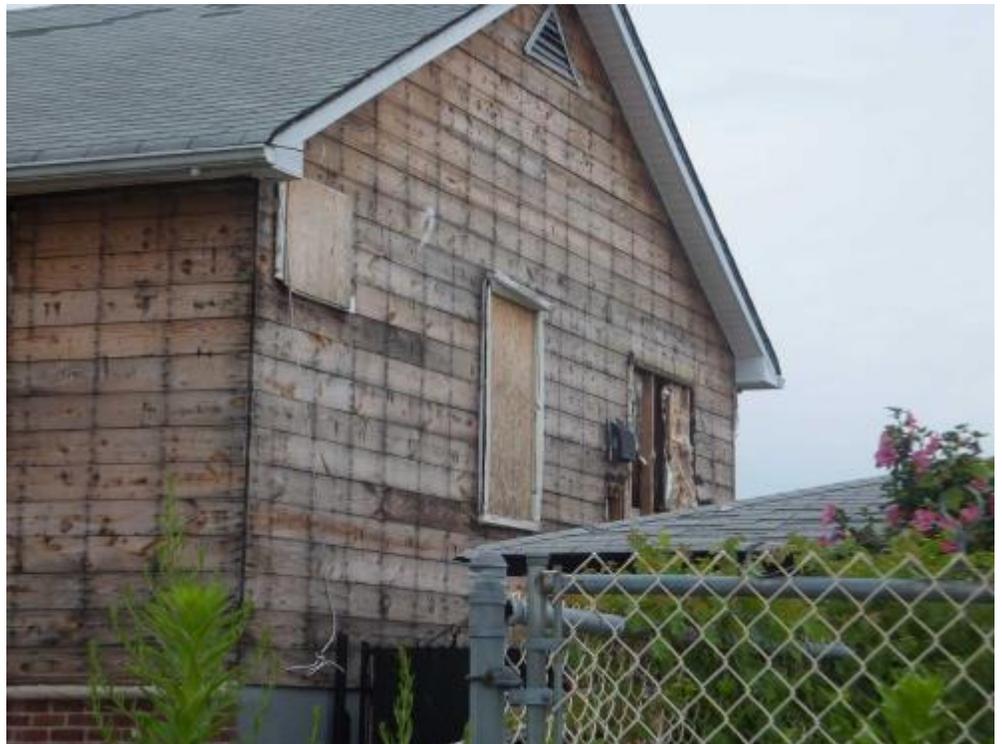
12 Left Elevation

House has no siding and the rear window appears to be unboarded.

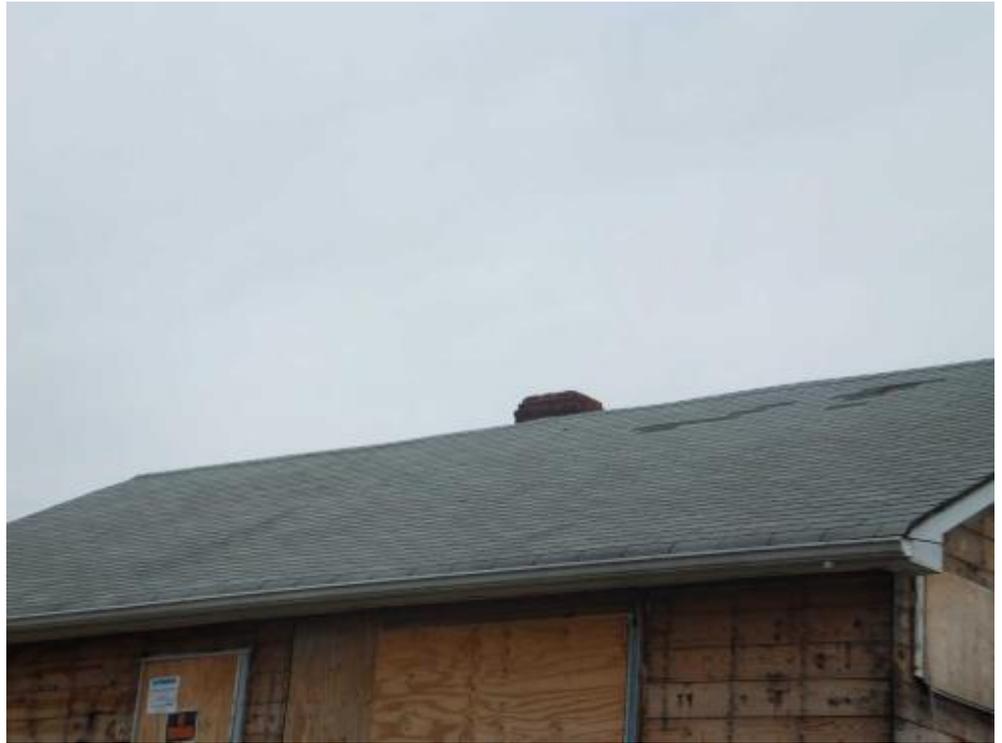
13 Roof

Partial damage to the roof with missing shingles.
