New Moxey Rigby Apartments, Freeport, NY
Environmental Assessment

Project Name: New Moxey Rigby Apartments

Project Location: 195 East Merrick Avenue and 33 Buffalo Avenue, Village of Freeport, Town of Hempstead, NY

Project NEPA Classification: 24 CFR 58.36 (Environmental Assessment)

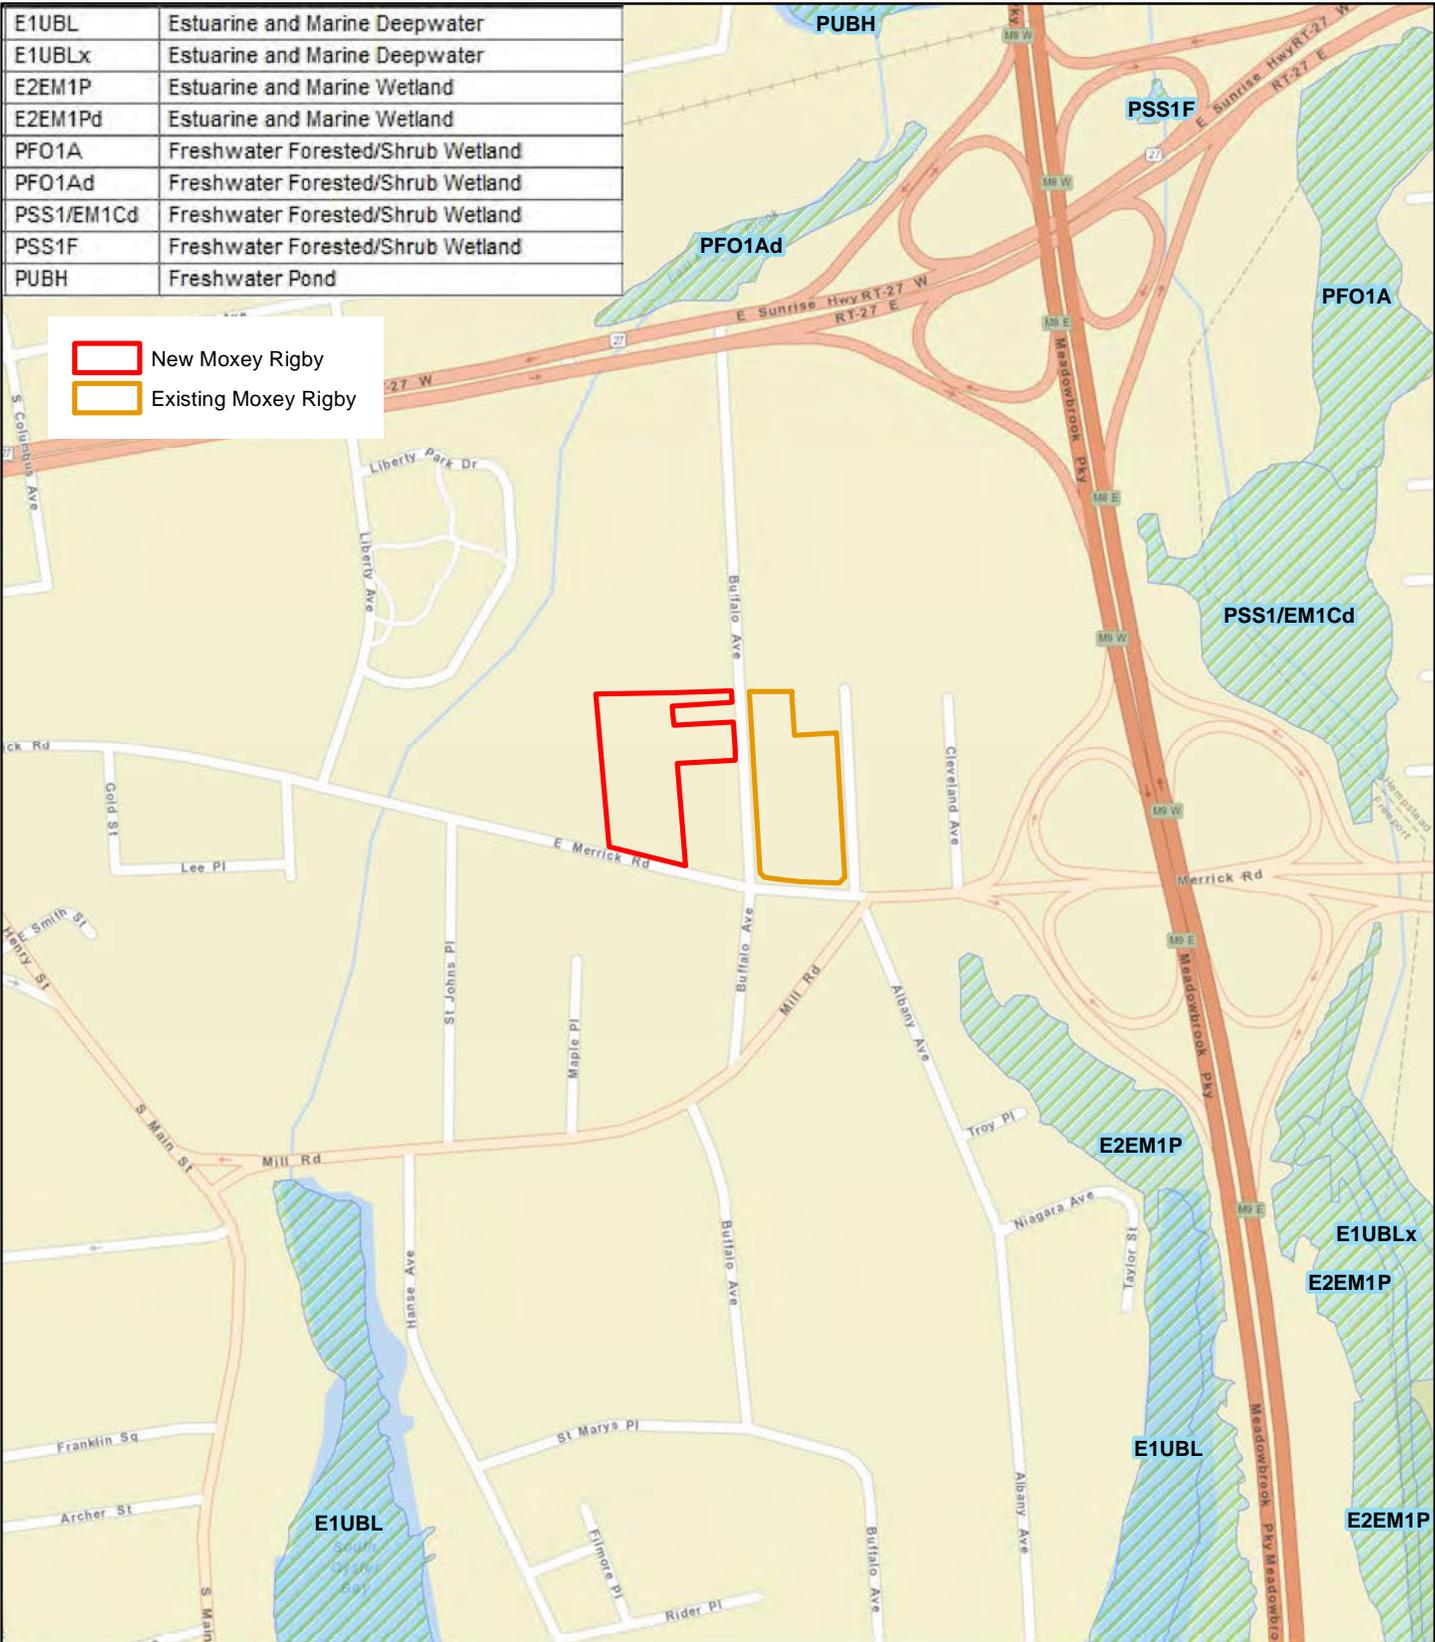
FIGURE 2-4
NATIONAL WETLANDS
INVENTORY MAP

Source: ESRI Web Mapping Service, National Wetlands Inventory Map
 Scale: 1 inch = 500 feet

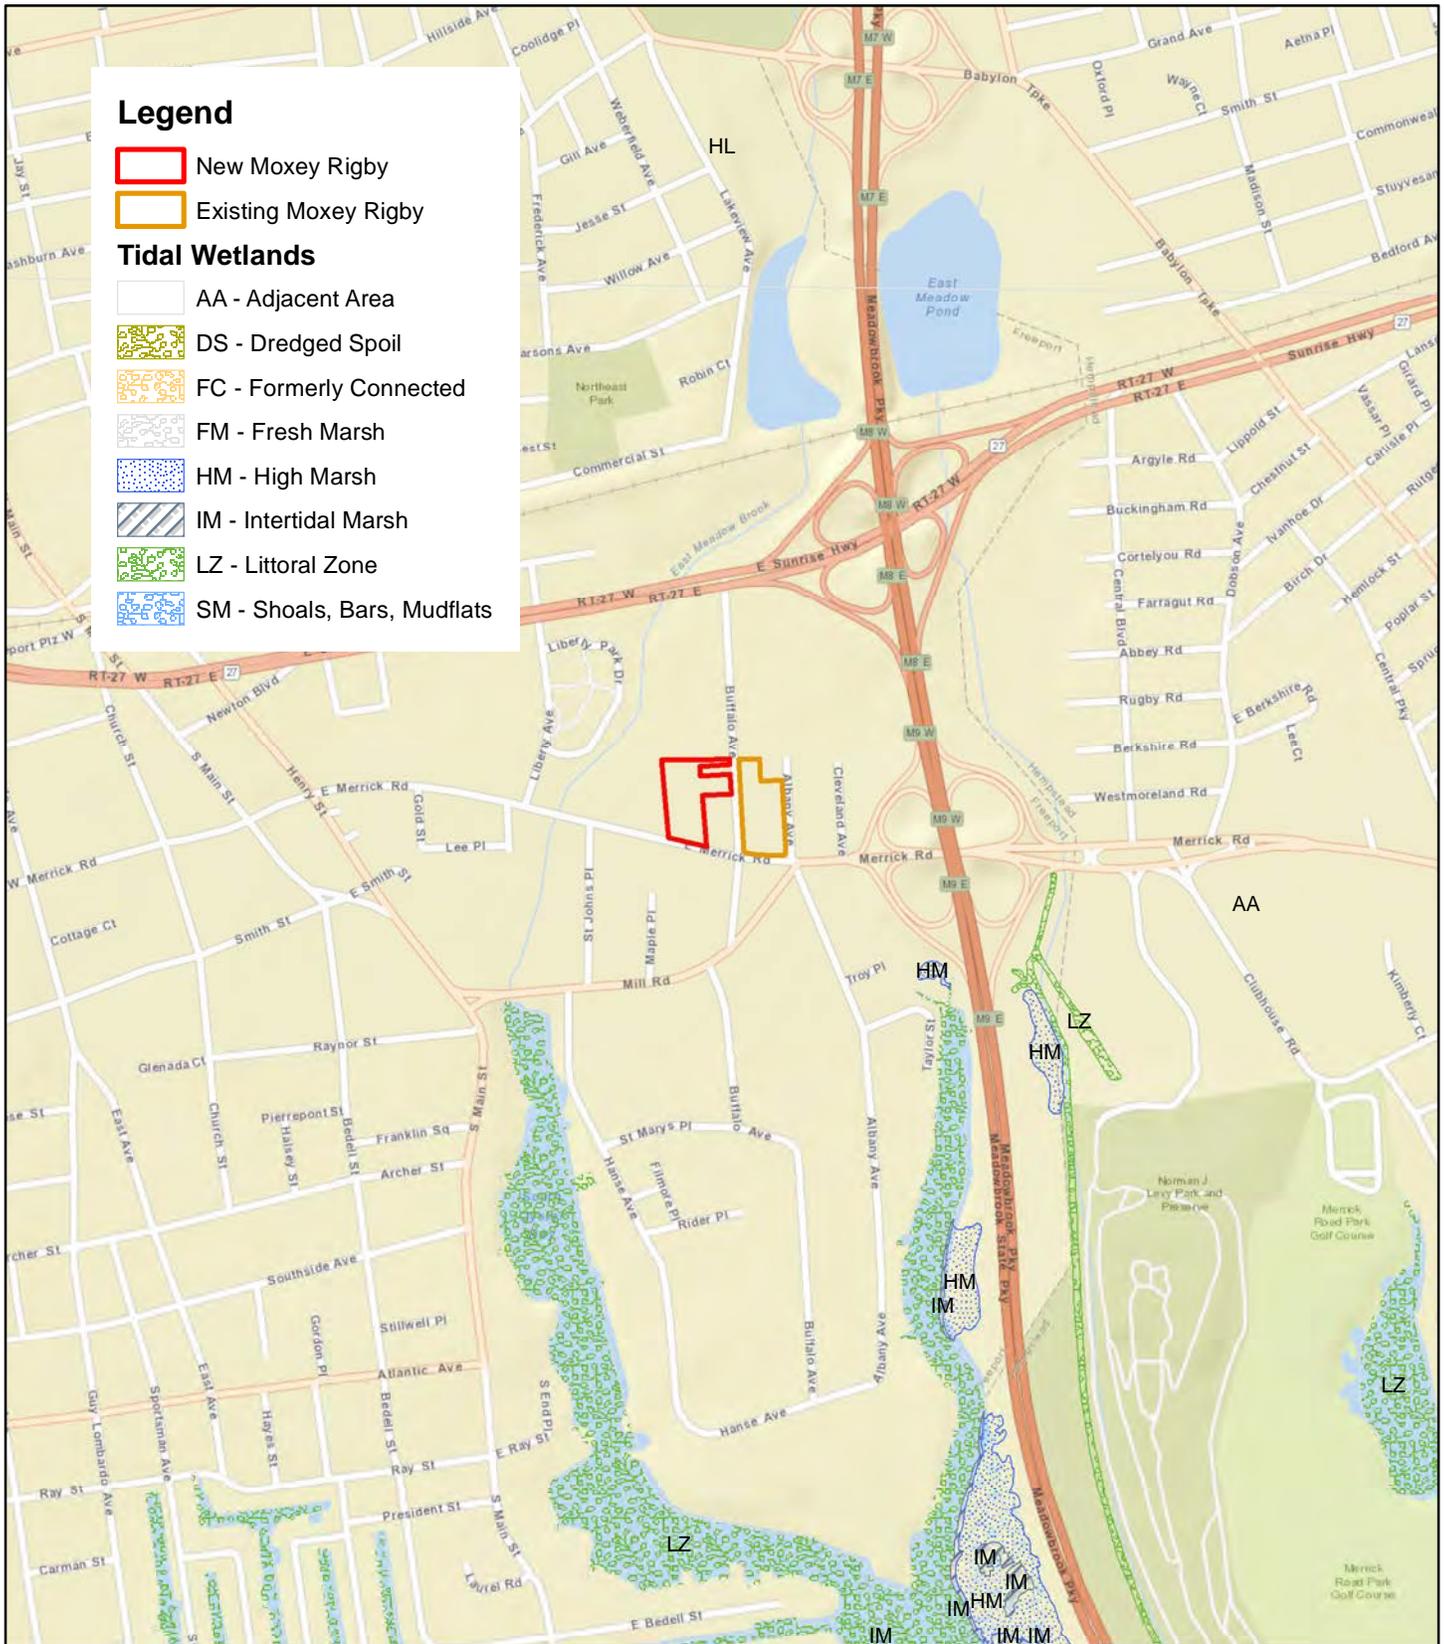
FIGURE 2-5
NYSDEC TIDAL WETLANDS
MAP

Source: ESRI Web Mapping Service, NYSDEC
 Tidal wetlands, 2013
 Scale: 1 inch = 1,000 feet

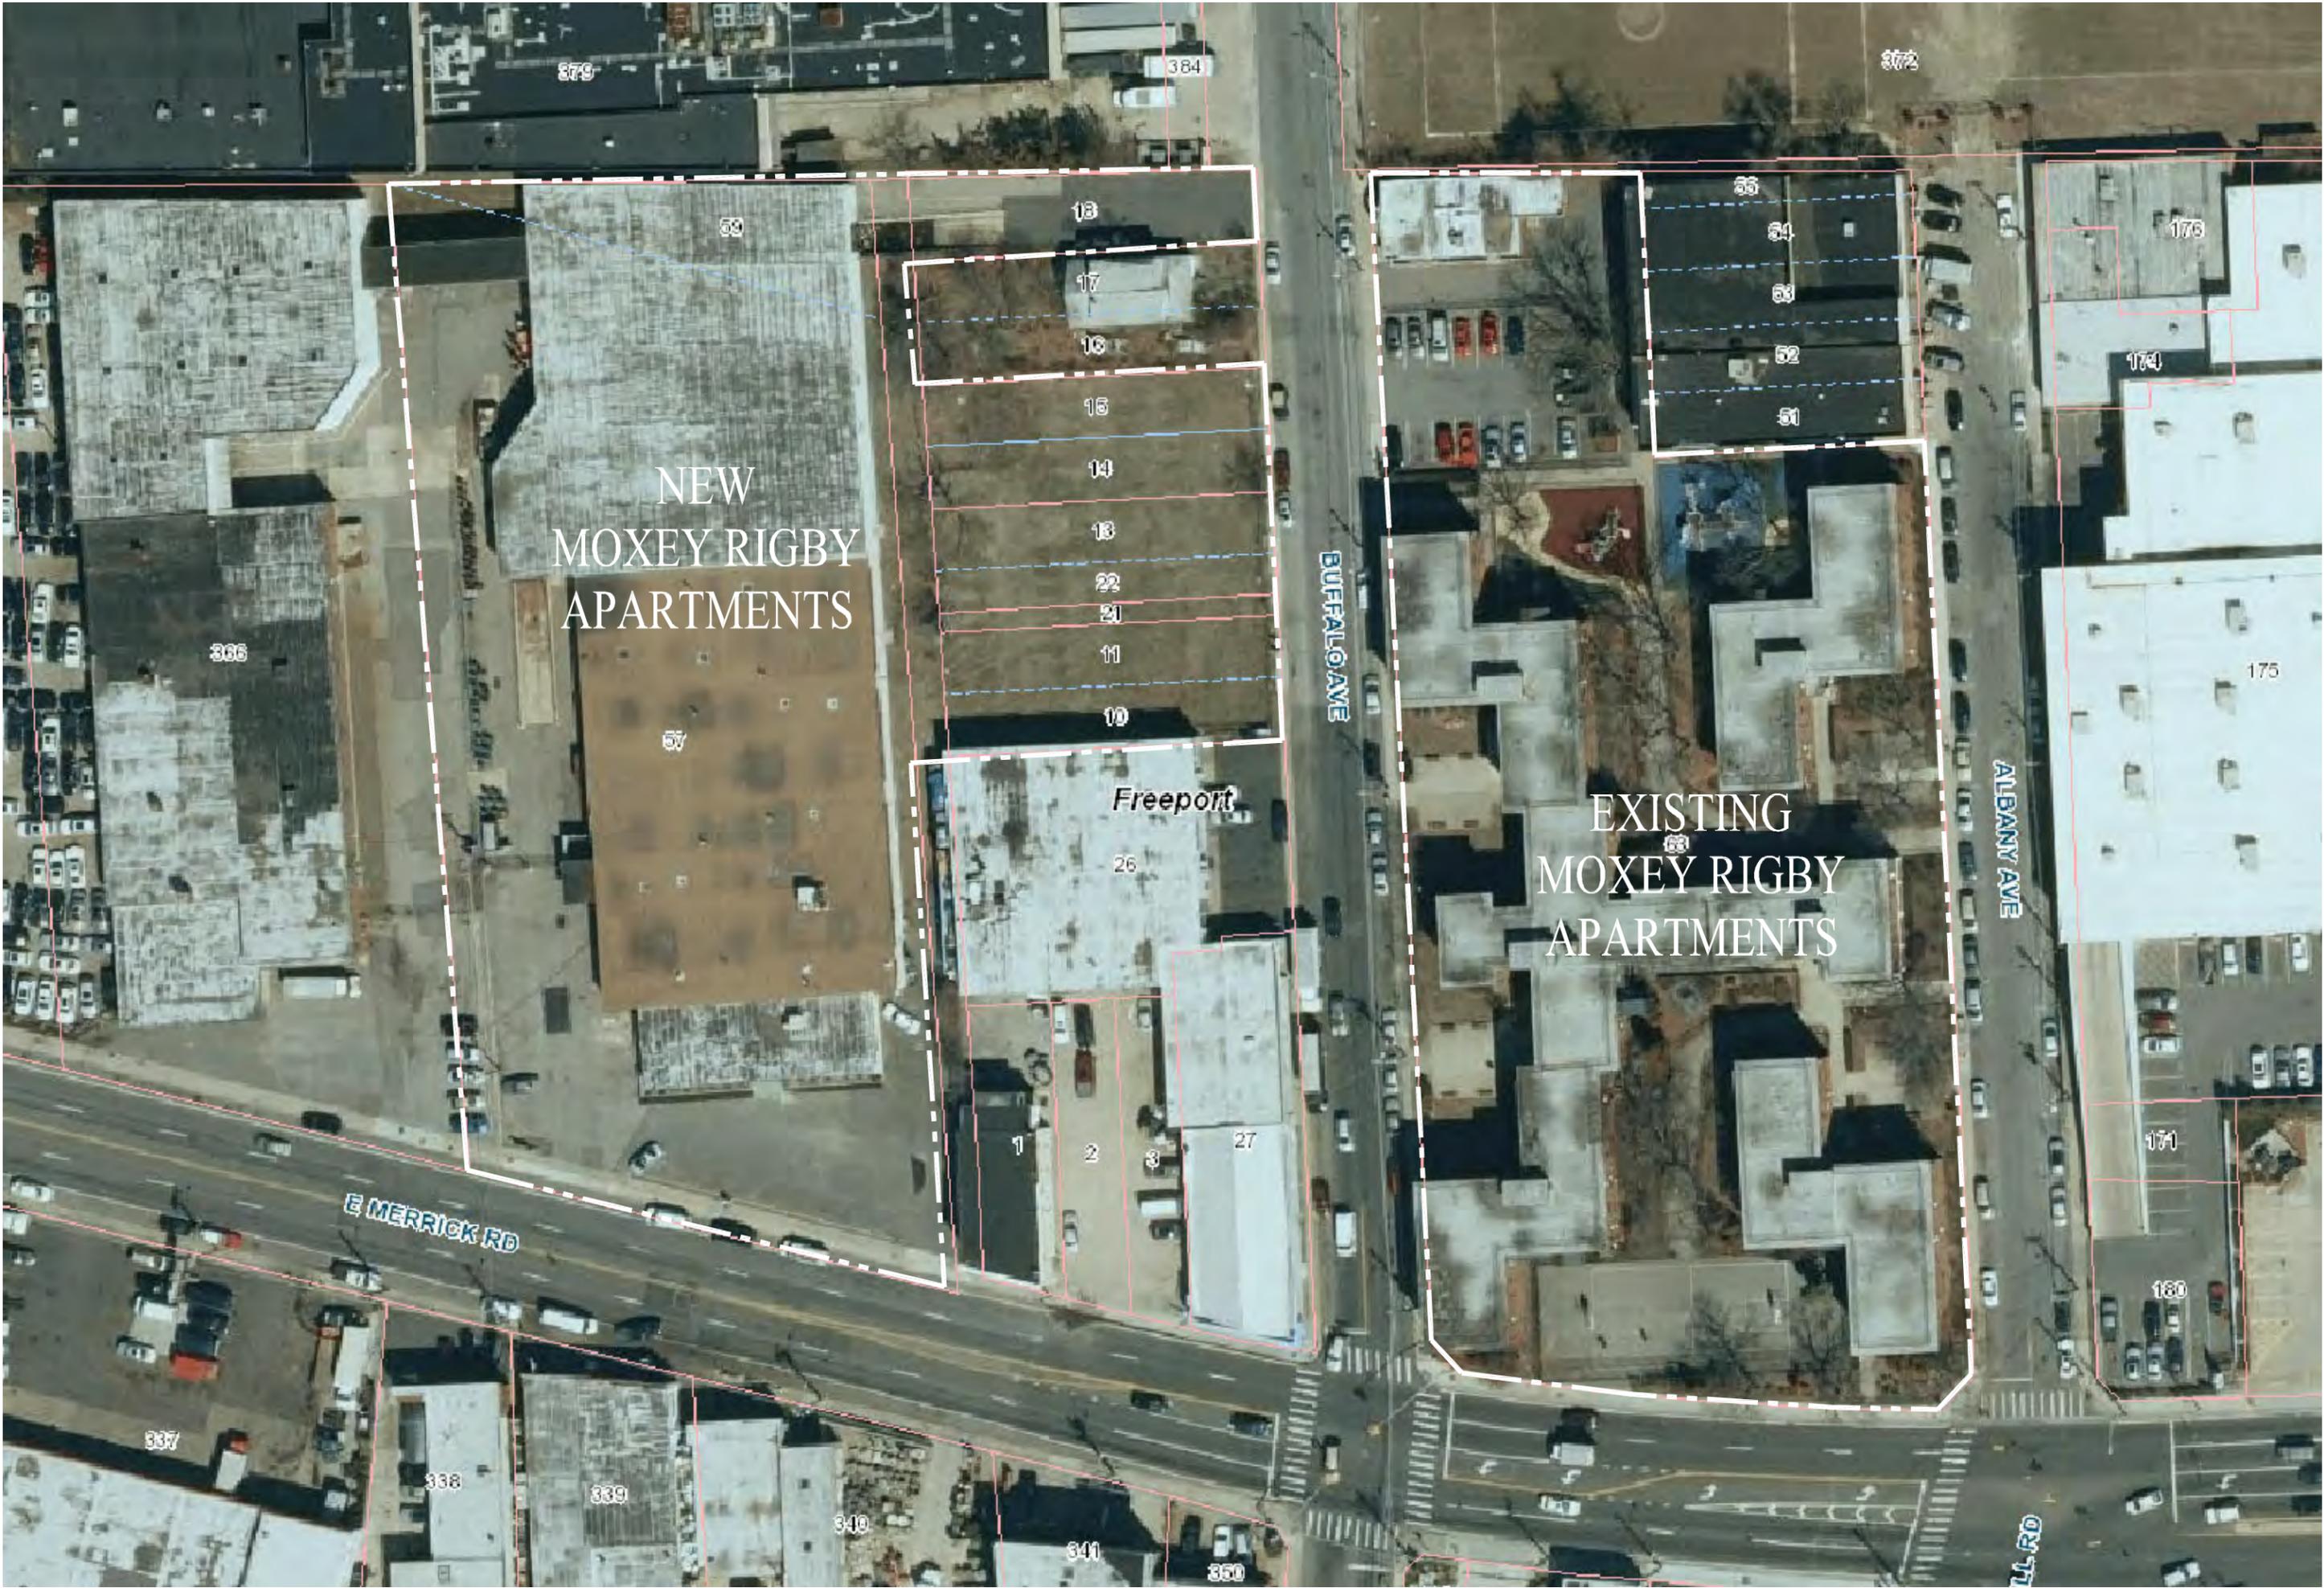
1 FIRST FLOOR PLAN & SITE PLAN
SCALE: 1/8" = 1'-0"

<p>allow space necessary to install drainage facilities. The new building is designed with the ground floor as a parking structure to limit exposure of residents to flood hazards. Residential units would begin on the second floor above the BFE.</p> <p>Currently, the property has virtually no on-site stormwater storage, so most runoff flows into the Village's stormwater system. Retaining and recharging project runoff on-site, would allow for handling of a large storm event with no overflow to the Village's stormwater drainage network, which would represent a long-term beneficial change to the condition of the 100-year floodplain. Long-term direct impacts would include replacement of impervious surface with new impervious surface, with integral drainage systems. As a result, the proposed action represents short-term impacts to previously disturbed areas. The design for the proposed redevelopment of the 195 East Merrick Avenue has been approved by the Village of Freeport Floodplain Manager/Mitigation Coordinator. There would be no relative change in the level of development within the 100-year floodplain at the 195 East Merrick Avenue site.</p> <p>The existing 2.2-acre Moxey Rigby Apartment complex at 33 Buffalo Avenue would be decommissioned and demolished. The former administrative area on the north end of the existing Moxey Rigby site may be retained and utilized for storage. The level of development at the 33 Buffalo Avenue site would be reduced through demolition of the existing structures. Direct impacts include demolition of most of the existing impervious surface. The proposed action represents short-term impacts to previously disturbed areas and may result in a beneficial change to the condition of the 100-year floodplain. As the final use of the existing</p>
