December 18, 2019

**Re: Wetland Investigation Technical Memorandum  
Monhagen Brook Culvert Project – Site 1  
West Main Street over Monhagen Brook  
City of Middletown, Orange County, NY**

West Main Street Culvert  
Replacement Project  
City of Middletown  
Orange County, New York

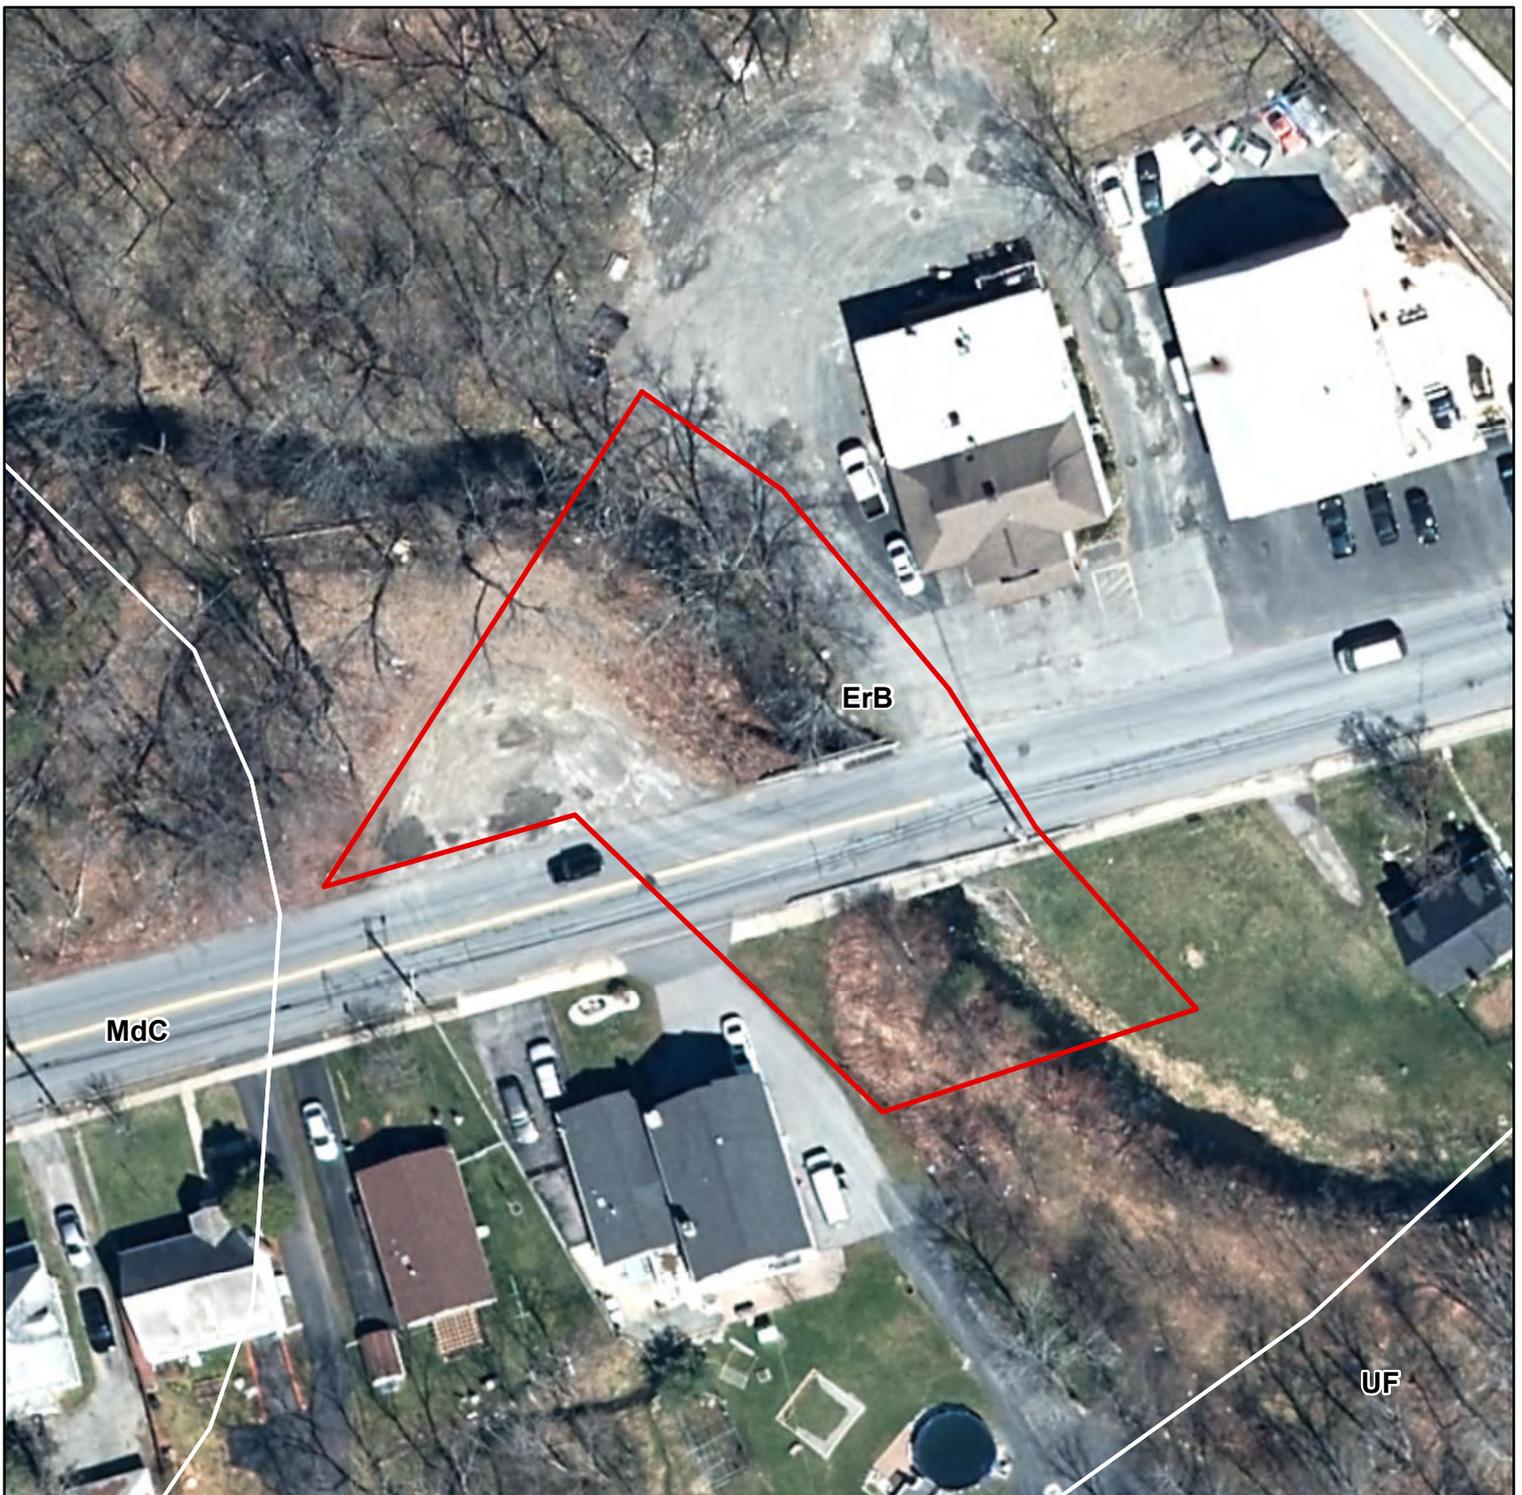
**Figure 3**  
**SSURGO Soils Map**

ErB - Erie gravelly silt loam, 3 to 8 percent slopes

No soils with hydric inclusions were found within the project study area on Orange County USDA-NRCS SSURGO Soils Mapping (**Figure 3**). No wetlands were mapped within the project study area by the USFWS NWI map (**Figure 4**) or NYSDEC freshwater wetland mapping (**Figure 5**).

USDA-NRCS SSURGO Soil mapping identified Erie gravelly silt loam (ErB) soil type within the project study area (**Appendix A, Figure 3 – SSURGO Soils Map**). Descriptions of these soils include silt loam with 3-8% slopes with parent material is described as ‘Loamy till derived from siltstone, sandstone, shale, and limestone’. ErB soils mapped by the soil survey is not listed as hydric and is considered somewhat poorly drained. Hydric soils characterized by low chroma matrix and mottling were not identified within the project study area in any investigative soil samples less than 12” deep. Soils in the field observations were silt- and sandy-loam with some gravel. Soils were generally a 10YR 2/2 color to approximately 2” below ground surface with a silt-loam texture. Below 2”, soils were a 10YR 5/3 color with a sandy-loam texture.

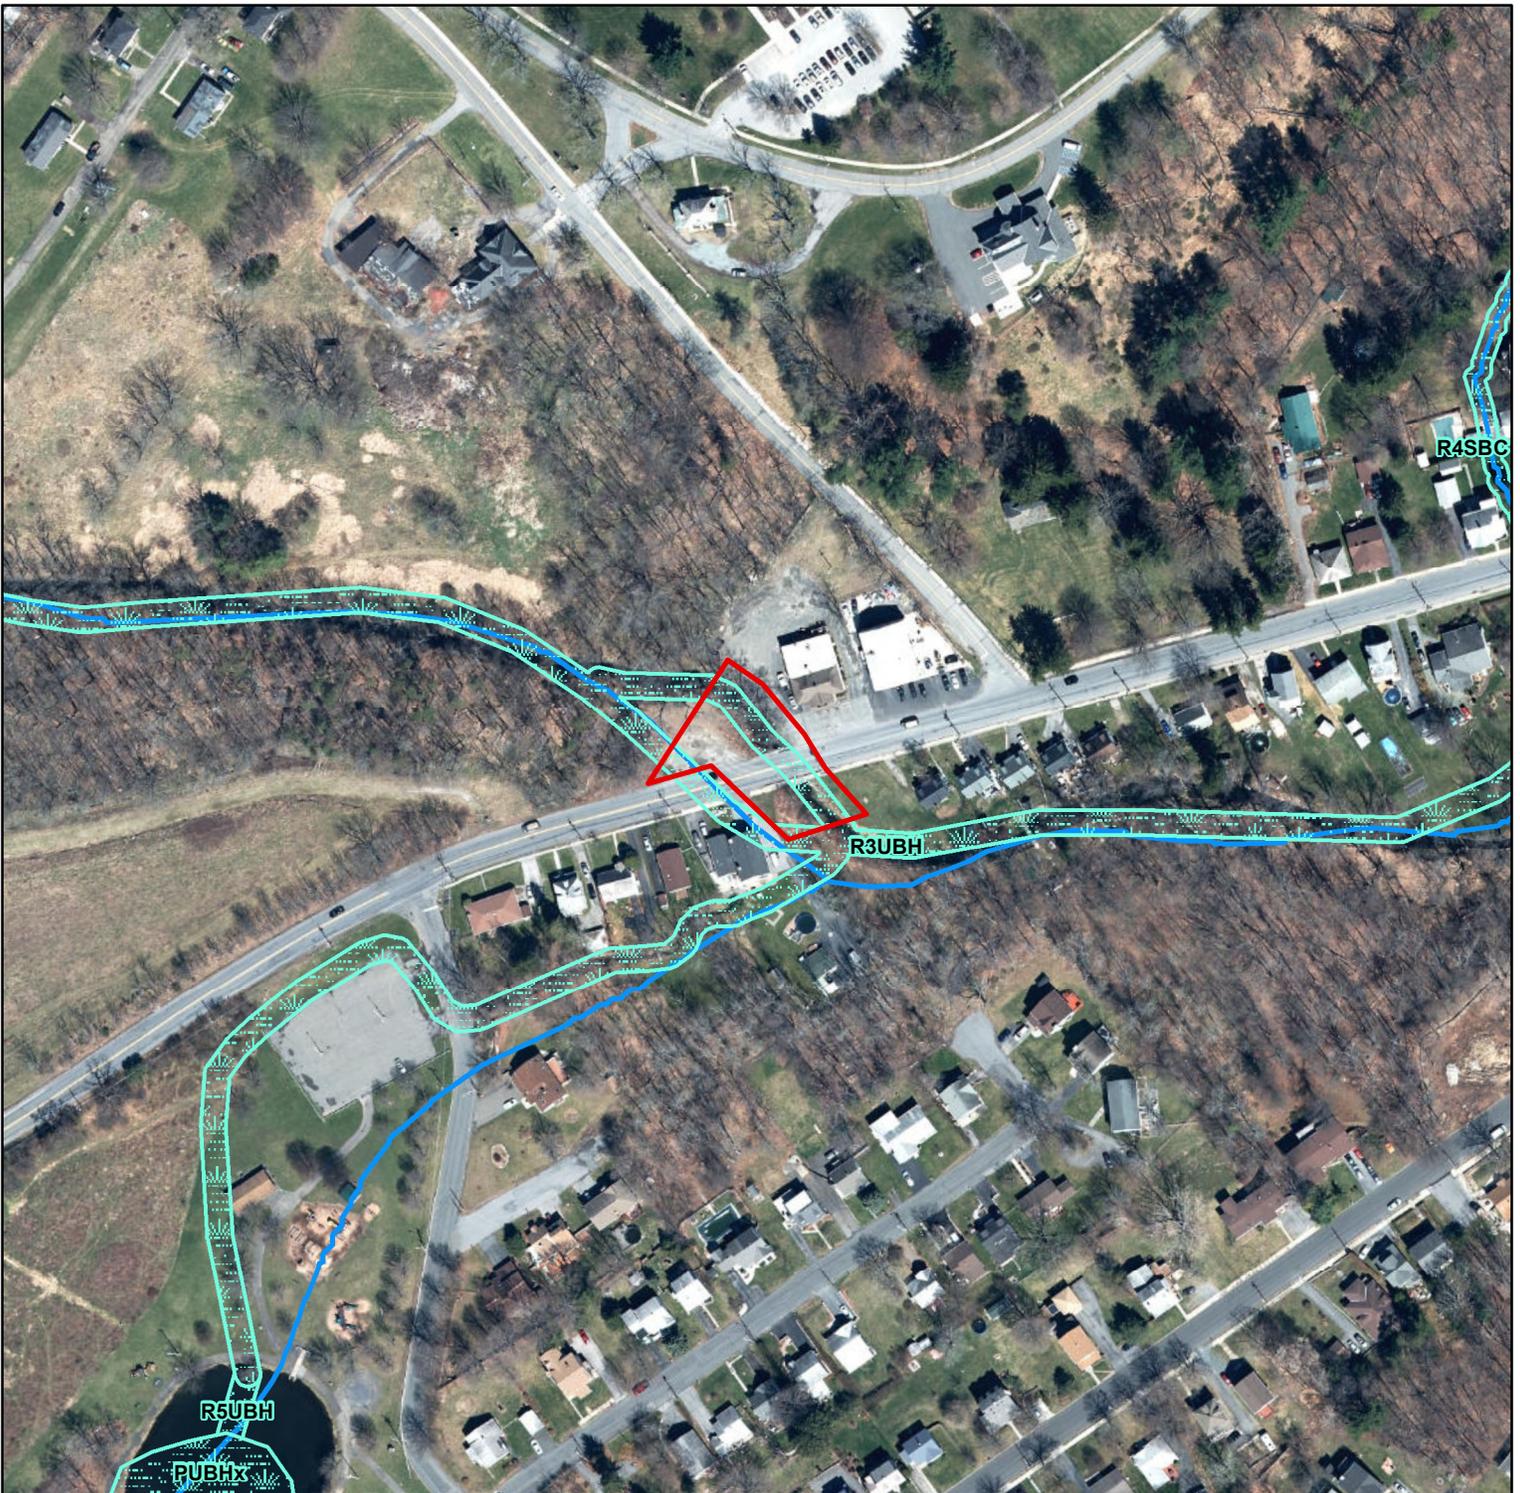
**Figure 4**  
**NWI Wetlands Map**

**NWI WETLAND CLASSIFICATIONS:**  
 R3UBH - Riverine, Upper Perennial, Unconsolidated Bottom, Permanently Flooded

The NYSDEC mapping does not map wetlands onsite. The nearest mapped feature is one NYSDEC-mapped wetland, located approximately 4,350 feet northeast of the site. The Monhagen Brook runs generally northwest to southeast through the project study area. USFWS NWI mapping shows one mapped Freshwater Pond, Lake, or Riverine wetland onsite classified as ‘R3UBH – Riverine, Upper perennial, Unconsolidated bottom, Permanently flooded’.

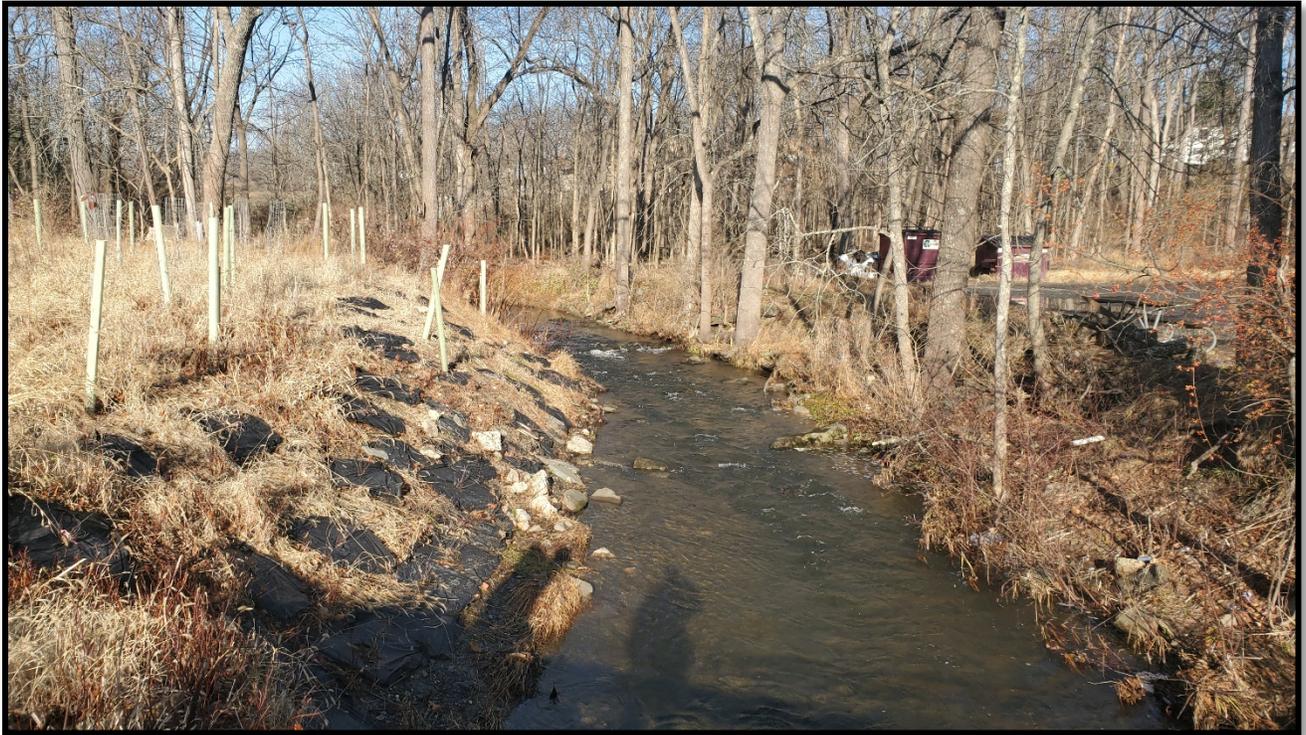
**Photo 1:** View looking northwest and upstream along Monhagen Brook from West Main Street bridge (11/26/19).

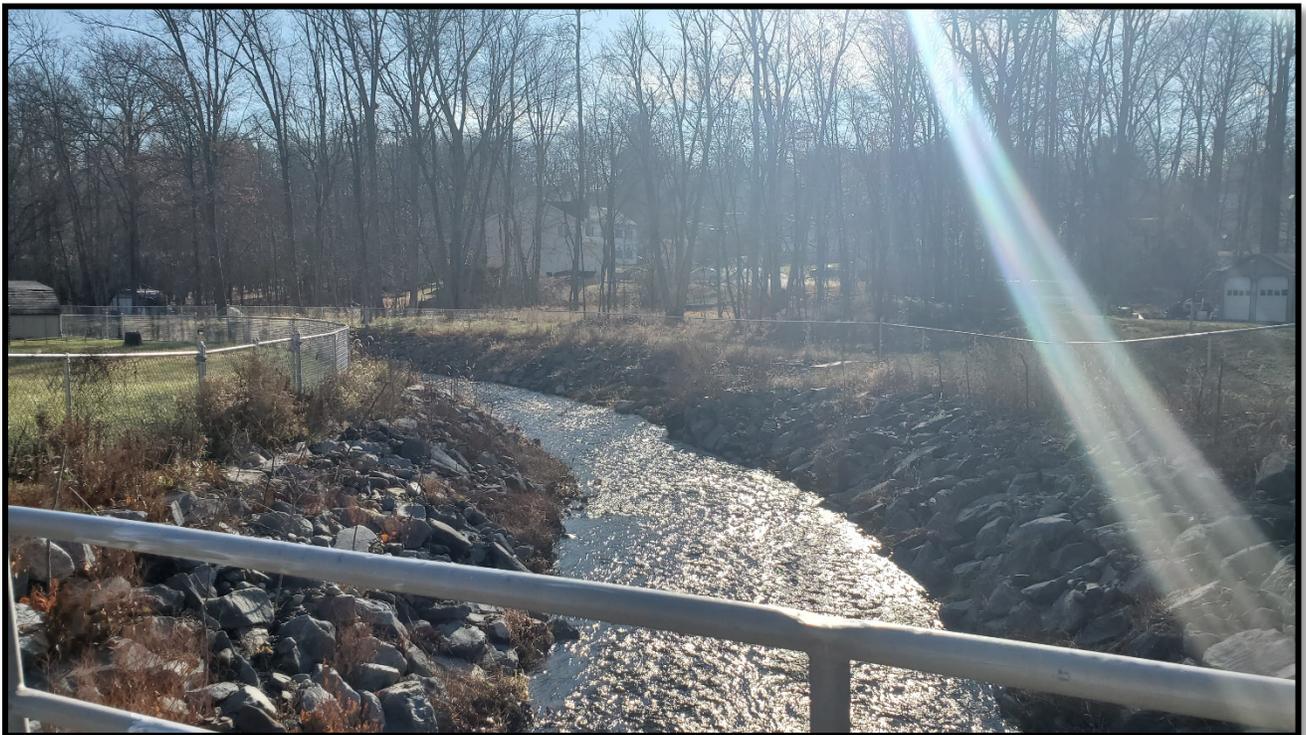
**Photo 2:** View looking southeast and downstream along Monhagen Brook from West Main Street bridge (11/26/19).

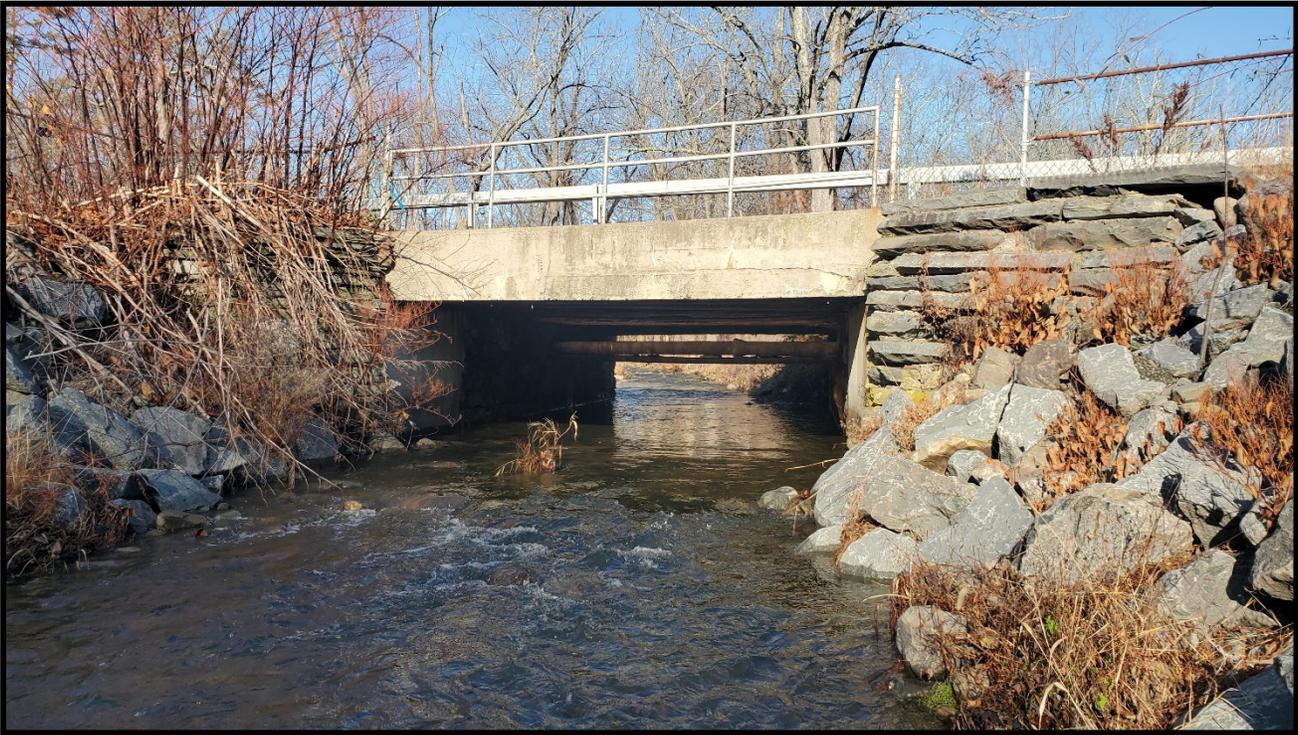
**Photo 3:** View looking northwest and upstream along Monhagen Brook towards existing West Main Street bridge from edge of limits of disturbance (11/26/19).

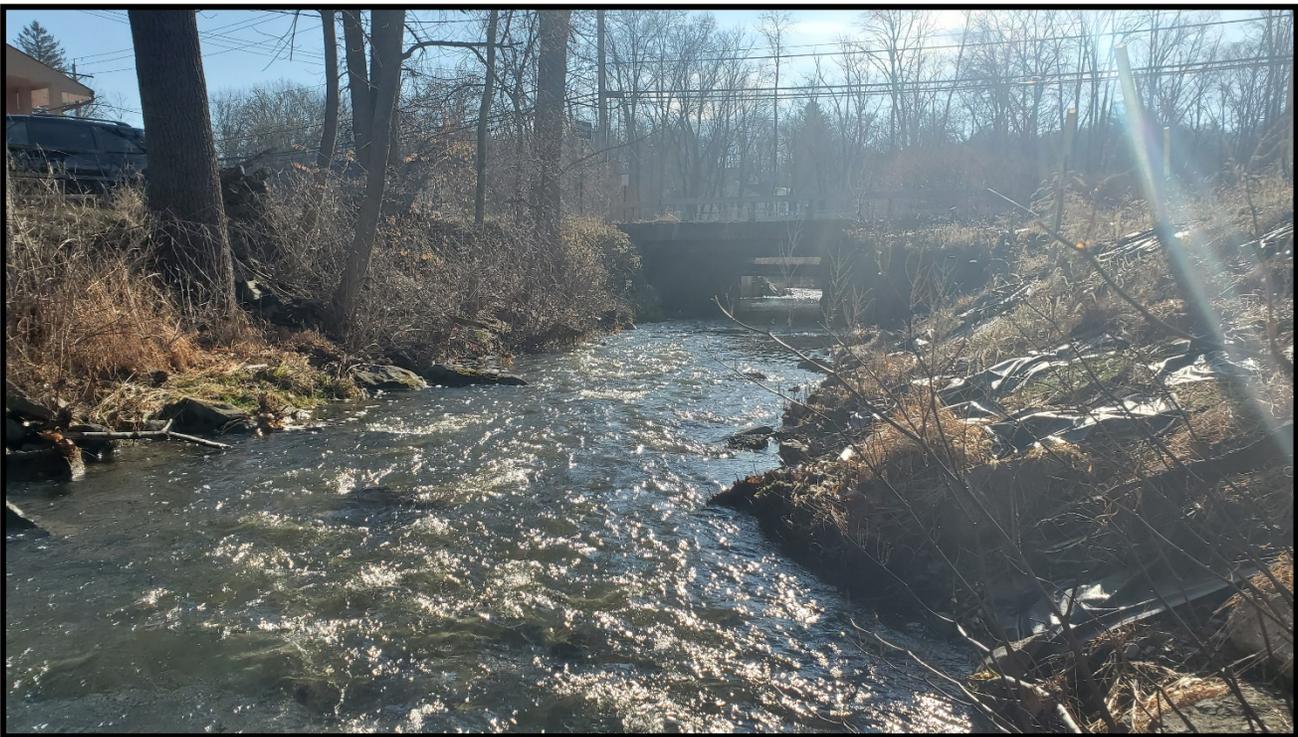
**Photo 4:** View looking southeast and downstream from edge of limits of disturbance (11/26/19).

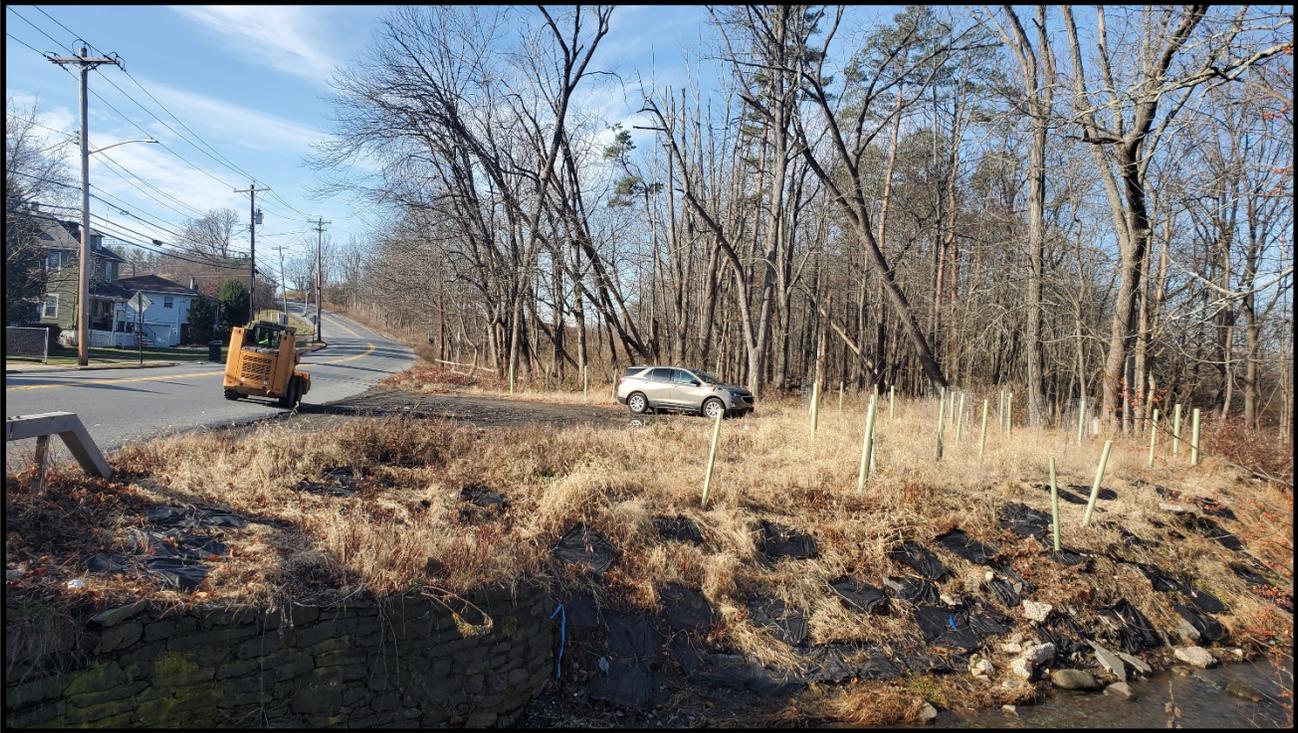
**Photo 5:** View looking west across gravel pull-off adjacent to Monhagen Brook from West Main Street bridge (11/26/19).

No indicators of wetland hydrology were observed within the proposed project study area. The soil was dry and compacted south of West Main Street and gravel fill north of West Main Street.
