**Old Fort Johnson Conditions Assessment and Flood Mitigation  
Fort Johnson, Montgomery County, NY  
Environmental Review Record  
Old Fort Johnson Conditions Assessment and Flood Mitigation, Fort Johnson, NY**

**Project Name:** Old Fort Johnson Conditions Assessment and Flood Mitigation, Fort Johnson, NY

**Project Location:** Old Fort Johnson  
2 Mergner Road, Fort Johnson, NY 12070

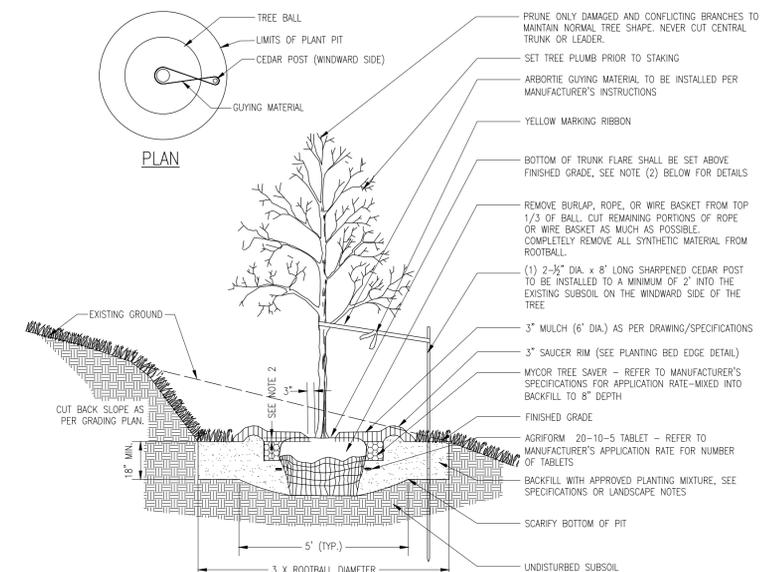
DECIDUOUS TREE PLANTING LESS THAN 4" CAL.  
N.T.S.

1. MAINTAIN A 3" MINIMUM RADIUS CLEAR OF MULCH AROUND THE TRUNK.
2. THE DISTANCE BETWEEN THE BOTTOM OF THE TRUNK FLARE AND THE FINISHED GRADE SHALL BE AS FOLLOWS:  
FOR SANDY OR LOAMY SOILS: 1"  
FOR CLAY OR POORLY DRAINED SOILS: 3"  
THE CONTRACTOR SHALL REVIEW THE APPROPRIATE PLANTING DEPTH WITH THE OWNER'S REPRESENTATIVE PRIOR TO INSTALLATION.
3. WHEN TAGGING TREES AT THE NURSERY, MARK THE NORTH SIDE OF THE TREE IN THE FIELD AND WHEN INSTALLING, ROTATE TREE TO FACE NORTH WHENEVER POSSIBLE.

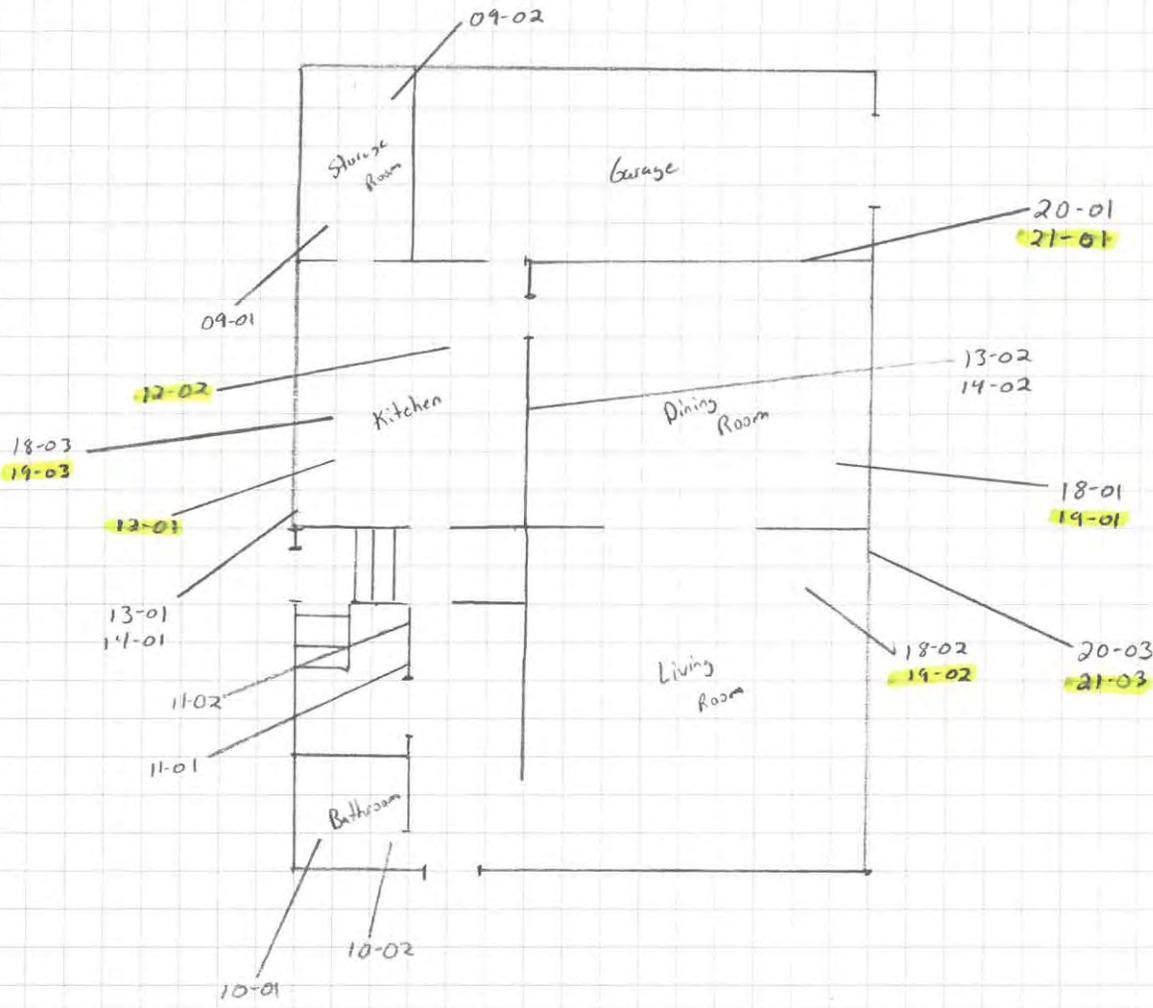
1st Floor

XX-XX = Positive Asbestos Sample

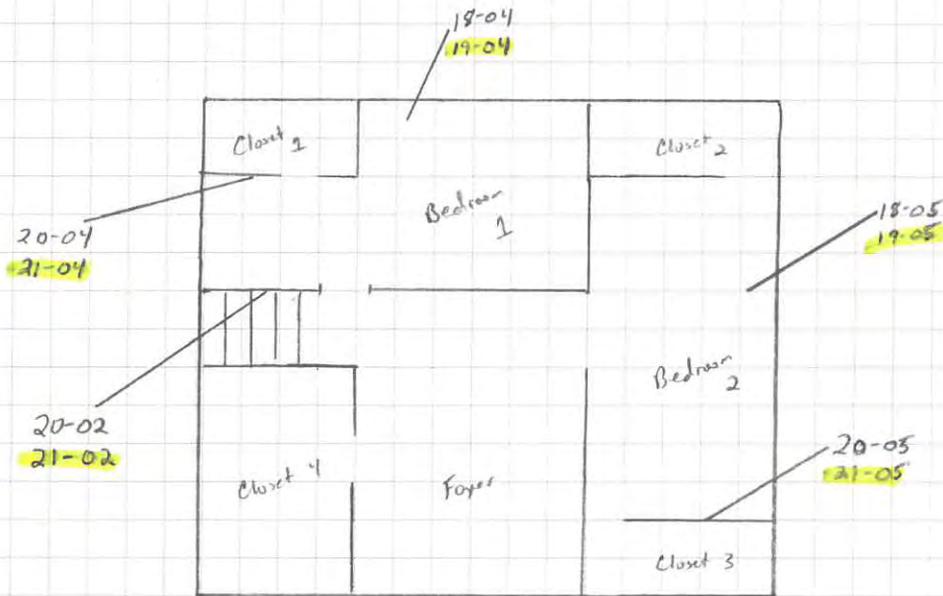
2nd Floor

XX-XX = Positive Asbestos Sample

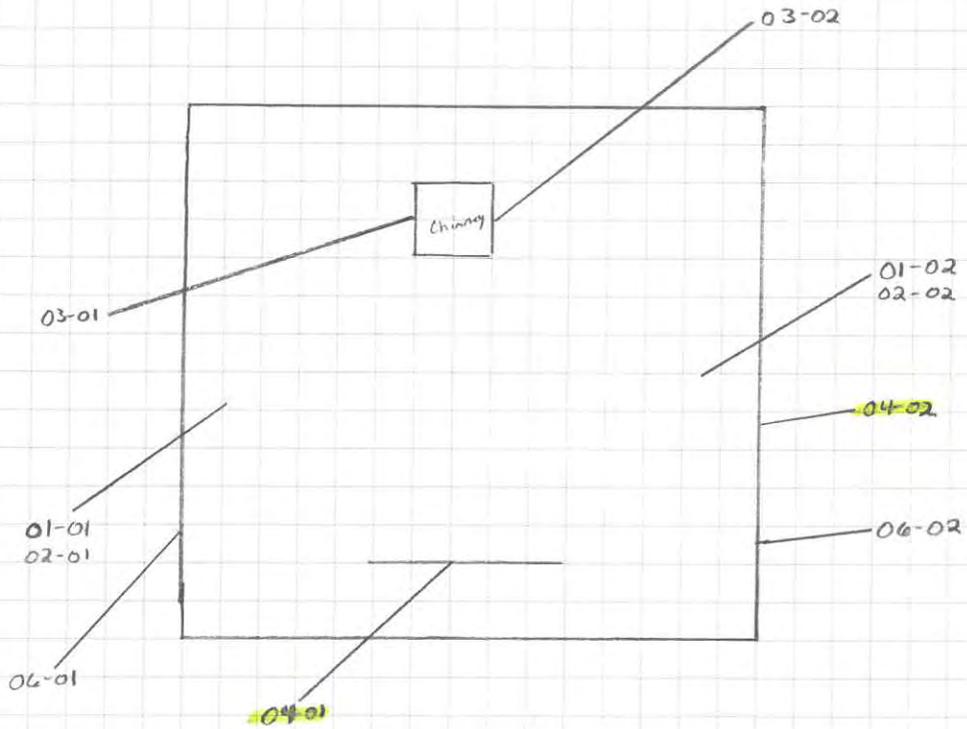
Roof and Exterior

NI-IX = Positive Asbestos Sample

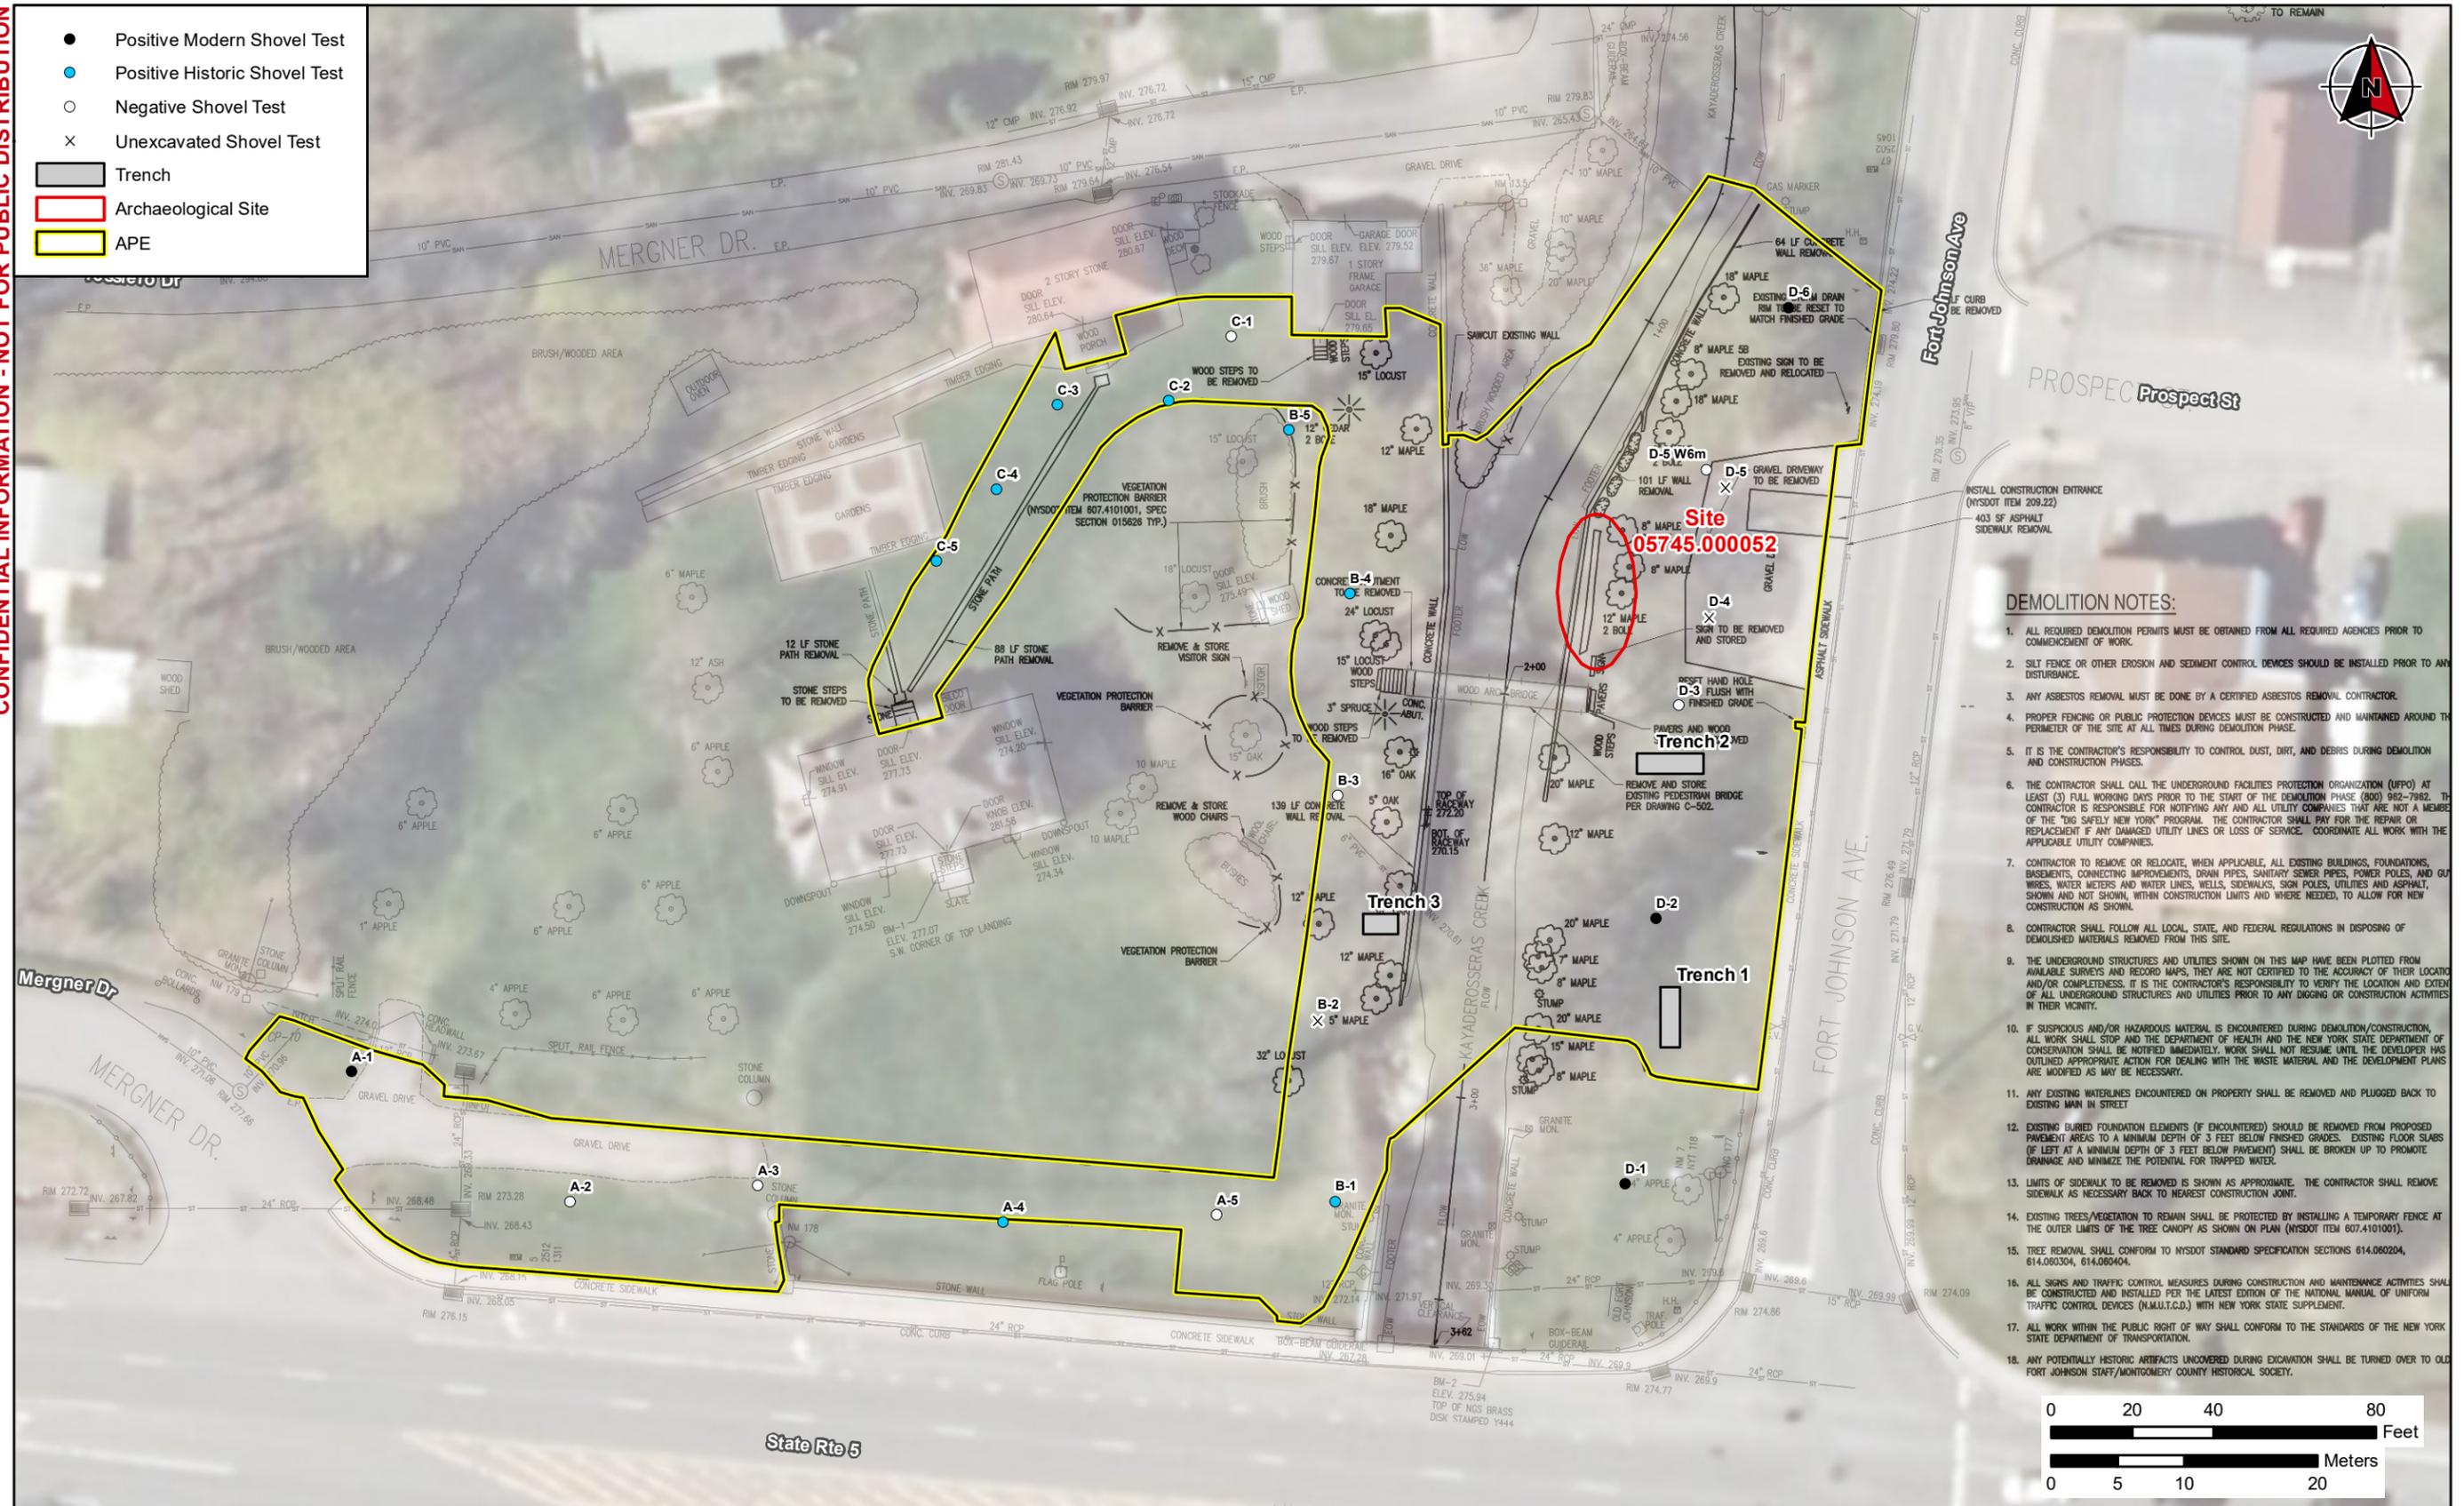
FIGURE 2: Plan Map of Project APE Showing Subsurface Testing (ESRI World Imagery 2017)

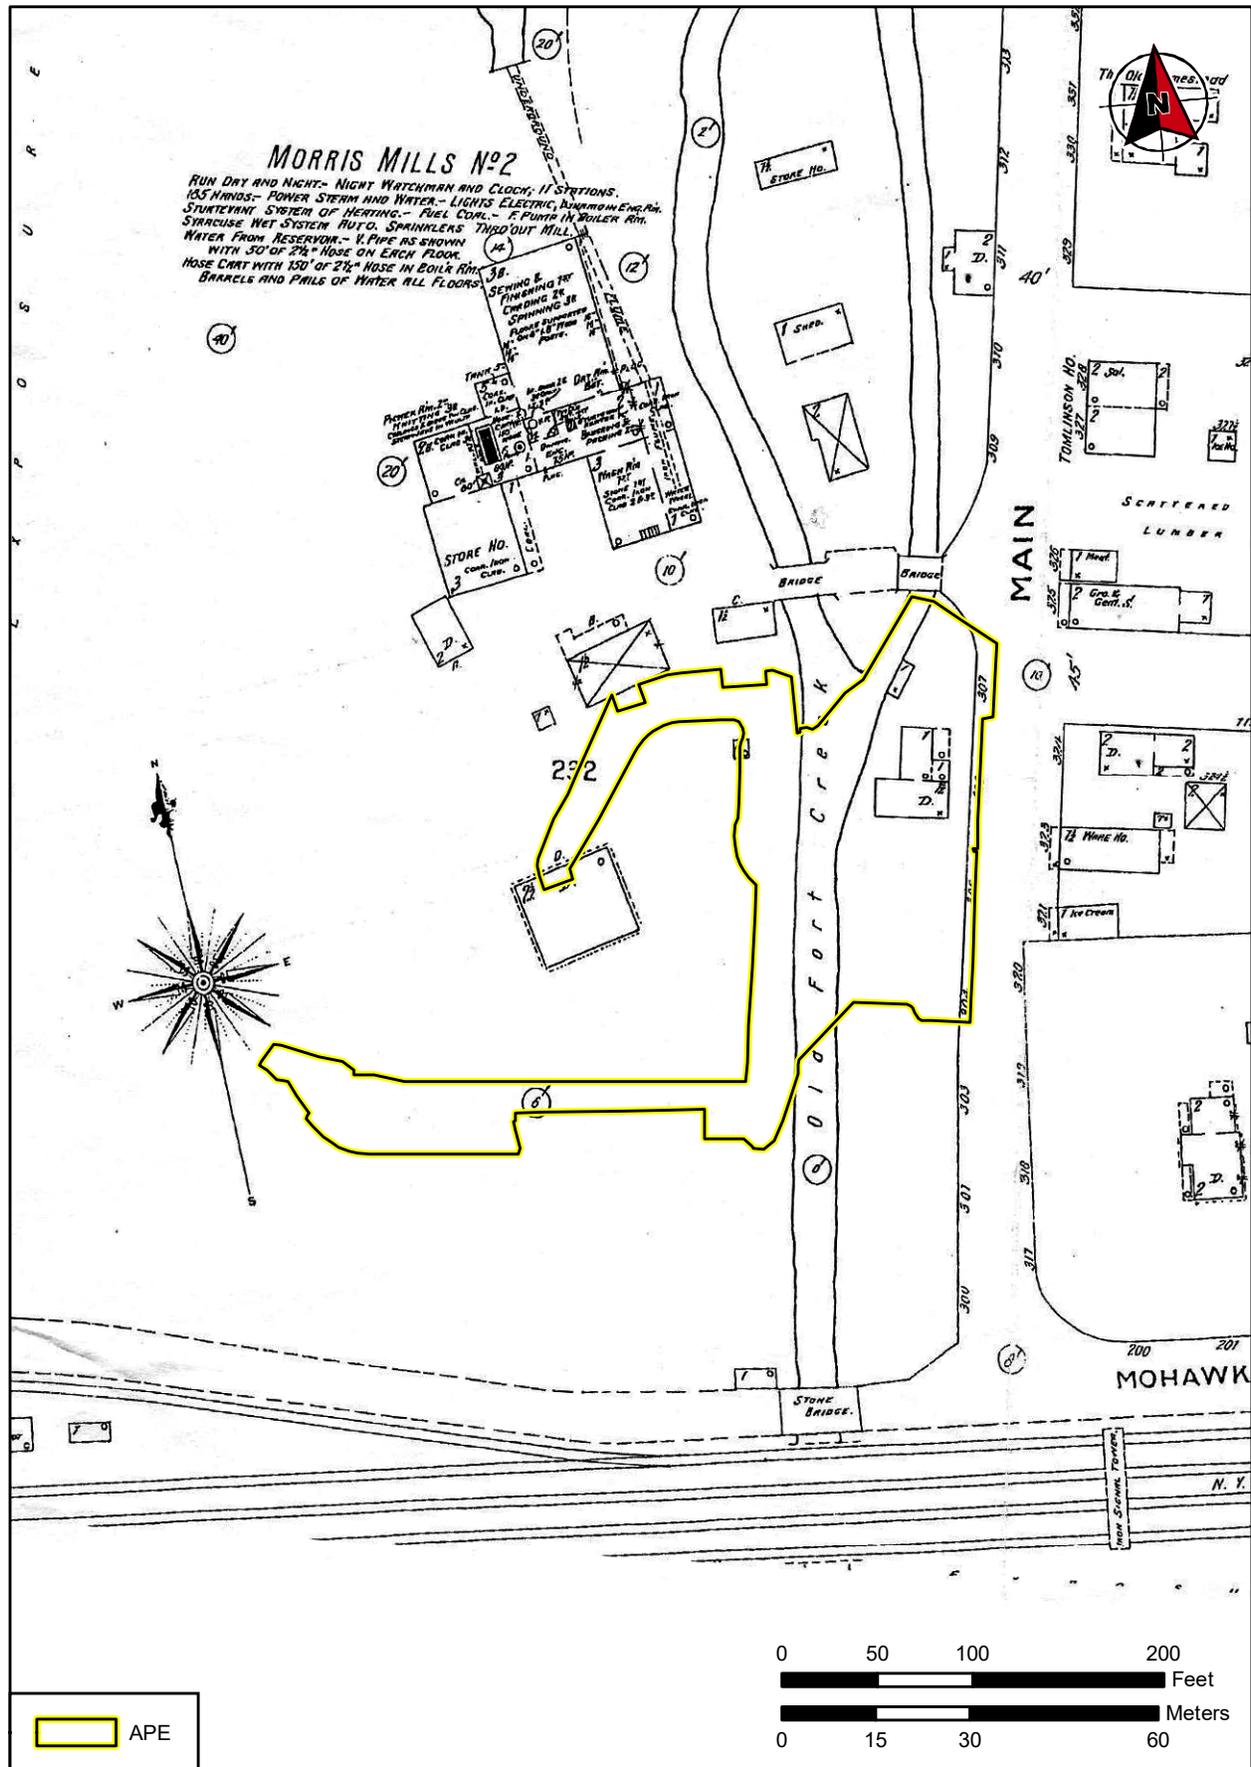
FIGURE 3: APE and Vicinity in 1895 (Sanborn 1895)

The Sanborn (1895) map shows a small outbuilding west of the creek off the northeast corner of the house and one west of the stable (see Figure 3). One of these may be the original Johnson privy that has been maintained to the present day, although it has been moved more than once (see Figure 2, labeled "Wood Shed"). In the 1880s the privy was sketched as being built on a stone foundation into the stream bank (Mendel, Mesick and Cohen 1978:figure 23). If this description is accurate, then within a decade the structure had been moved away from the bank. The Sanborn (1905) map does not show any small outbuildings, but a Sanborn map from circa 1916 shows that the small outbuildings to the west of the stable had been moved or removed and two small outbuildings are located within the project APE (see Figures 5 and 6). The location of the smaller of these two outbuildings is the same as the single small outbuilding shown 20 years earlier, and the second outbuilding is depicted as noticeably larger (see Figure 6). It is not clear if either of these buildings is the privy structure, but the positioning is relatively close to its current location. By 1905 the property had passed into the hands of the county and was no longer a residence. In 1950 the privy building was located adjacent to the floodwall approximately 10 meters (33 feet) south of the garage and remained there until

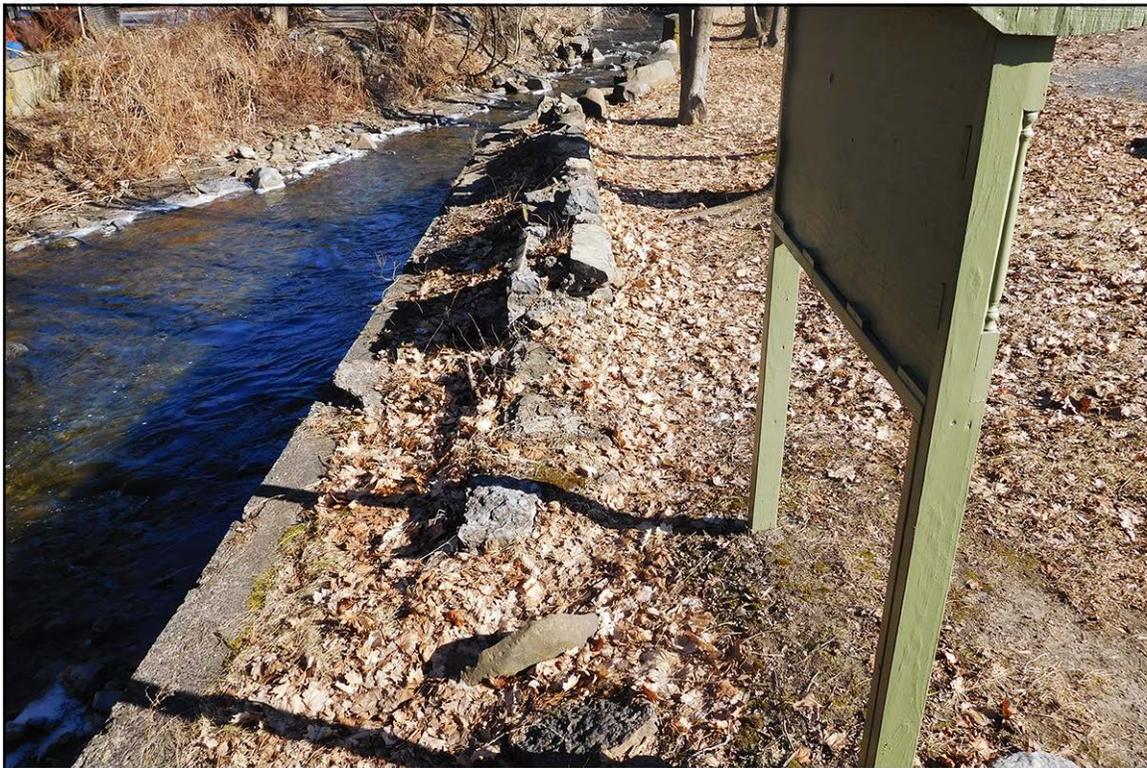
PHOTOGRAPH 1: Foundation Wall on the East Side of the Creek, View North

By 1950 Fort Johnson was a popular tourist attraction with a circular drive on the south side of the building, and the gap between the former Shepard residence and the filling station had been filled in by low one-story garages (see Figure 7). Between 1950 and 1970, Route 5 was expanded to four lanes and over the former location of the filling station and the former south boundary of the Fort Johnson property. In 1972 the other buildings on the east side of the creek were razed and the narrow parcel on the east side of the creek became the property of the Montgomery County Historical Society. This includes the Mrs. HB Shepard House Site (05745.000052), where the rear (west) portion of the foundation was left in place because it was close to the creek and flood wall (Photograph 1).

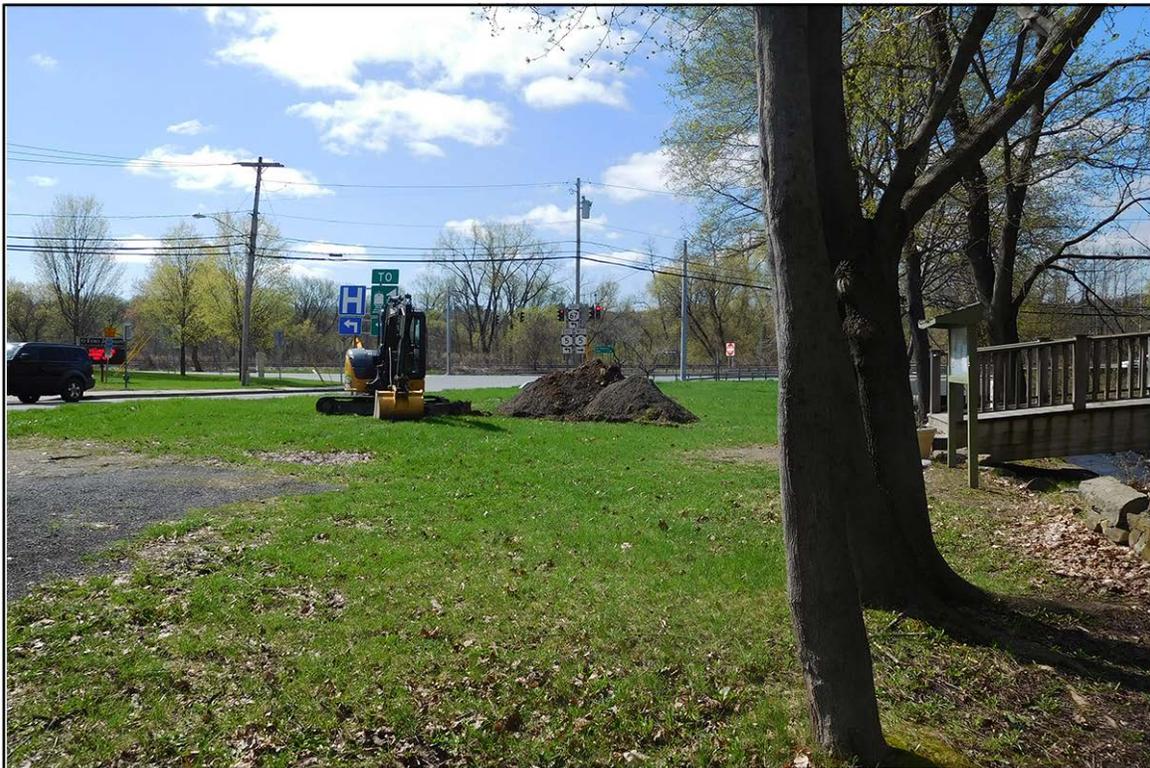
PHOTOGRAPH 2: Excavation of Trench 2, View Southeast

For the mechanical trenches, excavations began at ground level, and soil was carefully removed horizontally across each trench to expose soils and any potential features in plan view. Trenches were excavated using a John Deere 50G excavator (Photograph 2). Trenches were numbered 1 through 3 in order of excavation. These trenches extended into intact basal stream cobbles and were monitored for the presence of historic and prehistoric archaeological resources. All three trenches were excavated to more than 2 meters (6.6 feet) bgs. Each trench was recorded with a measured profile drawing and digital photography.

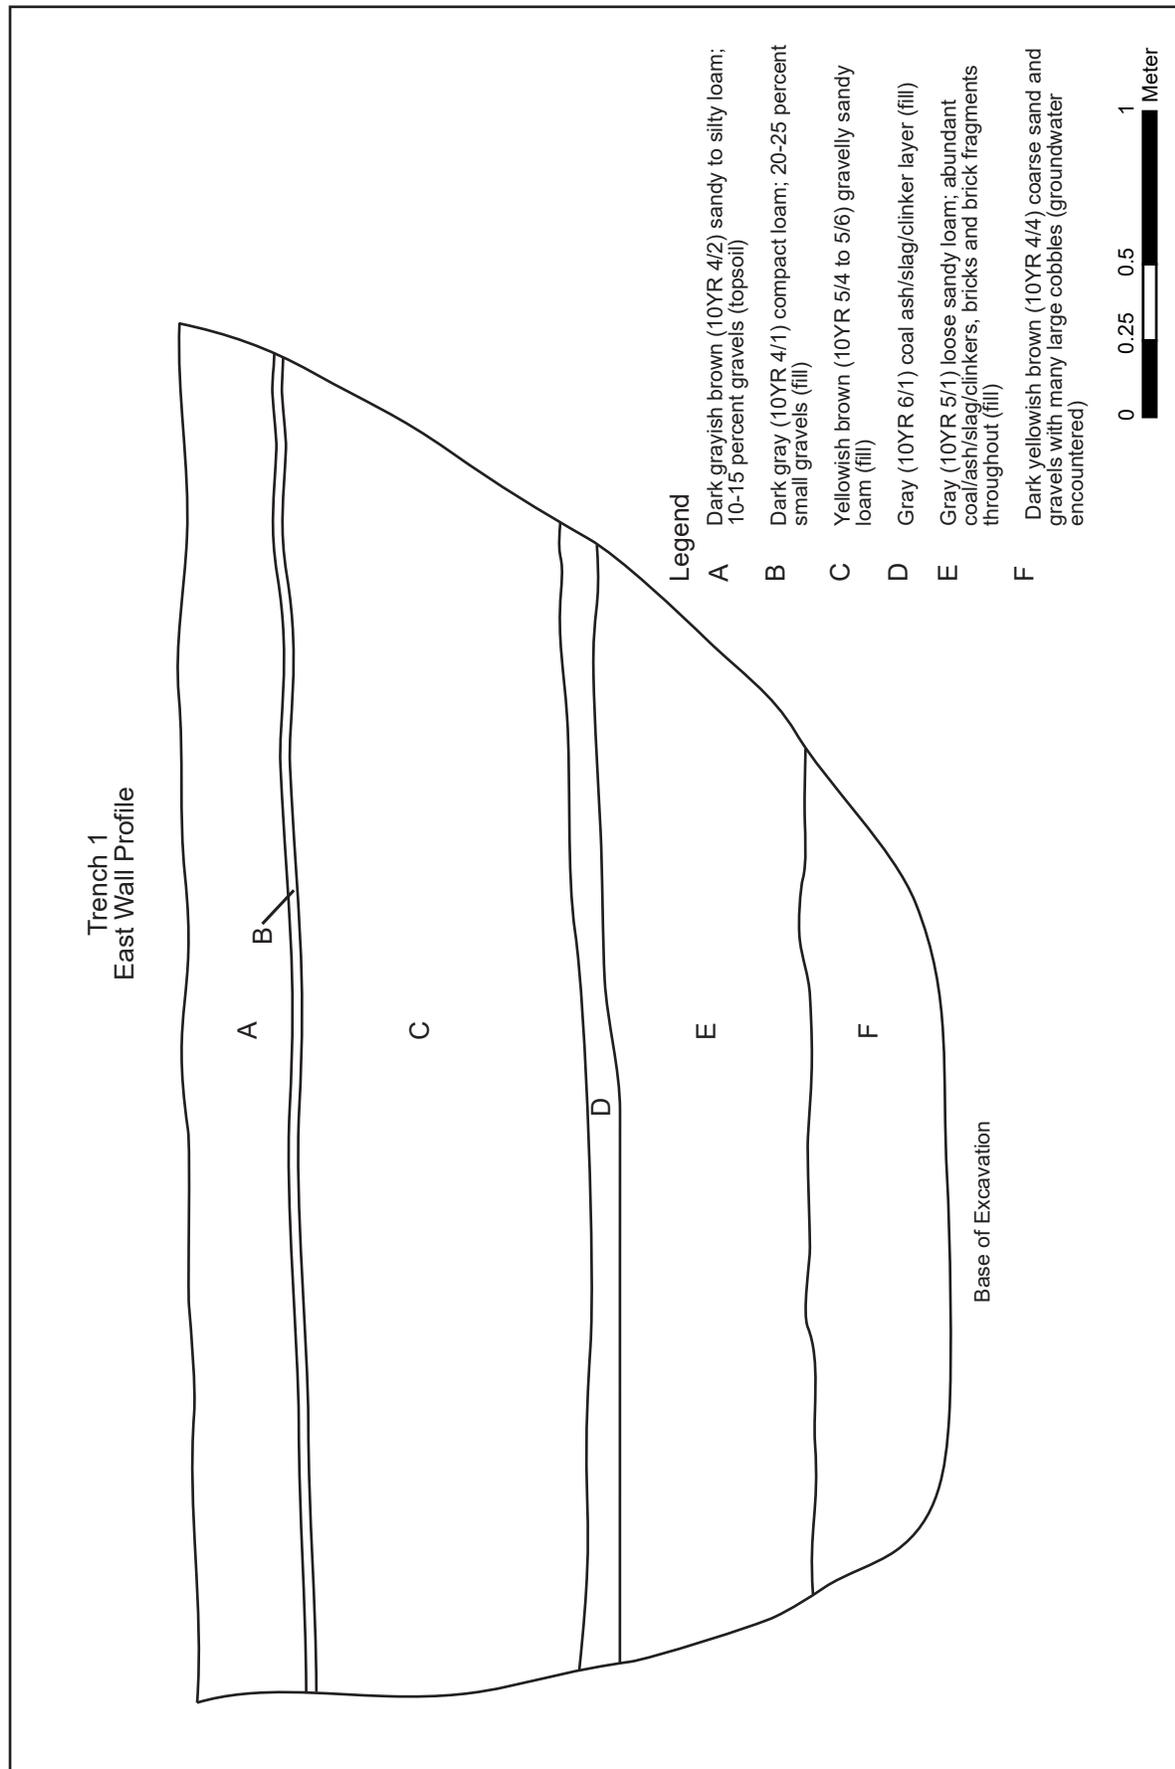
FIGURE 8: Trench 1, East Wall Profile

No artifacts were recovered from any of the three trenches. Despite the abundant structural/industrial material present, domestic debris does not appear to have been mixed with the debris in any meaningful concentration.

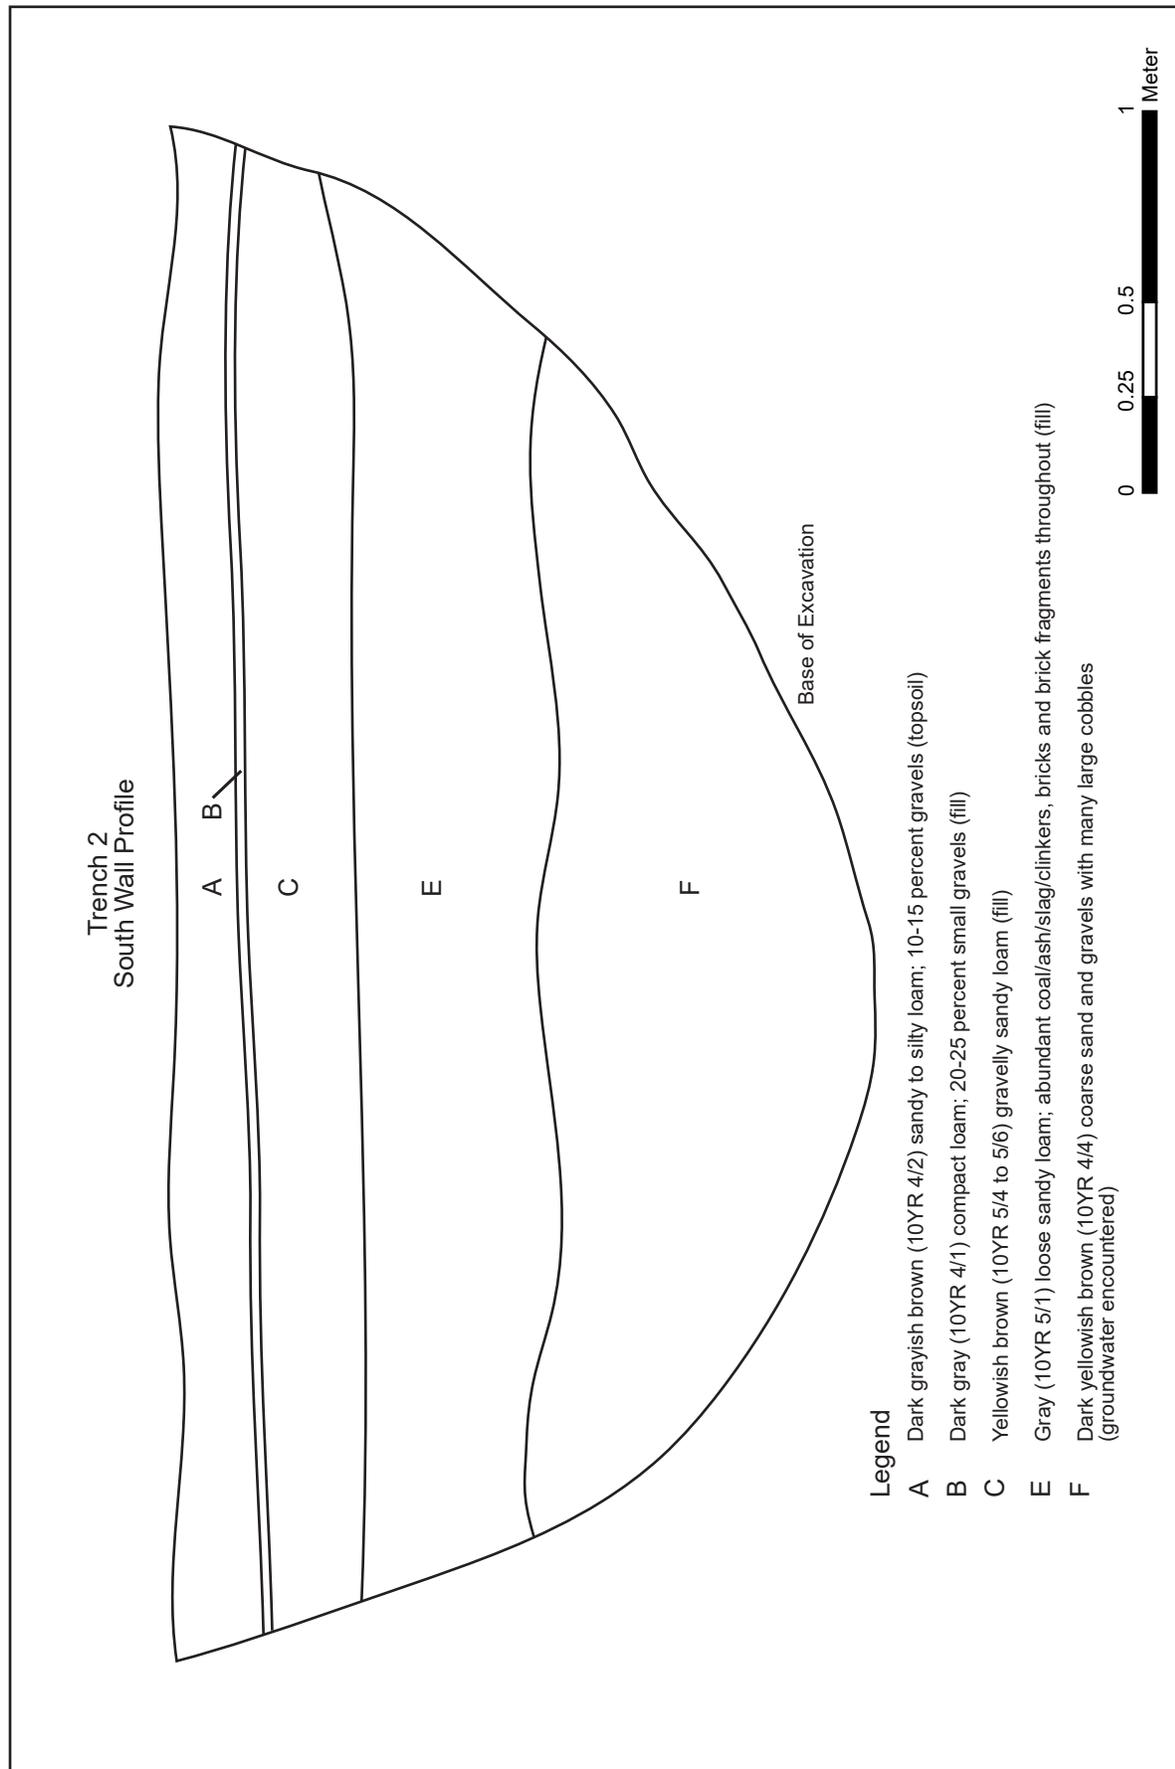
FIGURE 9: Trench 2, South Wall Profile

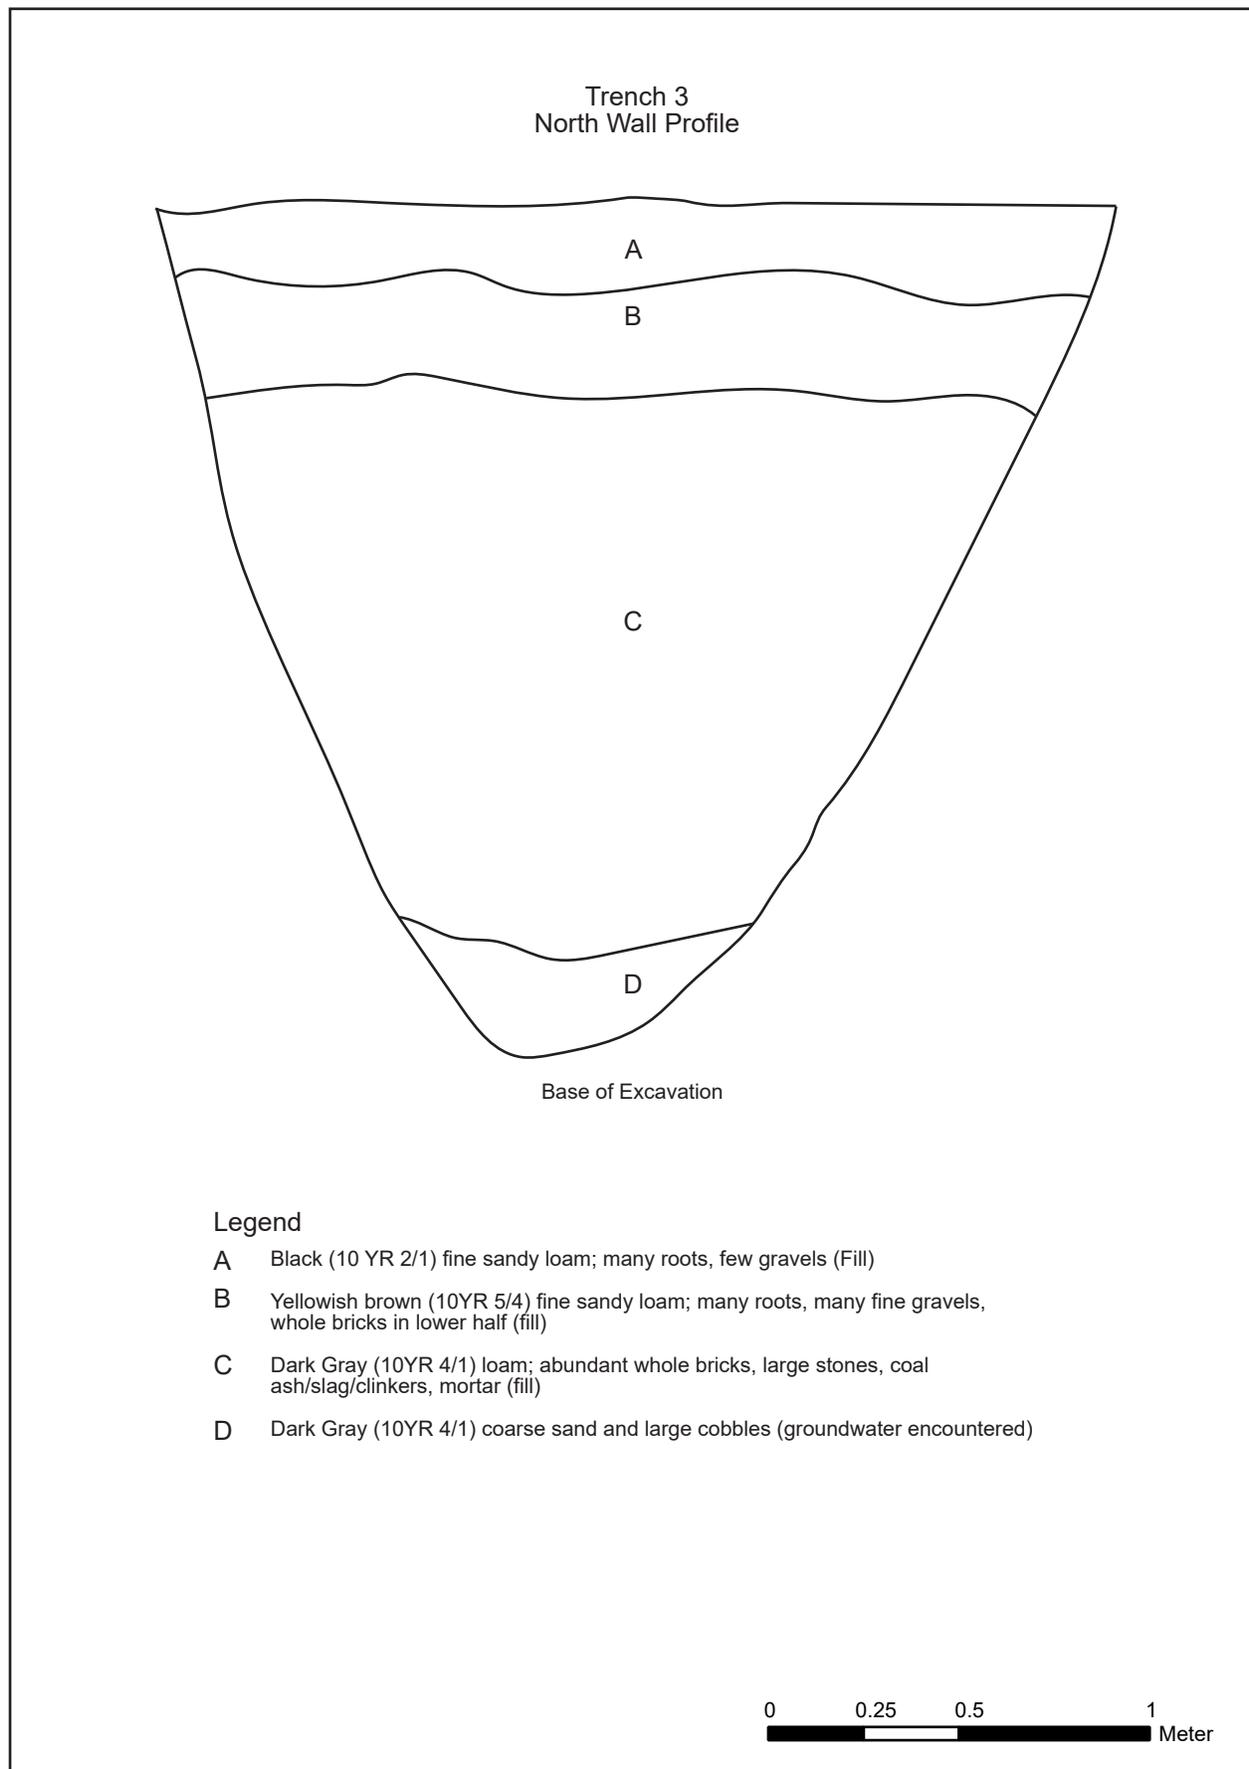
FIGURE 10: Trench 3, North Wall Profile

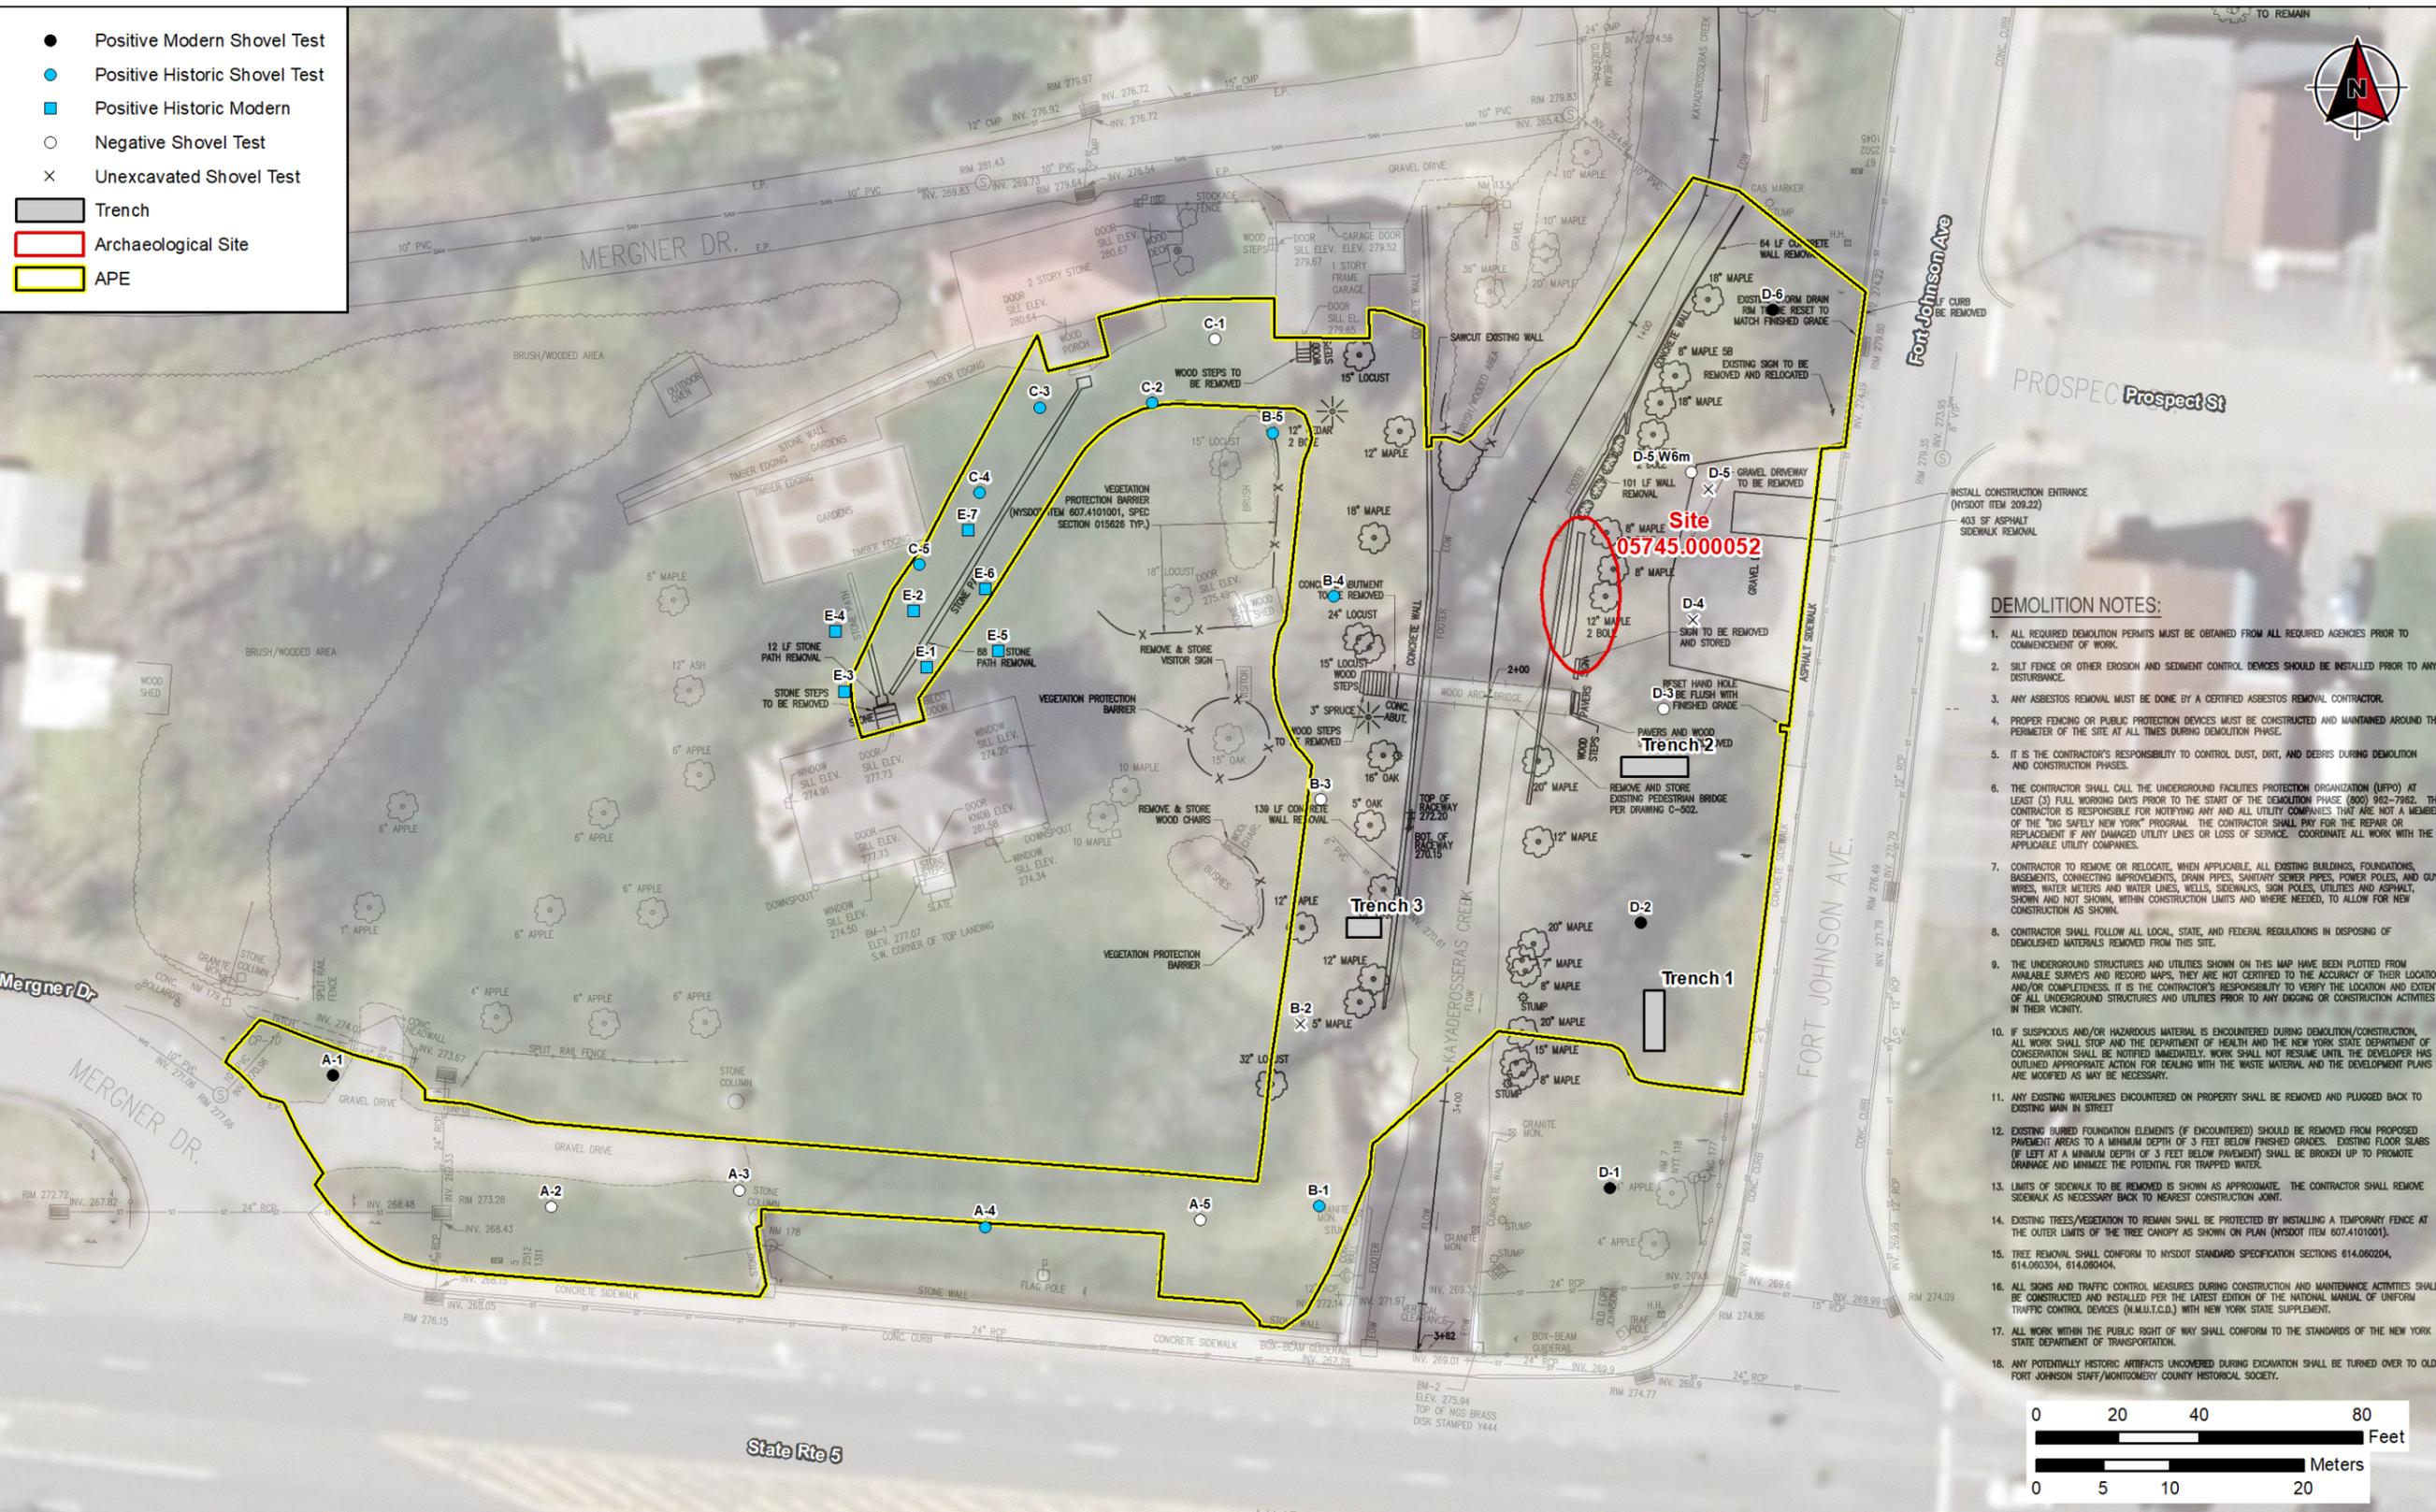
FIGURE 2: Plan Map of Project APE Showing Subsurface Testing (ESRI World Imagery 2017)
