# South End Drainage Improvements Environmental Assessment

New York Governor's Office of Storm Recovery  
Original - July 22, 2016  
Revised - August 25, 2016

**Project Name:** South End Drainage Improvements

**Project Location:** State Route 30/Main Street/Bridge Street, South End, Village of Schoharie, Schoharie County, NY

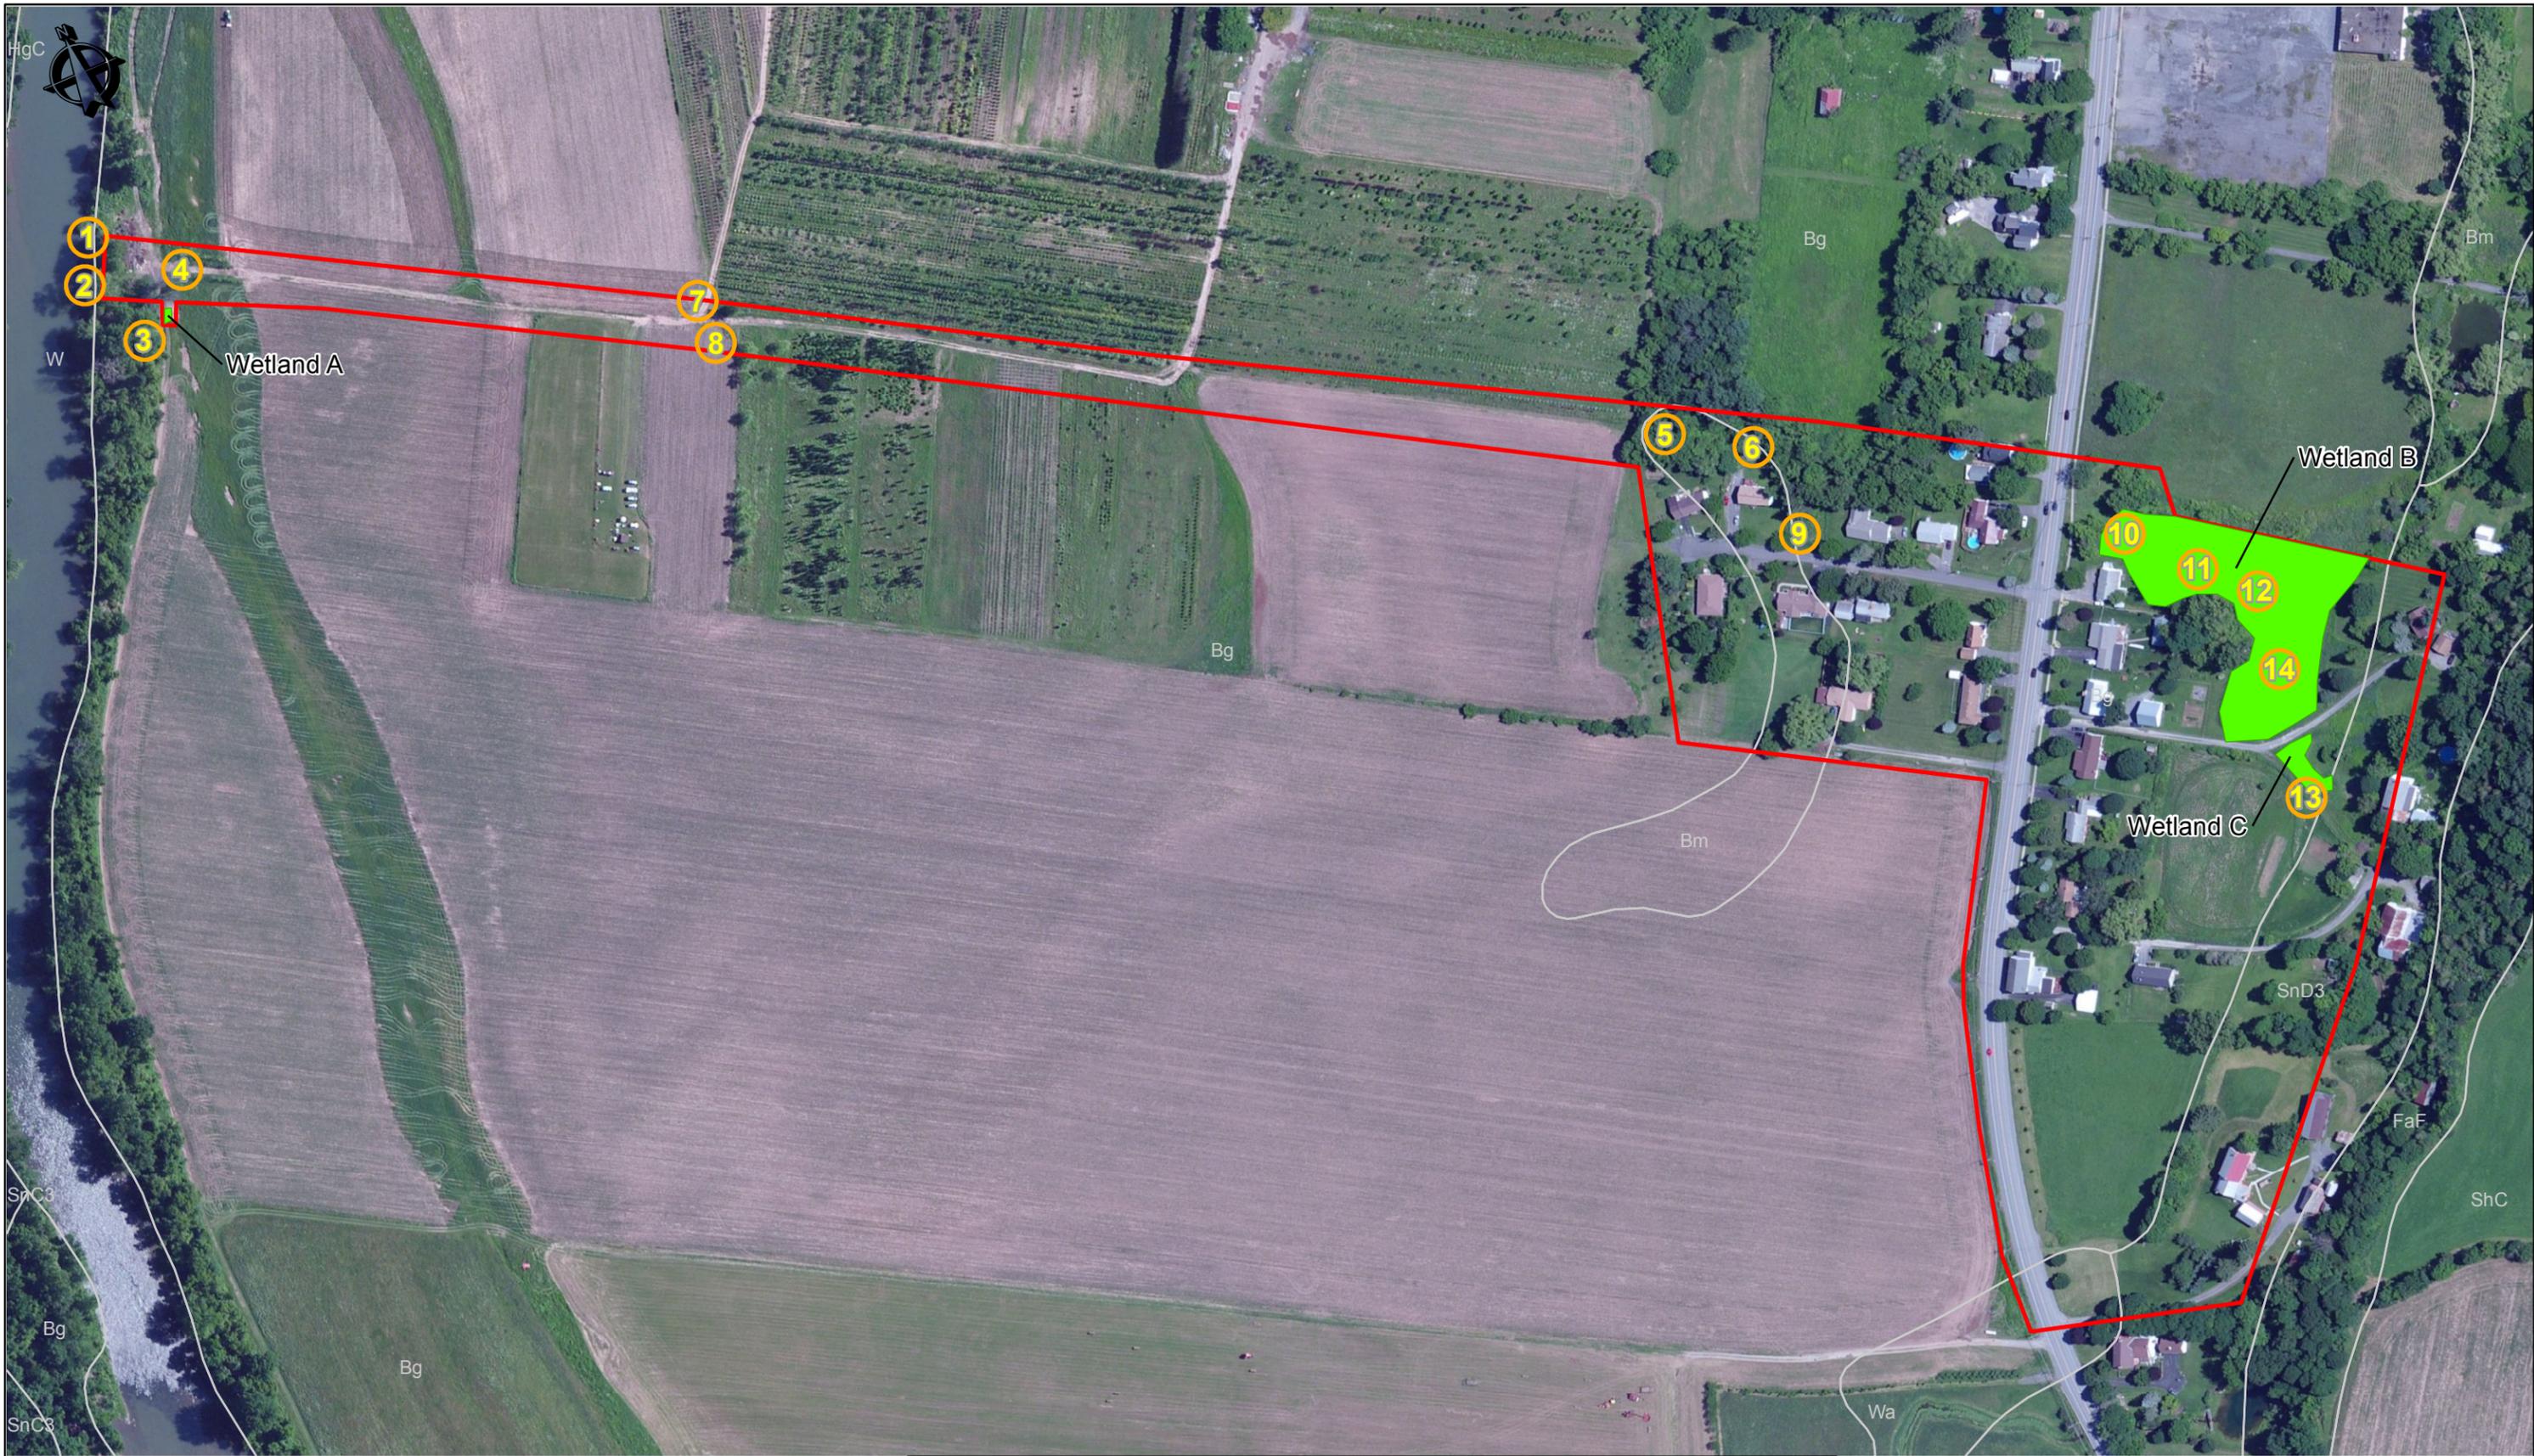
**FIGURE 1**  
**WETLAND DELINEATION AND PHOTOGRAPH LOCATION MAP**

Proposed Drainage Improvements  
 NYS Route 30  
 Schoharie, New York  
 Schoharie County

Wetland A is a depressional emergent wetland located far northwestern end of the Review Area (reference Figure 1). It is a small depression within the floodplain of Schoharie Creek. The area was observed to be dominated by the hydrophytic reed canary grass (*Phalaris arundinacea*), creeping yellowcress (*Rorippa sylvestris*), and devil's-pitchfork (*Bidens frondosa*). This wetland contains hydric sandy loam soils, and exhibited indicators of wetland hydrology including geomorphic position, surface soil cracks, and the FAC-neutral test. The Wetland Delineation Data Form for test site TS-1 that pertains to Wetland A is attached. Wetland A connects to Schoharie Creek via a short drainage channel. Wetland A would therefore be considered jurisdictional by the U.S. Army Corps of Engineers (USACE).

Wetland B is a combination emergent/scrub-shrub/forested wetland located toward the northeastern corner of the Review Area (reference Figure 1). The wetland was observed to be dominated by hydrophytic vegetation including reed canary grass, broad-leaf cat-tail (*Typha latifolia*), devil's-pitchfork, redosier dogwood (*Cornus sericea*), and silver maple (*Acer saccharinum*). This wetland contains hydric silty loam and silt clay loam soils; indicators of wetland hydrology included geomorphic position, sparsely-vegetated concave surface, and the FAC-neutral test. The Wetland Delineation Data Forms for test sites TS-6, TS-7 and TS-8 and TS-10 that pertain to Wetland B are attached. Wetland B continues off-site to the northeast and is anticipated to possess a hydrologic connection off-site, and thus be under the jurisdiction of the USACE.

Wetland C is a depressional slope wetland situated toward the eastern side of the Review Area, near Wetland B and south of Estenes Lane (Reference Figure 1). Historically, Wetland C was likely part of Wetland B, but is now divided by a driveway. The wetland was observed to be dominated solely by reed canary grass. This wetland contains hydric clay loam soils; indicators of wetland hydrology included geomorphic position, oxidized rhizospheres on living roots, and the FAC-neutral test. The Wetland Delineation Data Form for test site TS-9 that pertains to Wetland C is attached. Wetland C appears isolated; a significant nexus determination would need to be made by the USACE to determine whether they would assert jurisdiction over the wetland.

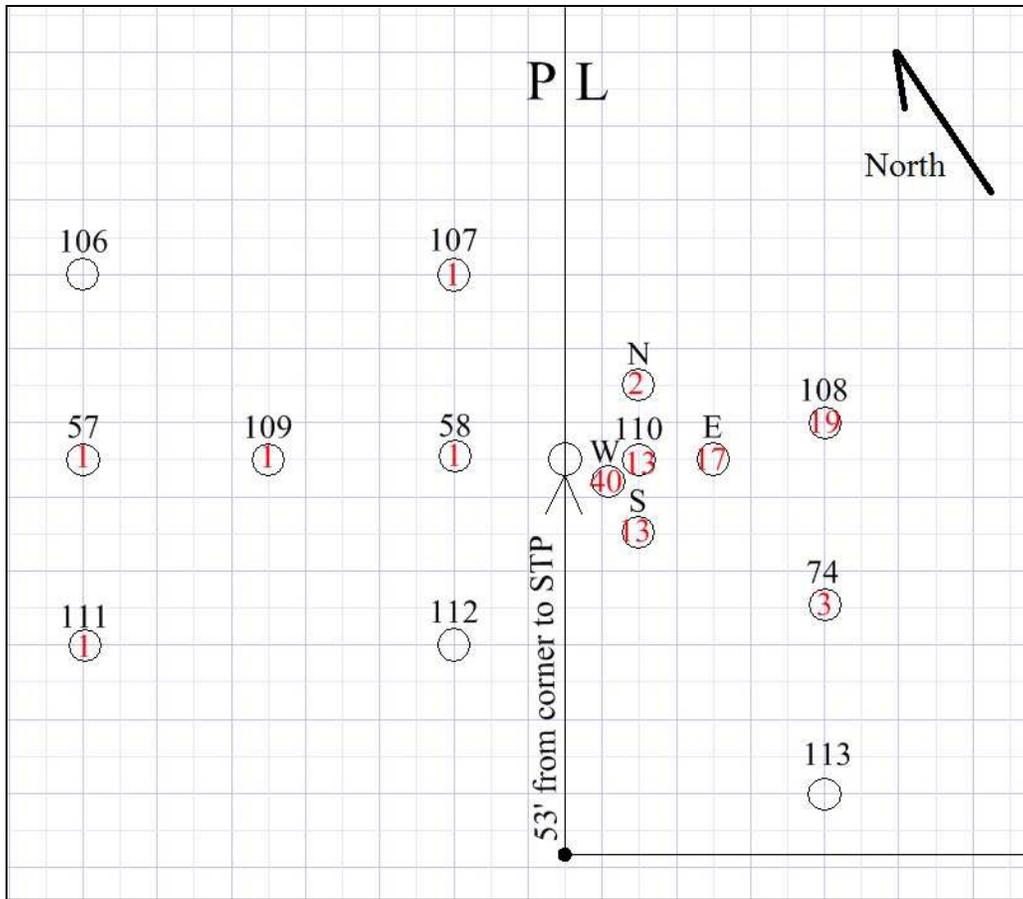
Map 2: Artifact distribution across Site #2 for Phase IB and Phase II excavations.

Site #2 was originally identified through three consecutive positive shovel tests at 50-foot intervals within the limits of the proposed Stormwater Retention Pond #1 (STPs 57, 58 & 74) (Map 2). The original Phase II work scope consisted of eight STPs and one excavation unit. The STPs were placed at 25-foot intervals around the positive Phase IB tests although the number of tests was inadequate to establish a proper site grid. High densities of chert debitage were recovered from STPs 110 & 108. As with Site #1, there was insufficient data to inform the placement of the excavation unit so this was translated into four additional STPs which were arrayed at 10-foot intervals around STP 110 at the cardinal directions. Altogether STP 110 and its radials produced 75 pieces of chert debitage. While no diagnostic artifacts or subsurface features were observed, the high artifact densities suggest these could be present within Site #2 but the small sample has yet to identify them. The site limits are not properly understood and discussions with Tim Lloyd at SHPO indicated additional Phase II testing is recommended.

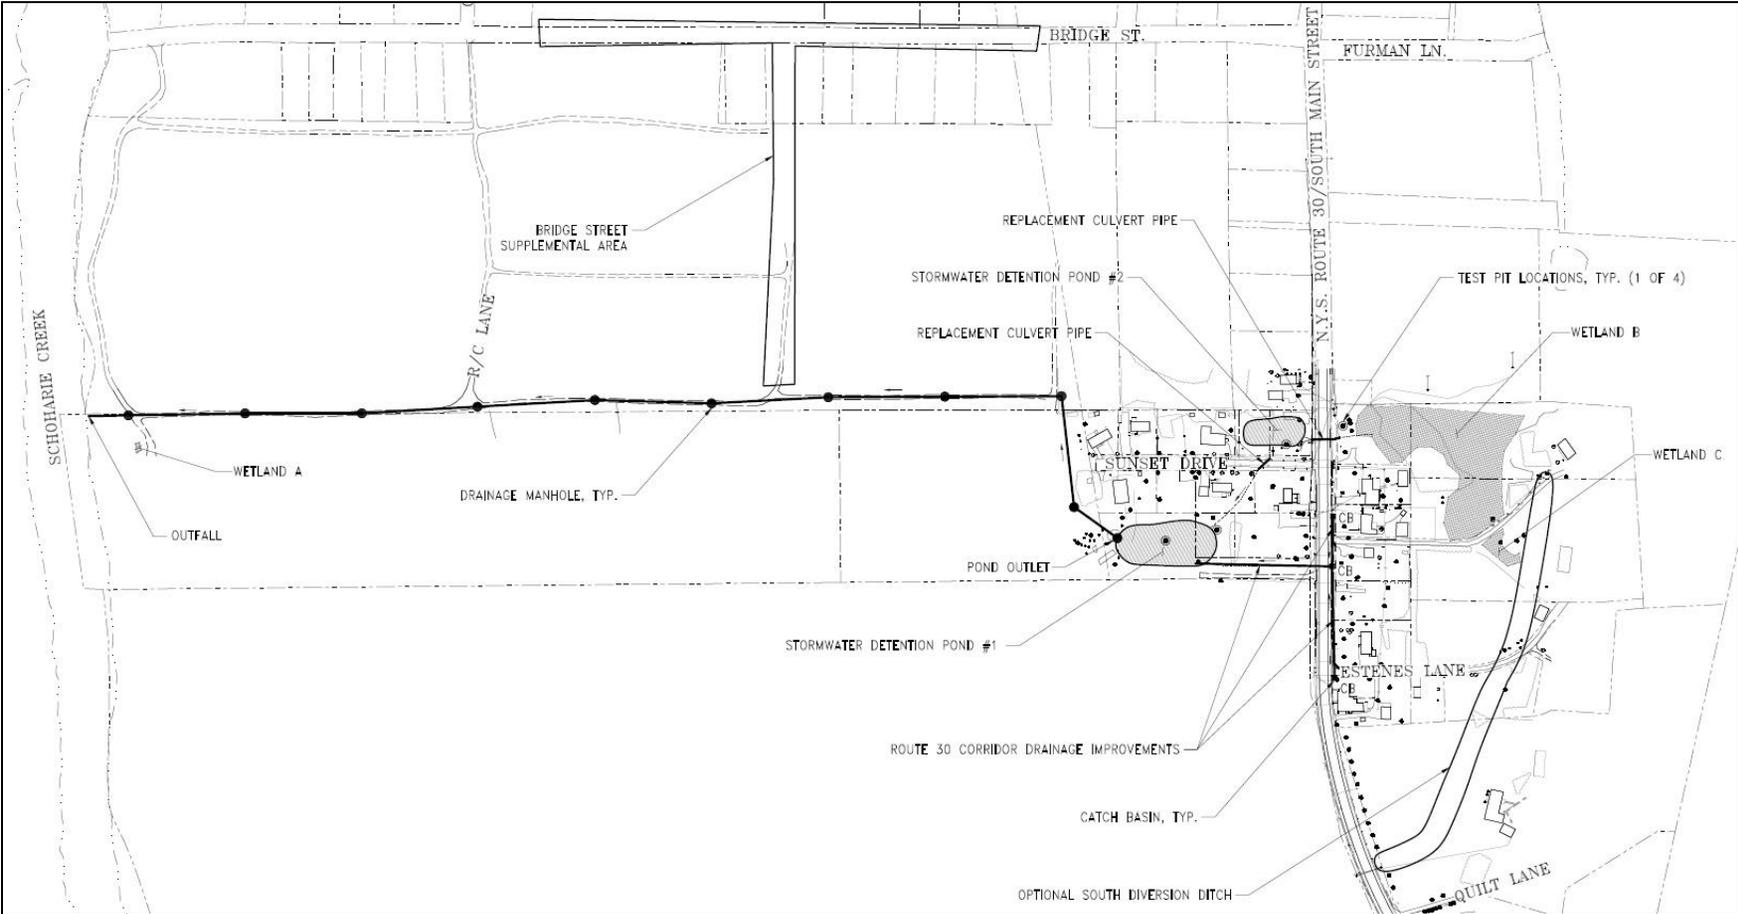
FIGURE 3: PROPOSED DRAINAGE IMPROVEMENTS WITHIN PROJECT AREA. [NOTE: SOUTH DIVERSION DITCH IS NOT INCLUDED]

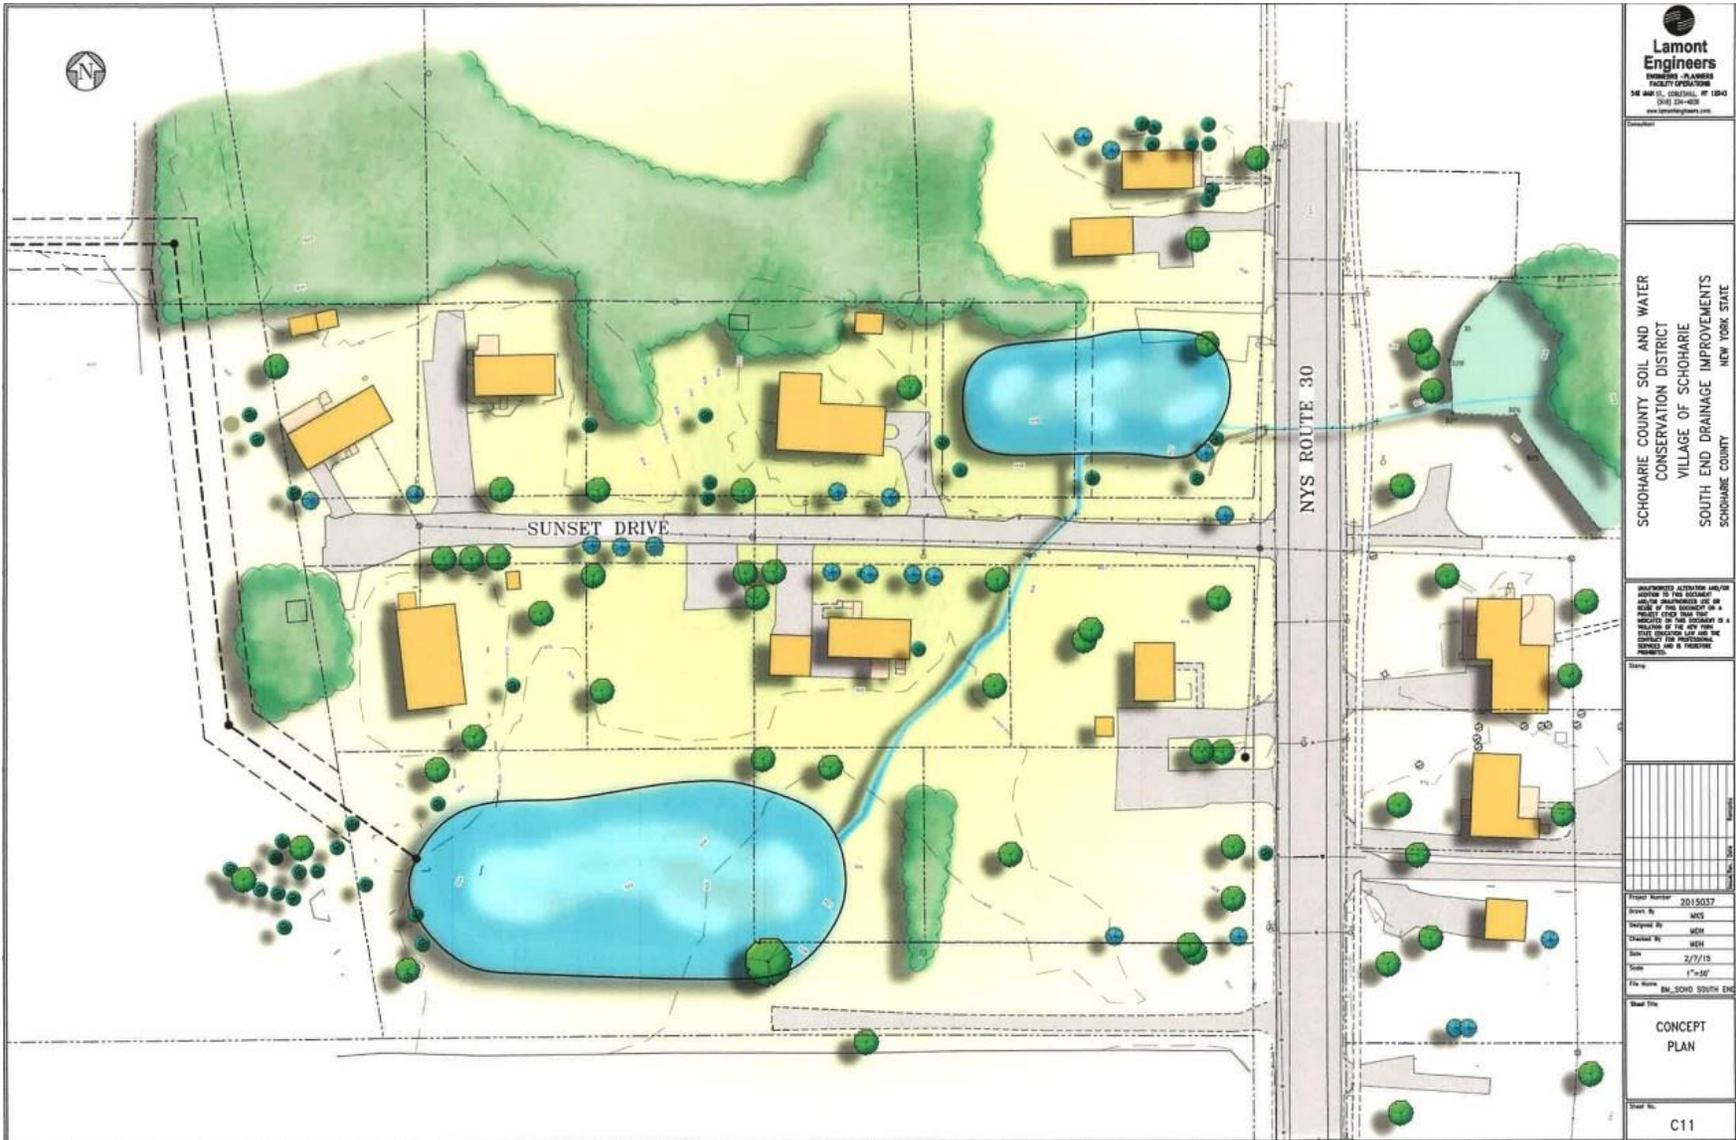
FIGURE 4: GRAPHIC DEPICTION OF PROPOSED STORMWATER DETENTION PONDS.

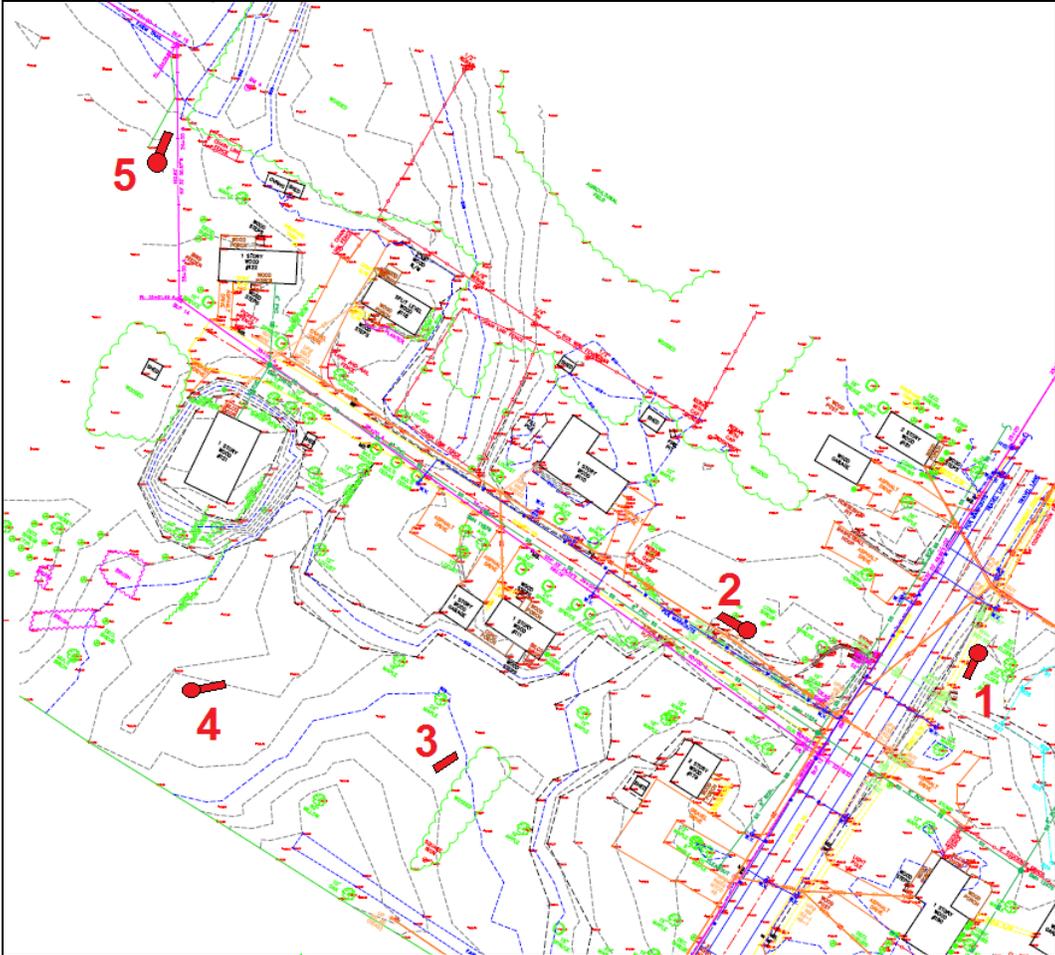
FIGURE 10. LOCATIONS OF BACKHOE TRENCHES OBSERVED BY PRINCIPAL INVESTIGATOR.

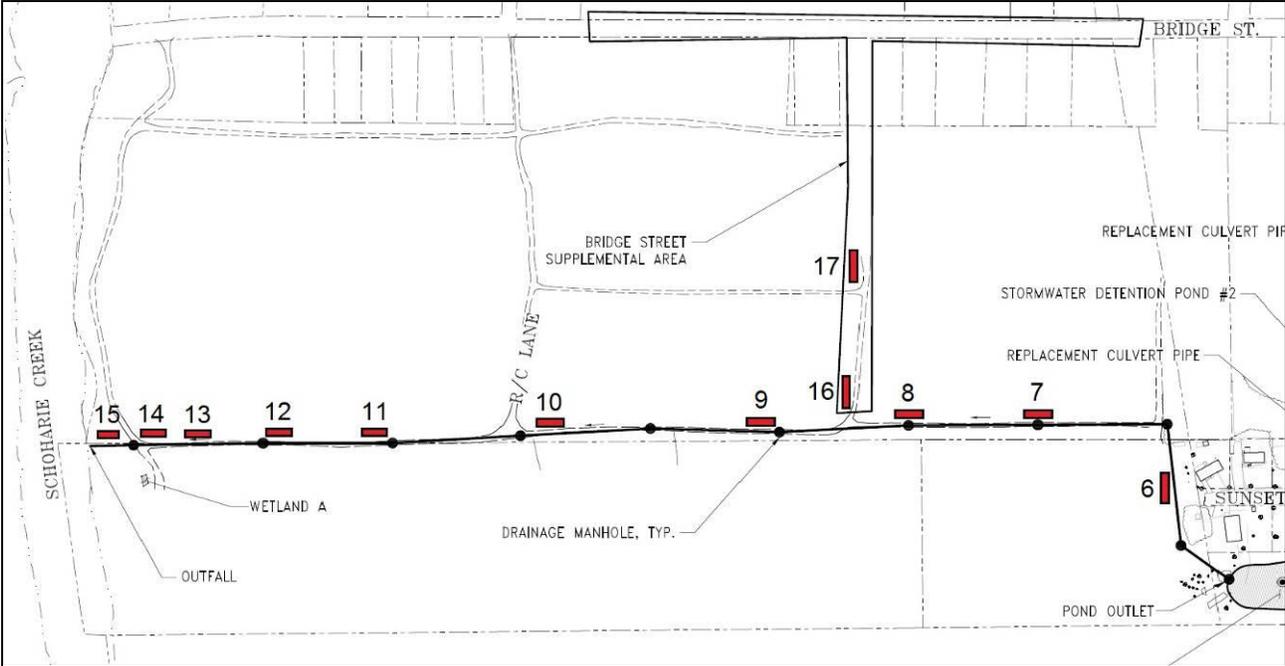
FIGURE 11. LOCATIONS OF BACKHOE TRENCHES SUPERVISED BY DR. DESIMONE.

The geomorphological analysis continued with additional backhoe trenches supervised by Dr. DeSimone. These trenches continued the numbering scheme of the previous ones and were designated Trenches #6-17 (Figure 11). The trenches were excavated with varying lengths (averaging 20ft) with the first half excavated to a depth not exceeding 4ft and the second half excavated to depths of 10-14ft. With the assistance of the Principal Investigator the soil profiles of each trench were drawn and the stratigraphy was inspected for the presence of subsurface features, artifacts and buried horizons; none were identified. Dr. DeSimone used the data to reconstruct a cross-section of the floodplain geomorphology and concluded that the soils to a depth exceeding 10ft (the maximum depth of proposed disturbance of the current project) are all of Holocene age and therefore have the potential to contain cultural resources. Dr. DeSimone's report is attached as Appendix D.

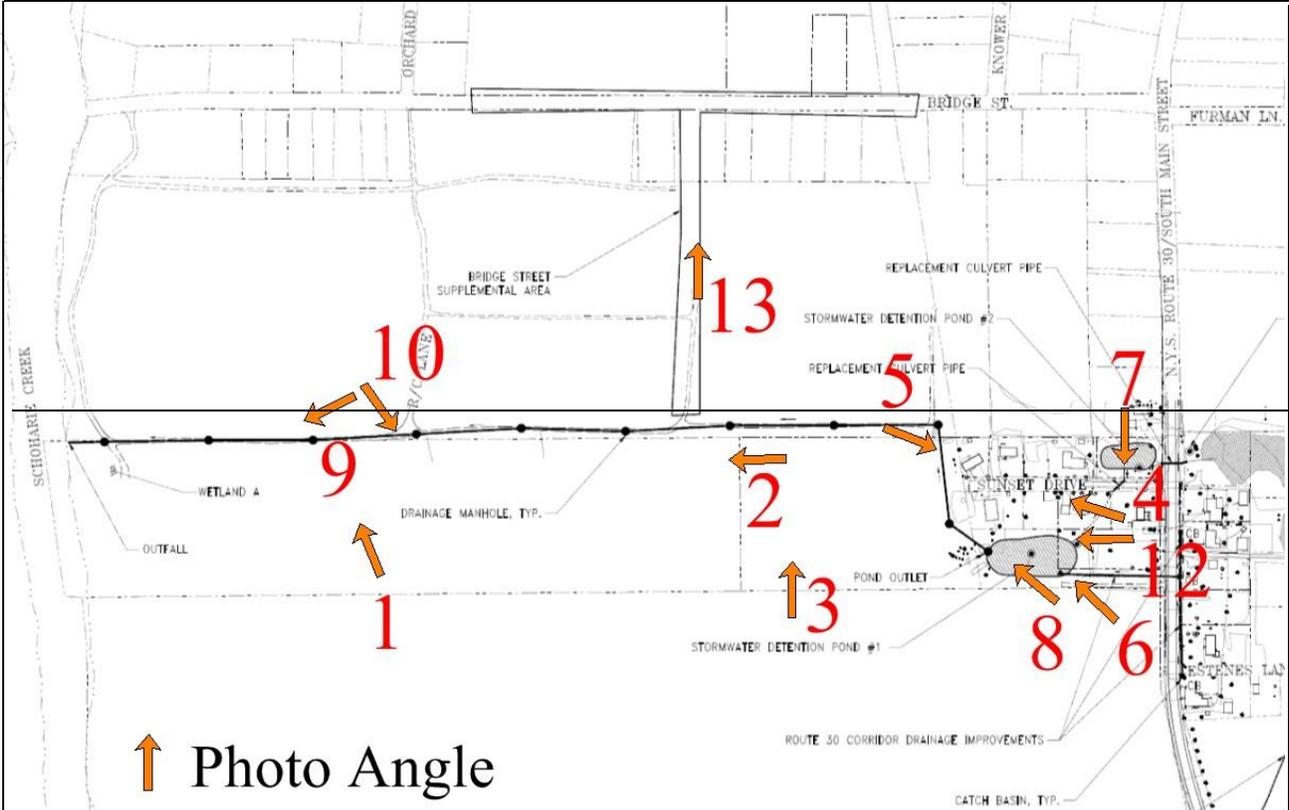
FIGURE 14. PROPOSED SITE PLANS ALONG WITH PHOTOGRAPH LOCATIONS.  
(Aerial Imagery Source: Google Earth)

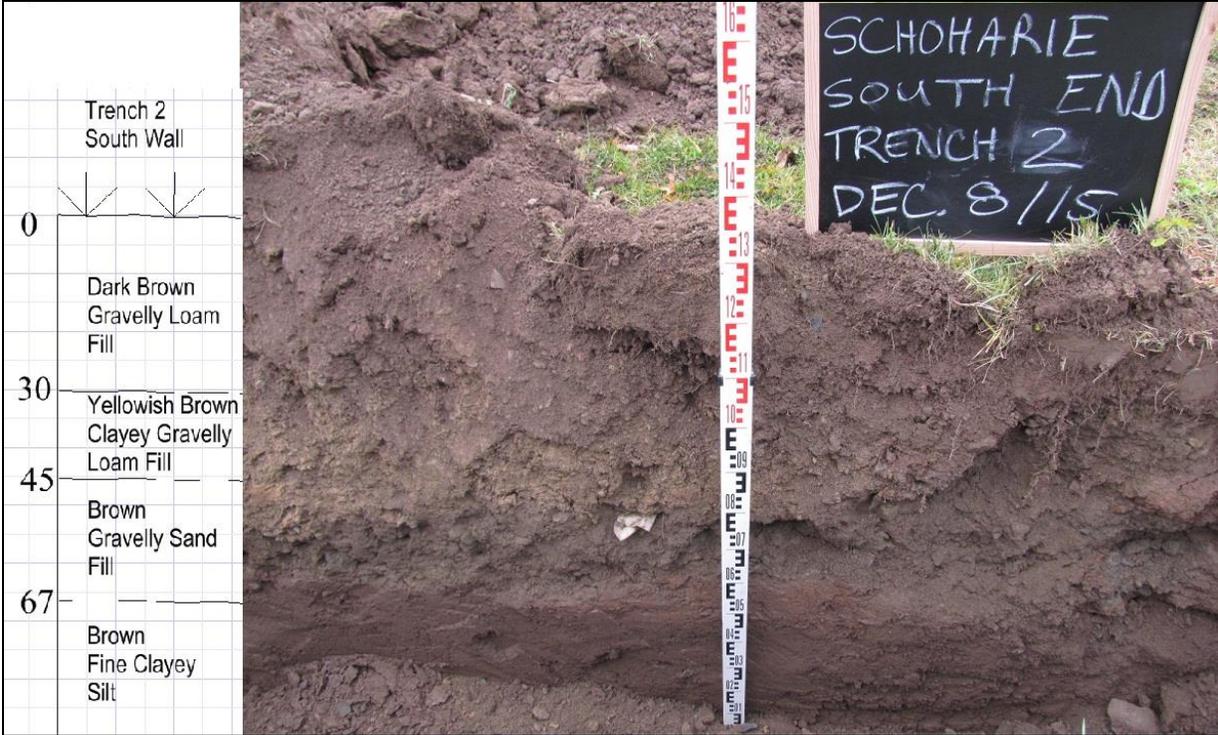
PHOTOGRAPH 7. SOUTH WALL PROFILE OF TRENCH 2 SHOWING FILL DISTURBANCE.

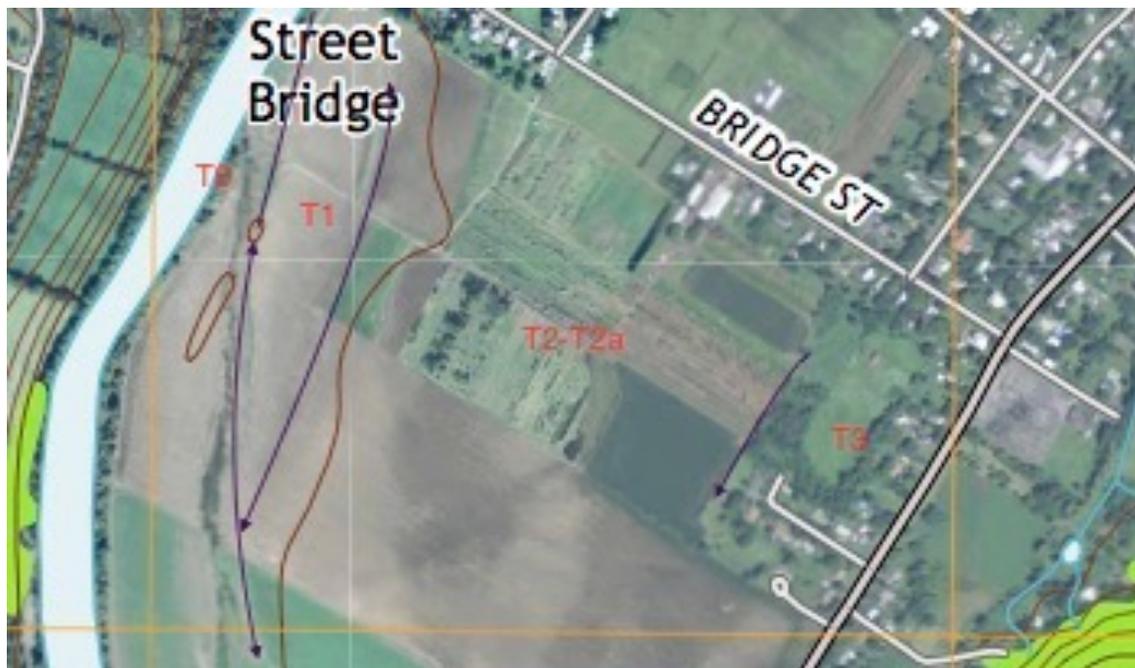
**Map 1: Terraces along the West-East alignment.**

Trench 6: A thin chocolate brown silt layer overlies a thick gray and brown sand unit consisting of MS-FS-CS textures. The setting for deposition of the sand is interpreted as a bar environment that may have accumulated to become a levee although that is not certain. Flood plain silt overtopped the bar or levee.

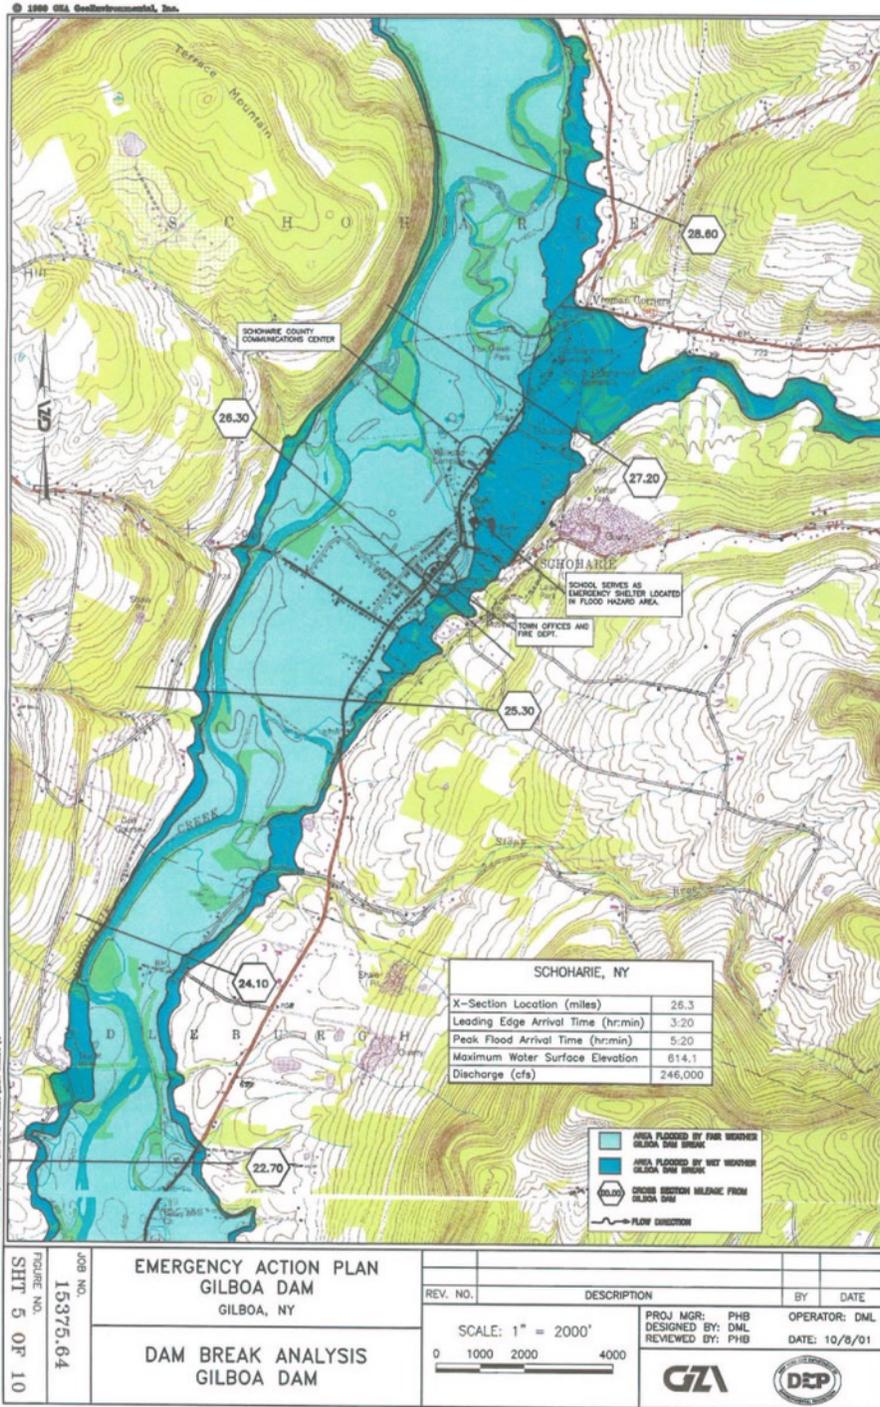
Map 2: Gilboa Dam Failure Flood Prediction

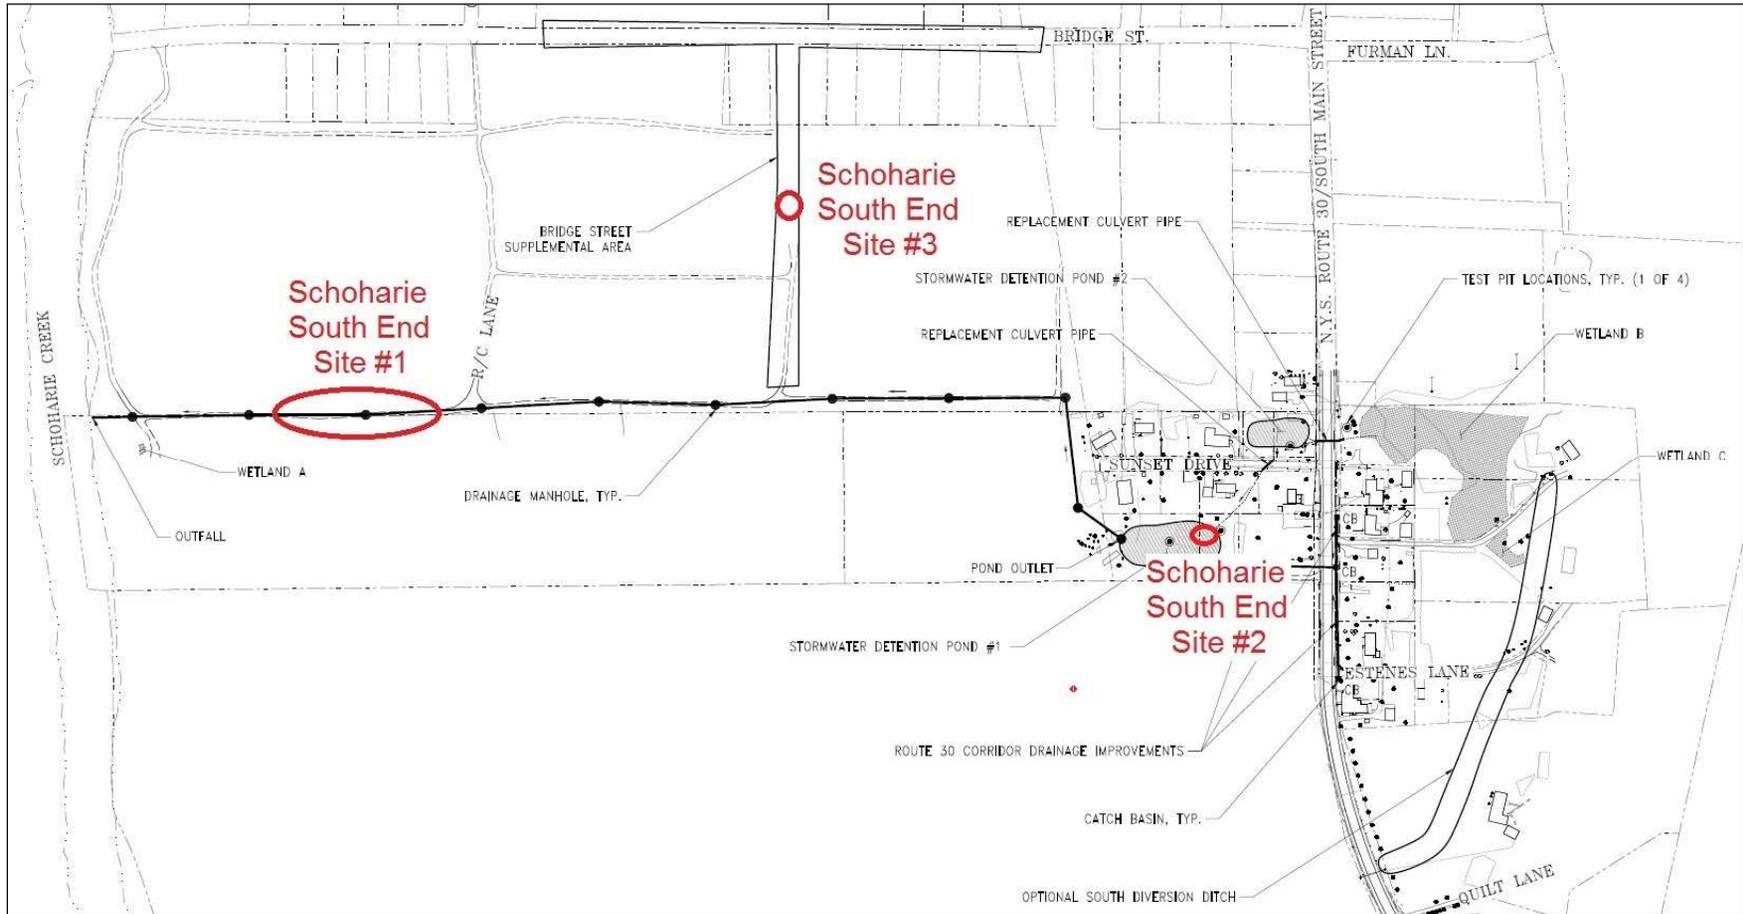
FIGURE 3: PROPOSED DRAINAGE IMPROVEMENTS WITHIN PROJECT AREA. (NOTE: SOUTH DIVERSION DITCH IS NOT INCLUDED.)

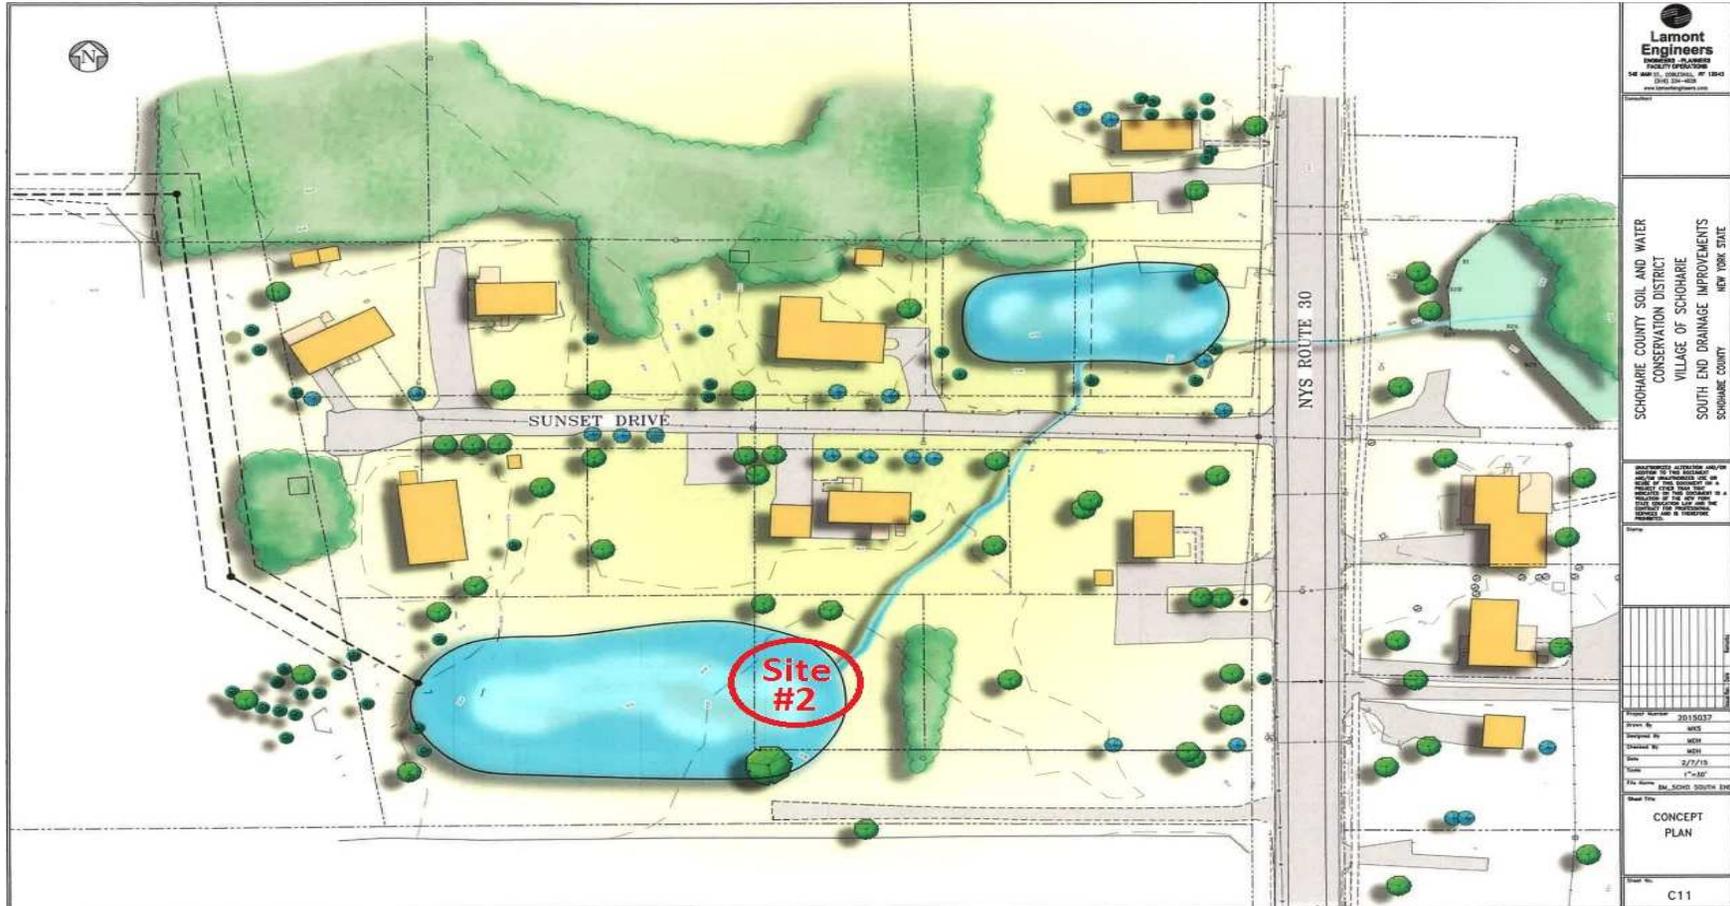
FIGURE 4: GRAPHIC DEPICTION OF ORIGINAL PROPOSED STORMWATER DETENTION PONDS WITH SITE #2.

Approximate site limits were indicated to the Project Engineers based on the combination of artifact density and the local landscape. In response, a smaller detention pond has been designed which avoids the area of highest artifact concentrations focused on the small rise to the north of the willow tree (Figure 12).

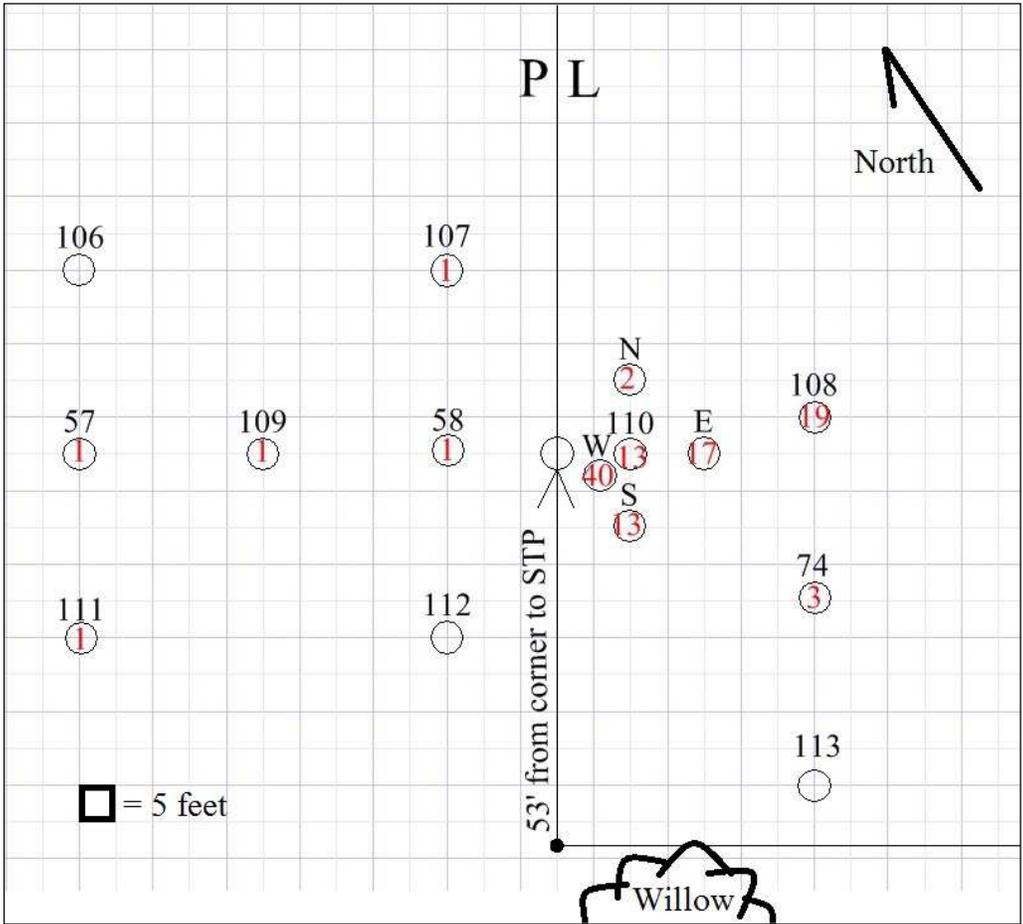
FIGURE 10: PHASE II STPs 106-113 & PHASE IB STPs 57, 58 & 74 WITH ARTIFACT COUNTS IN RED.
