NY Rising Community Reconstruction Program

Storm Recovery Projects for **ONEIDA COUNTY**

March 2014

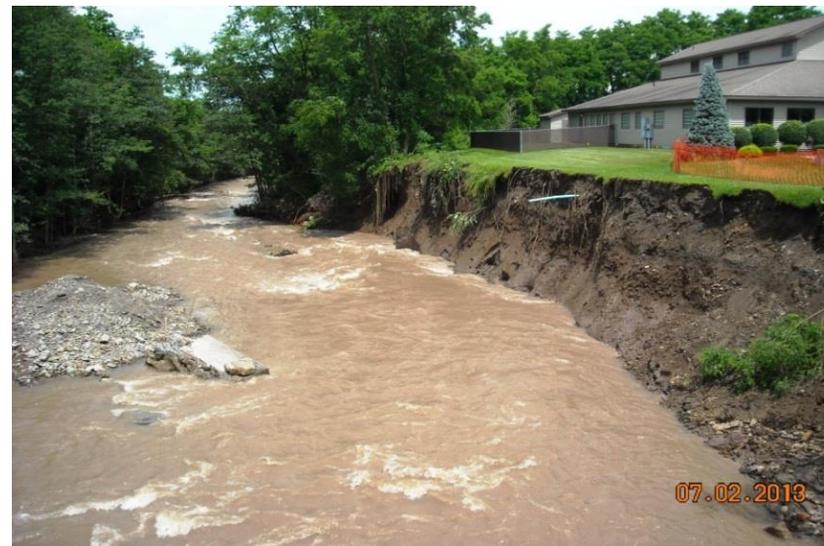
Above: Eroded creek bank as a result of the Summer 2013 flooding.

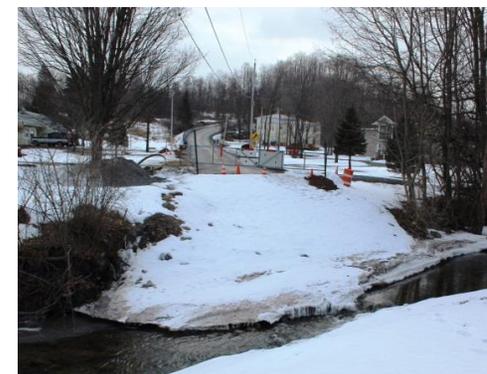
Above: Grant Road Bridge was completely washed away in the Summer 2013 flooding.

Grant Road Bridge, which crosses White Creek (Standards “C(T)” tributary¹³ to Oriskany Creek), was destroyed in the Summer 2013 flooding on Grant Road in the Town of Kirkland. The debris from the bridge’s collapse clogged the creek and exacerbated the creek’s flooding of nearby homes. The road has yet to reopen and residents face the hardship of driving several miles out of the way to access the Town, and face much longer response times by critical emergency services. This project would replace the bridge with one of appropriate size to allow for transportation and water flow. The Town is currently in negotiations with FEMA for the total bridge replacement cost of \$175,000.

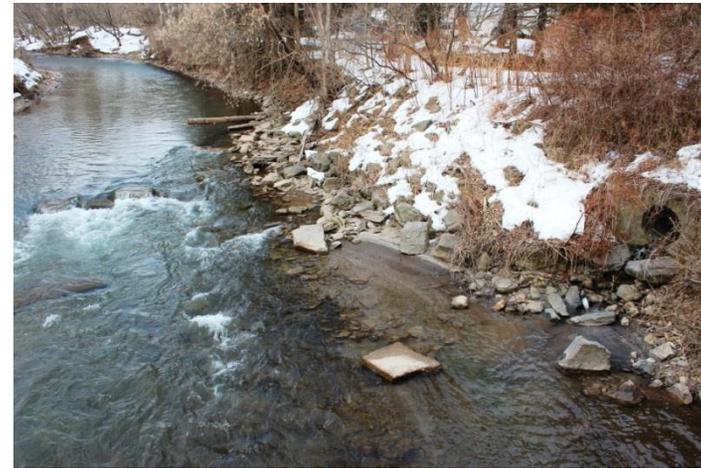
Above: Destabilized rock riprap and resulting sedimentation below.

In the Town of Kirkland is a bridge on College Street that crosses Oriskany Creek. Upstream of the bridge on the western bank, destabilization of rock riprap and erosion, caused by the Summer 2013 flooding, has resulted in sedimentation that is causing the creek current to flow predominantly and rapidly under the eastern half of the bridge. This increased velocity of flow on the eastern side has resulted in erosion to the eastern bank downstream of the bridge, where a house has lost significant land area to erosion. The summer flooding also inundated the downstream homes on Cleveland Place and eroded the bank beneath a water main that serves Hamilton

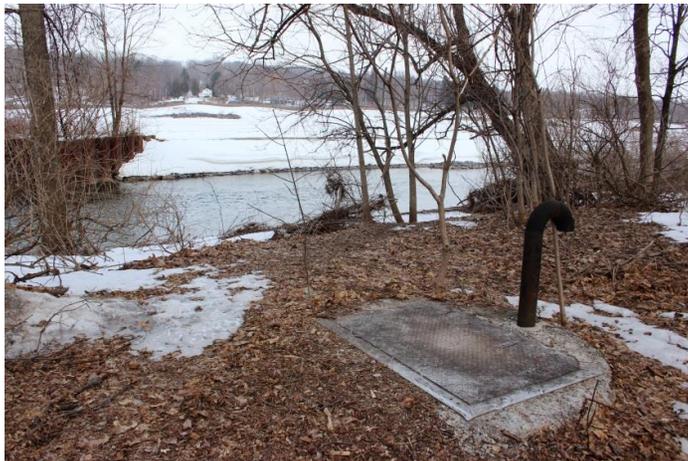
Above: Sewer pumping station on Cleveland Place.

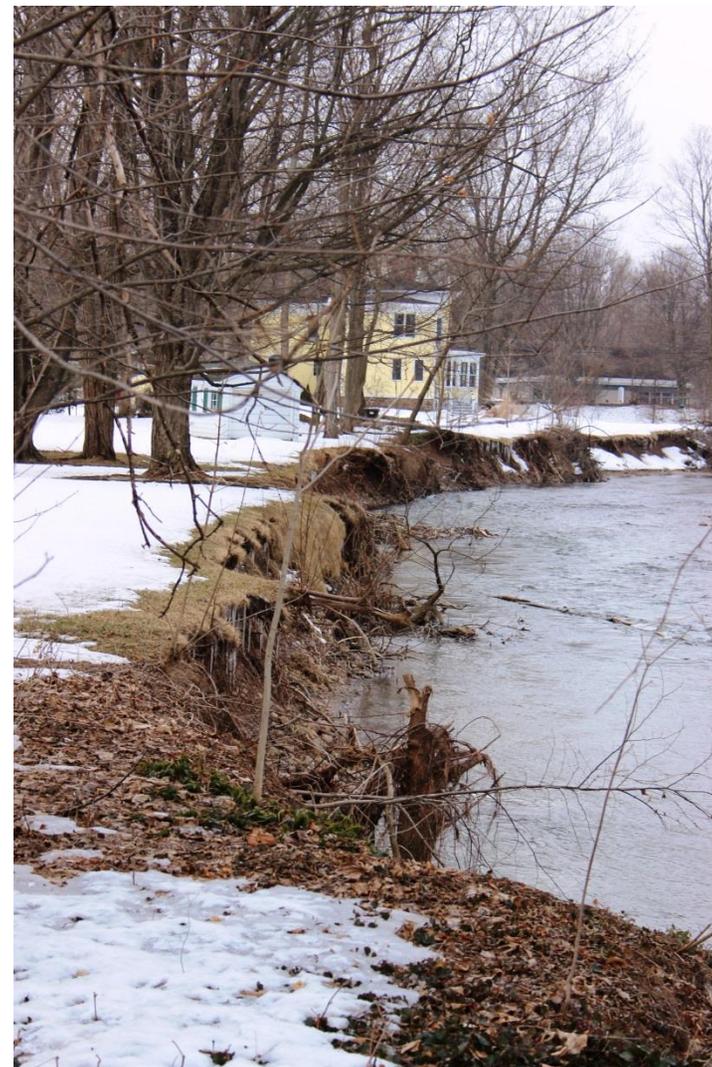
Above: Severe erosion of creek bank downstream due to new creek alignment following Summer 2013 flooding.

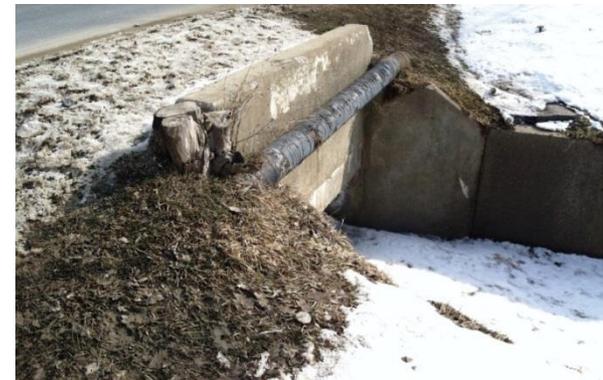
Right: Culvert on Pillmore Drive.

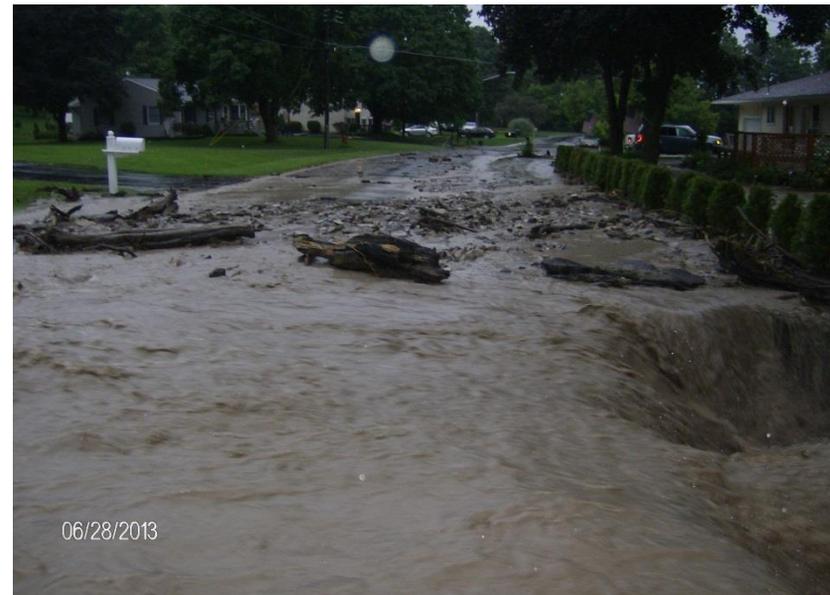
Above: The culvert failure and subsequent road failure and flooding occurring on Earl Manor Road on June 28, 2013.

creek. The flooding also tore up about 75 to 100 feet of asphalt on Earl Manor Road from the bridge heading north toward the cul-de-sac. The Town conducted emergency repairs to make the road and bridge passable for residents and emergency services. The patchwork repairs were done with cold patch pavement and were not intended to be long-term fixes. This project would improve the bridge and roadway with appropriate long-term materials and methods. While the road is torn up, the Town would also like to install French drains to improve drainage and mitigate future flooding from the creek.

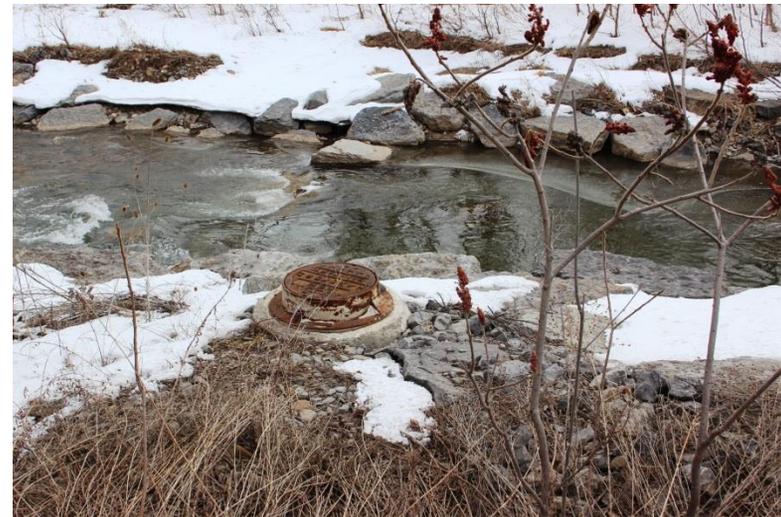
Above: Sewer infrastructure adjacent to the creek.

(1) Sauquoit Creek, Hand Place: The Town of New Hartford has worked to armor their sewer system against creek bank erosion that can destabilize and break the sewer infrastructure. Flooding undermined the armoring of a sewer pipe that crosses the Sauquoit Creek between Oneida Street and Hand Place. The velocity of the stormwater was so great that large boulders that armor the creek bank and line the cross veins were completely displaced. This has led to severe erosion of the creek bank and destabilization of the ground under and around the sewer line. The bank stabilization is also critical for the roadway, which is very close to the bank and has high potential for becoming destabilized as well. This project component would repair the damage and complete improvements to the bank and stabilization structures, including pinning of the stone armoring, and improve the bank stabilization design to better withstand future storm events. Pending the improved design, it may be estimated that approximately 200-300 linear feet of the bank requires stabilization.

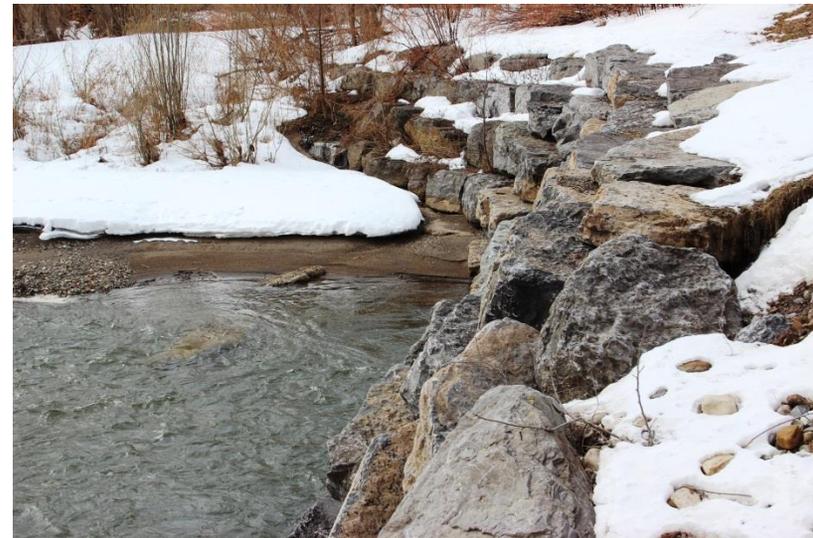
Above: Hillside Gardens creek bank armoring that is pulling away from bank.

(2) Sauquoit Creek, Hillside Gardens: Similarly, destabilization of the creek bank armoring along the Sauquoit Creek below the Hillside Garden housing development is leading to erosion of the bank and seriously threatening the housing development's sewer infrastructure. The creek bank was previously stabilized following 2011 flood events that broke the sewer line and resulted in the Town pumping sewage for eight months until the pipe could be repaired. The 2011 stabilization measures, however, did not include pinning the rock riprap to the creek bank; the unprecedented deluge in the Summer 2013 flooding undercut the armoring and the stone can be seen pulling away from the bank. This project component would repair the damage and implement improvements to the bank and stabilization structures, including pinning of the stone armoring, of approximately 200 to 300 linear feet.

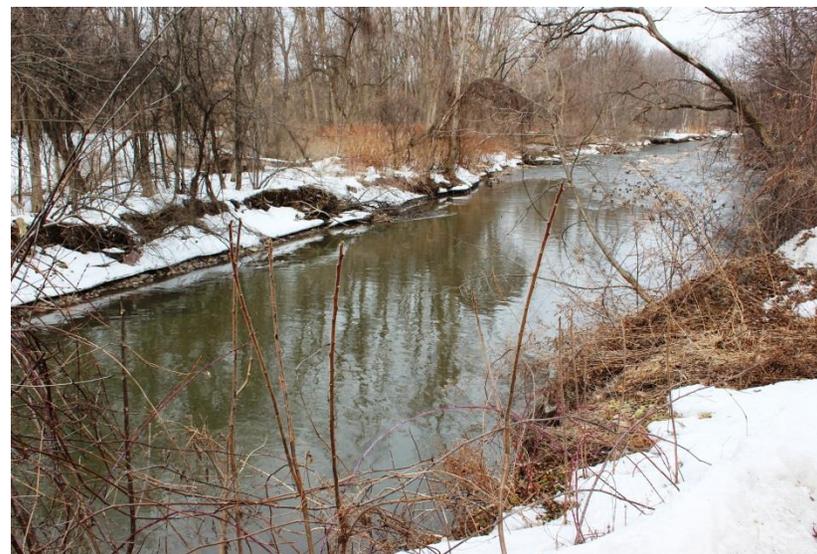
Above: Steep creek bank in foreground immediately behind Gingerbread Bake Shop.

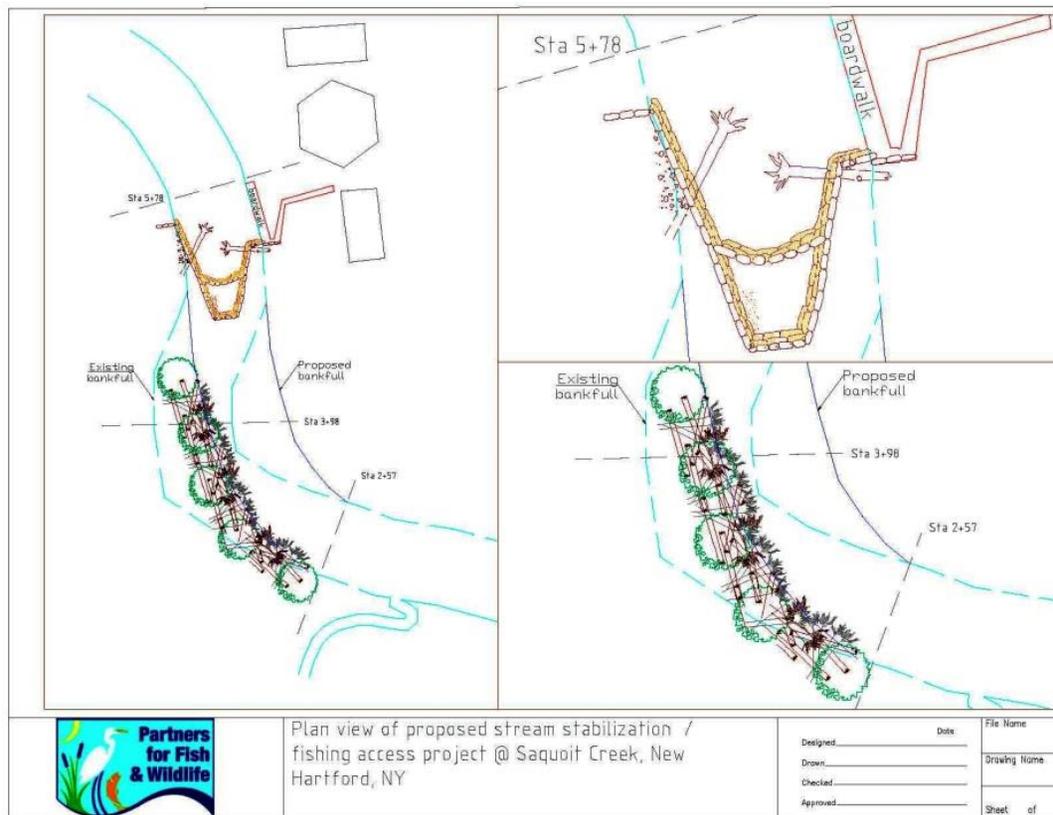
Above: Preliminary drawings of work to be completed at Washington Mills Park.

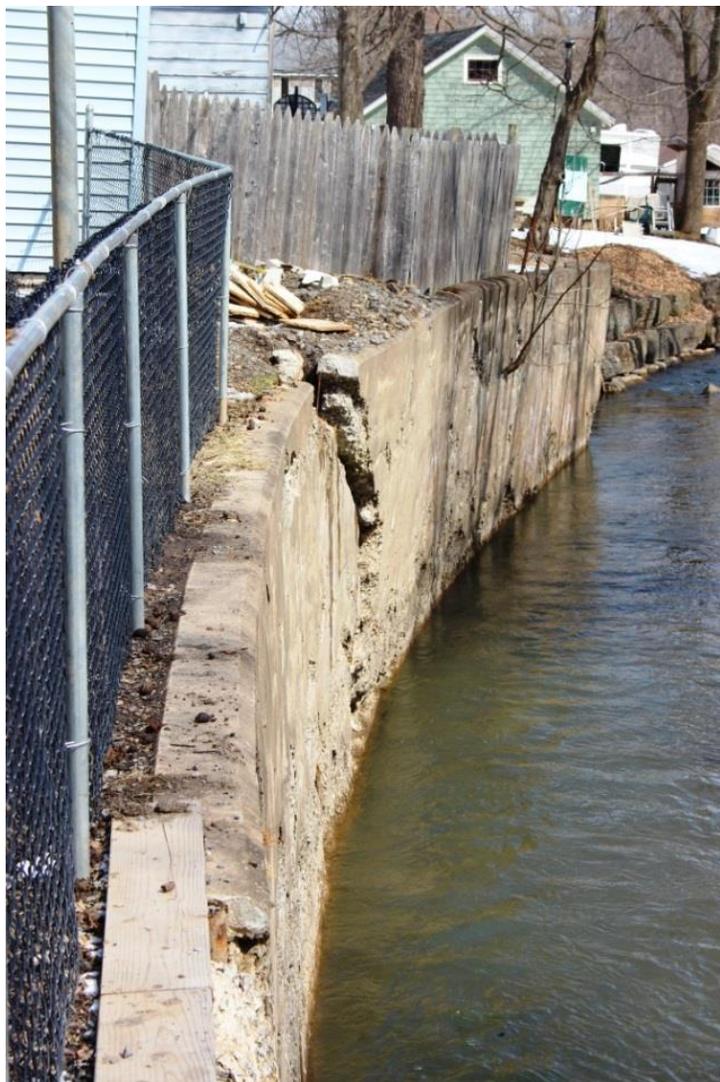
Above: Crack in retaining wall on Sauquoit Creek.

Across the creek, the homes on Oneida Street were built in the late 1800s as worker housing for the nearby mills. These homes back onto the creek with a 10-foot tall retaining wall that protects the properties from eroding or collapsing into the creek below. Long-term degradation of the wall was significantly worsened from the Summer 2013 flooding as the velocity of the swift waters undercut the retaining walls. Not only is the wall detaching from the banks and leaning into the creek, the eroded subbase beneath the wall is causing soil from the residential properties to leak out below the wall, creating dangerous sink holes in backyards. Following the Summer 2013 flooding, residents lost a swimming pool and a vehicle due to the degradation of the wall and sinkholes. The entire 250-foot length of retaining wall may be ready to cave in, potentially taking the ten houses with it.

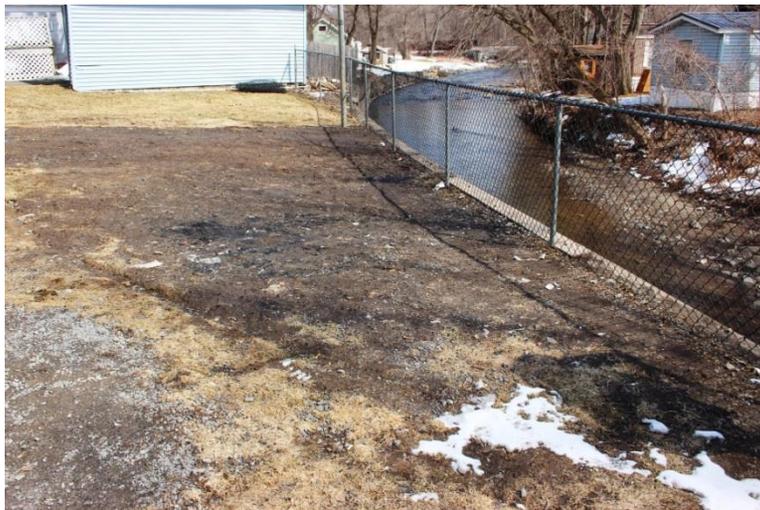
Above: Fresh dirt indicating filled in sinkhole in backyard of Bleachery residence.

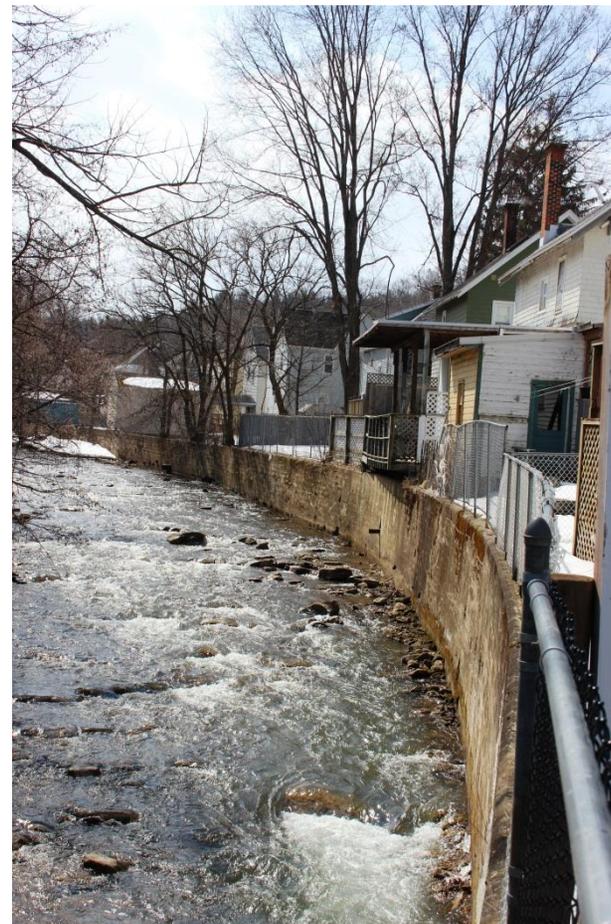
Above: Retaining wall behind Bleachery Place homes.

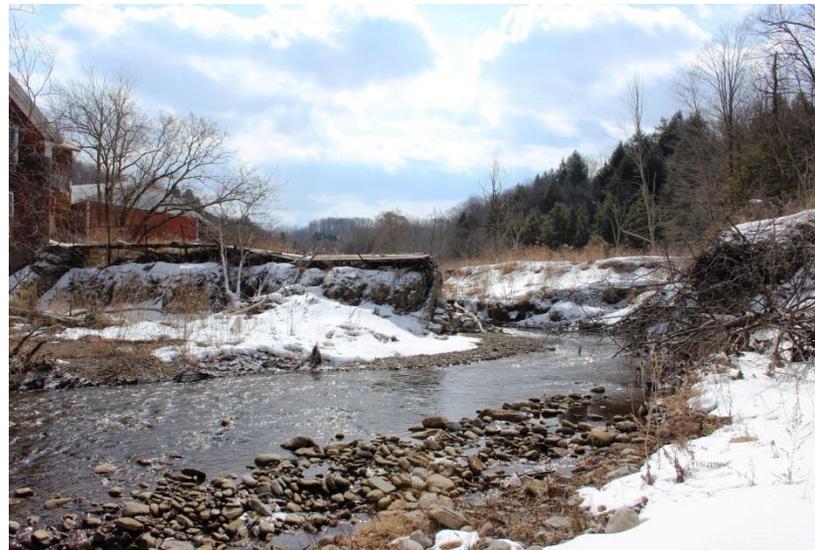
Above: Paris Dam breach and bedload sedimentation.

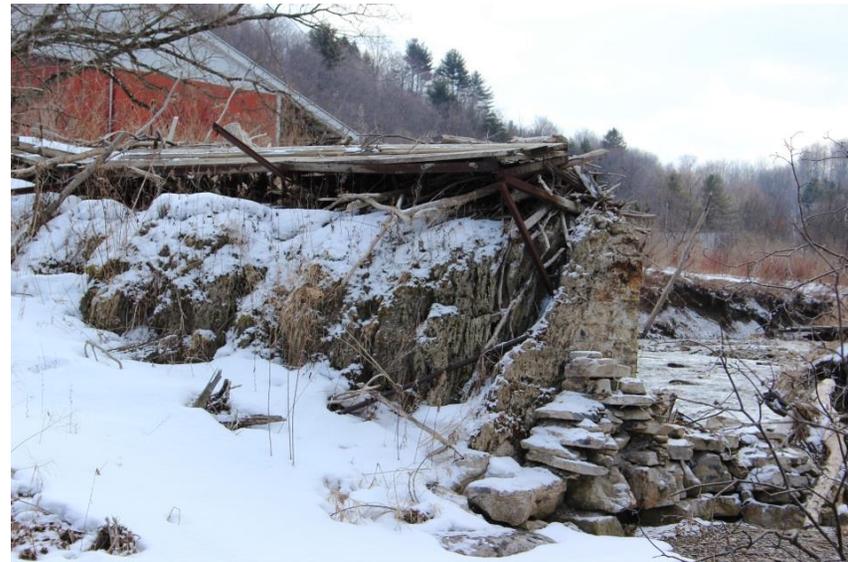
Above: Paris Dam breach.

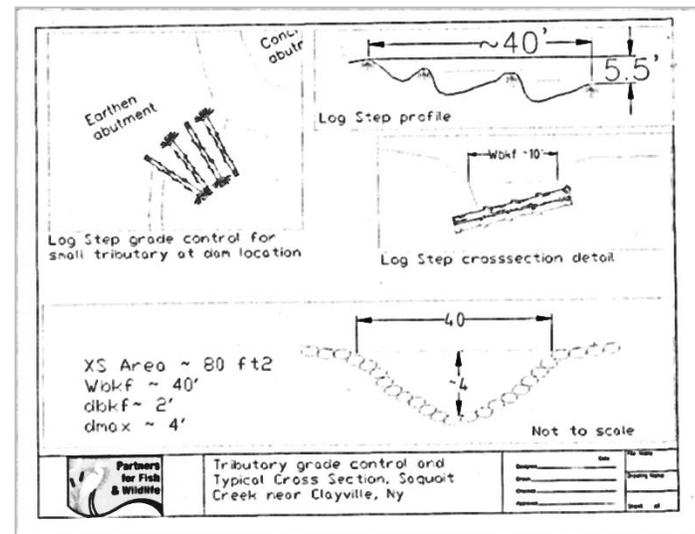
Below: Preliminary designs for Paris Dam project.

significant erosion. Phase 1 of this project, designed in conjunction with USFWS is already underway and entails repairs to creek banks upstream. This project would fund Phase 2 including removal of the dam and storm debris, realignment of the creek (as recommended by the Fish and Wildlife Service), and bank stabilization.

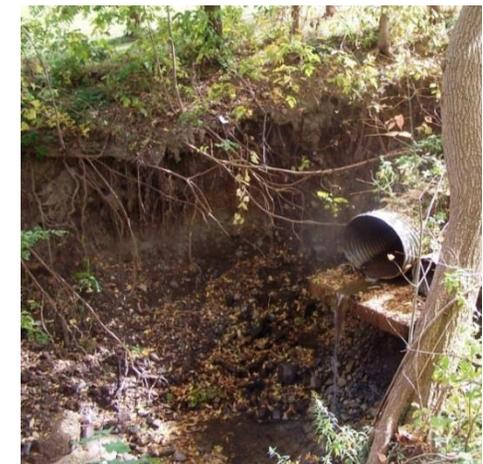
Above: Culvert outfall and eroded plunge pool.

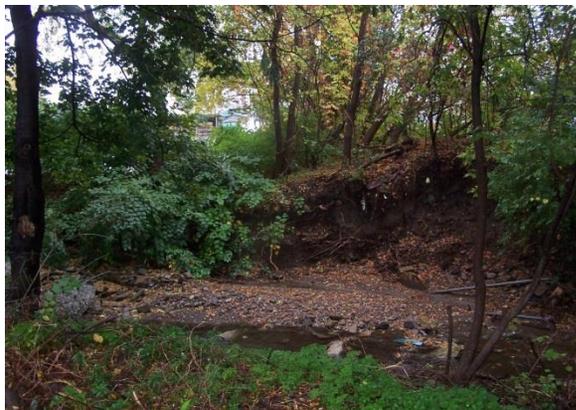
Left: Bank erosion at the Williams Tool site.

The Williams Tool Site in the Town of New Hartford would include two rock veins and 200 feet of armored bank with 400 feet of vertical armoring.

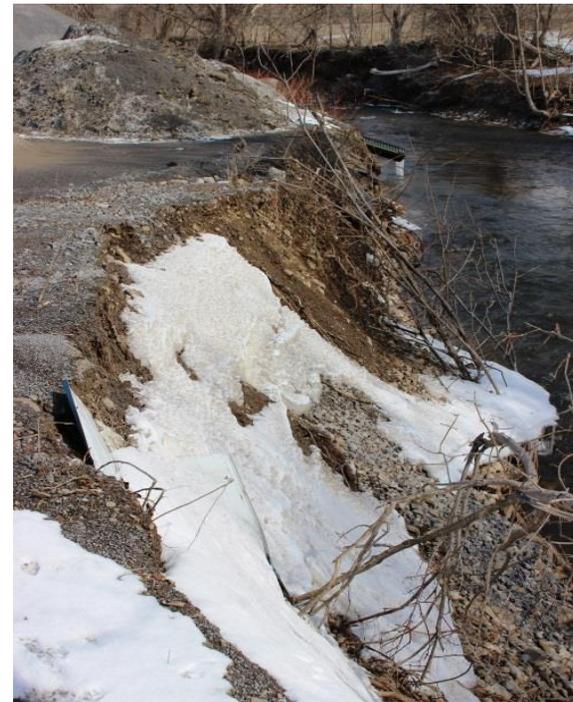
Above: Bank erosion at the Paris Highway Garage site.

The Paris Highway Garage Site in the Town of Paris would include 1,600 feet of armor and one rock vein.

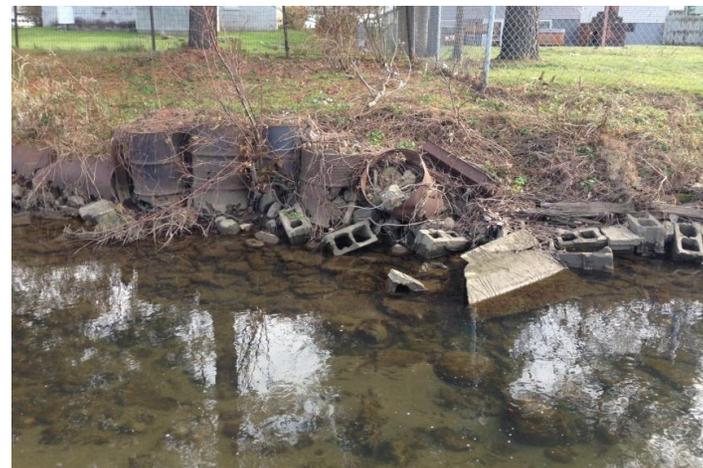
Above: An inadequate bank stabilization technique being undertaken to stem erosion.

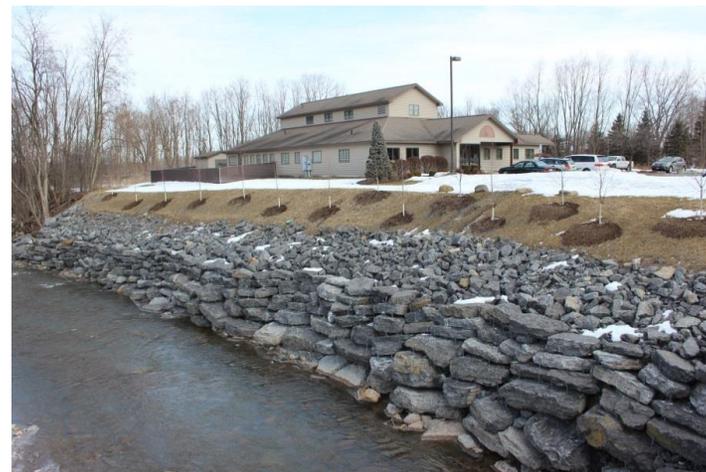
Below: Example of a stabilized and armored creek bank with pinned rock riprap.
