<b>UKRAINIAN AMERICAN CITIZENS CLUB, INC. - SMALL BUSINESS GRANT PROGRAM PROJECT #001-ED-32966-2013 ENVIRONMENTAL ASSESSMENT &amp; ERR PROJECT SUMMARY</b>	
<b>Responsible Entity:</b>	New York State Homes & Community Renewal – Housing Trust Fund Corporation Cooperating with the Governor’s Office of Storm Recovery (GOSR)
<b>Certifying Officer:</b>	Thomas King, Esq., Certifying Officer, GOSR
<b>Project Name:</b>	Ukrainian American Citizens Club, Inc.
<b>Funding Recipient:</b>	Ukrainian American Citizens Club, Inc.
<b>Federal Agency:</b>	U.S. Department of Housing & Urban Development (HUD)
<b>Project #:</b>	001-ED-32966-2013
<b>Project Sponsor:</b>	New York State Housing Trust Fund Corporation
<b>Program Name:</b>	New York State Community Development Block Grant-Disaster Recovery Small Business Grant Program (April 2013)
<b>Project Address:</b>	1 Pulaski Street, Cohoes, NY
<b>Project County:</b>	Albany County

<b>Environmental Assessment Prepared By:</b>	Tectonic Engineering & Surveying PO Box 37, 70 Pleasant Hill Road Mountainville, NY 10953

# REPLACEMENT OF UKRAINIAN AMERICAN CITIZENS CLUB, INC. PAVILION CITY OF COHOES, ALBANY COUNTY, NEW YORK

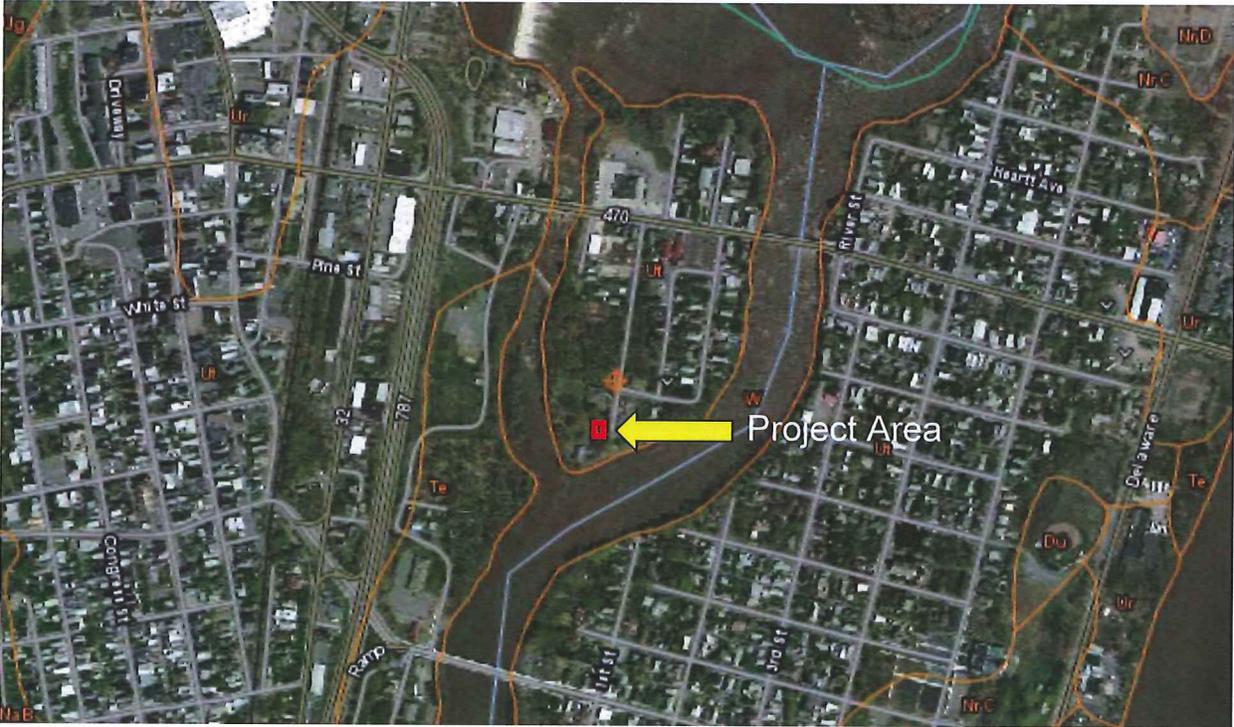
FIGURE 1. SOIL MAP OF THE PROJECT AREA (USDA 2015)

The general soil profile for the area encompassed by Simmons Island is characterized as Colonie-Elnora soils. These are generally dominantly nearly level to steep, somewhat excessively to moderately well drained, deep, and course textured. However, as seen above in **Figure 1**, soils within the PA consist of Udorthents (**Ut**). These soils consist of very deep, moderately to well drained loamy or clayey soils that commonly occur as the result of construction or urban development sites that have been cut and filled. The typical profile of this soil can be found below in **Table 1**. This type of soils has very low probability to contain intact archaeological sites.

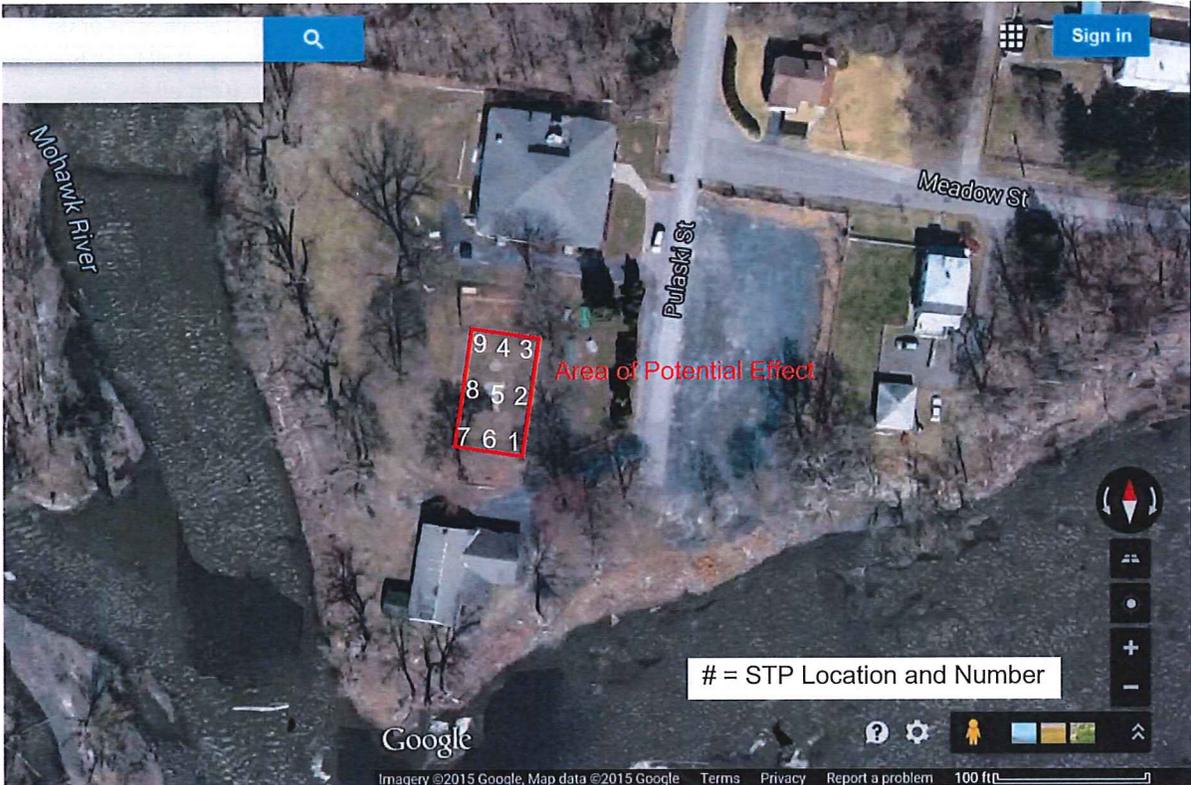
AERIAL IMAGE OF THE AREA OF POTENTIAL EFFECT ALONG WITH THE LOCATION OF SUBSURFACE TESTING

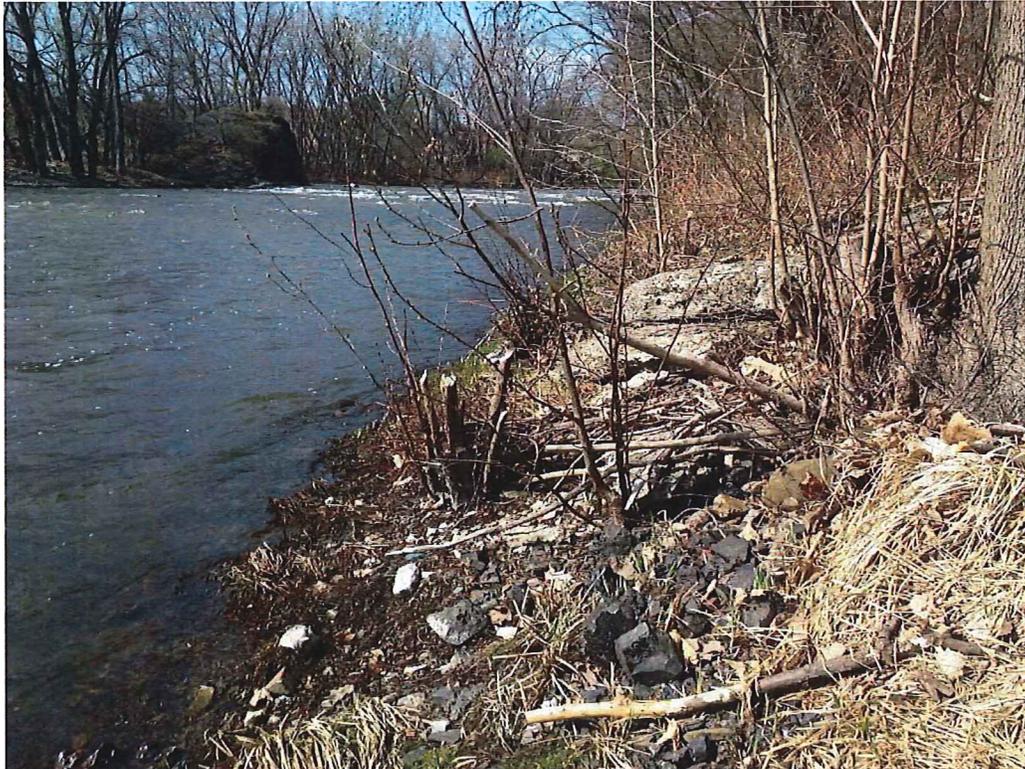
PHOTOGRAPH 6. FACING NORTH ALONG THE EAST BANK OF THE MOHAWK RIVER. IRON ORE SLAG IS ERODING OUT OF THE ISLAND'S BANKS.

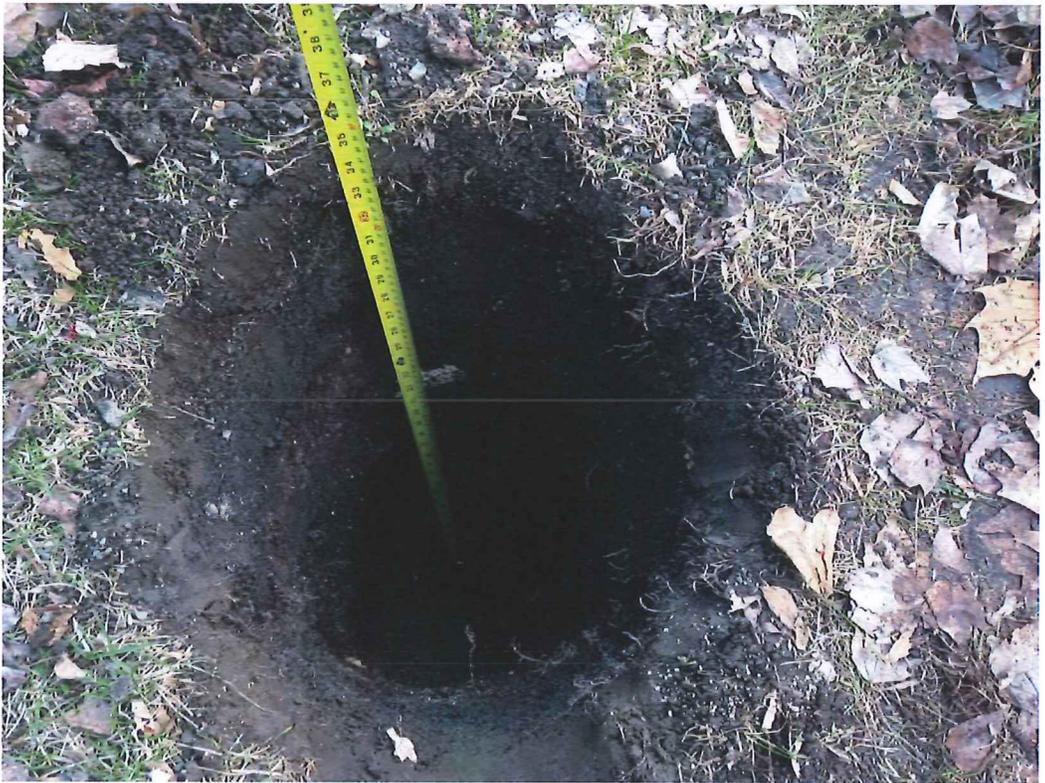
PHOTOGRAPH 8. VIEW OF COMPLETED STP1.

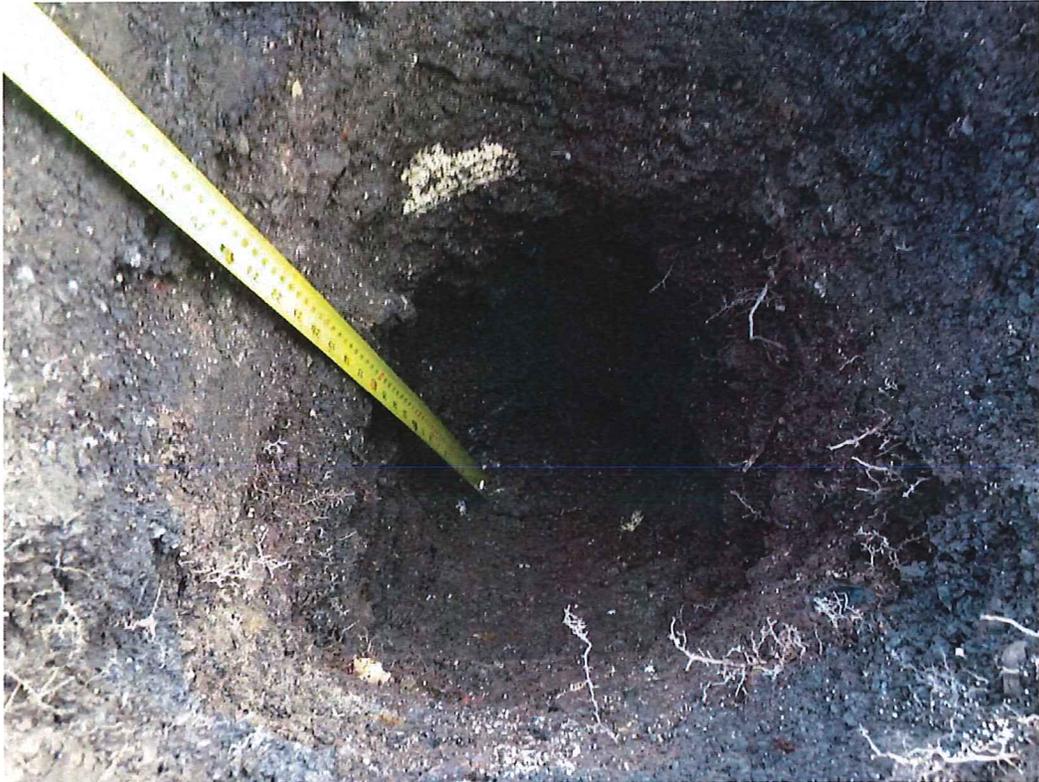
PHOTOGRAPH 9. SOIL PROFILE OF COMPLETED STP SHOWING LAYERS OF FILL.

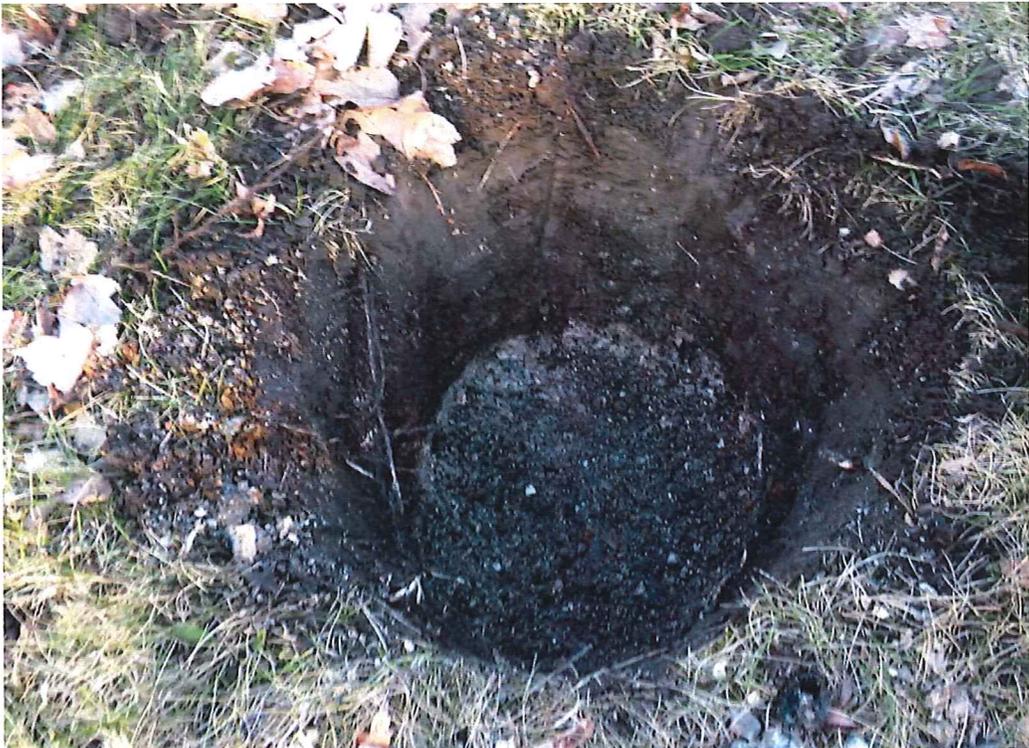
PHOTOGRAPH 10. SHOWING INTERFACE WITH ASHY HISTORIC FILL IN STP 5. MODERN GRAVEL FILL LAYER ABSENT IN THIS TEST.

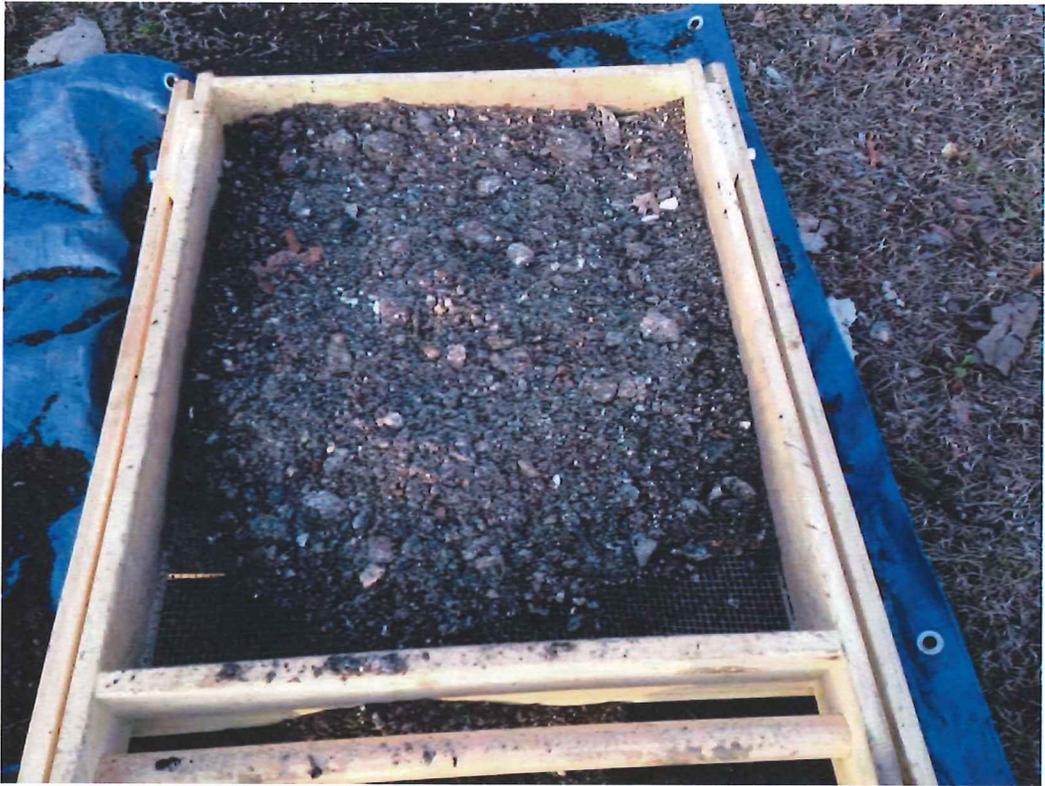
PHOTOGRAPH 11. SHOWING EXAMPLE OF ASHY HISTORIC FILL DEPOSIT.
