HYDE PARK LANDING, LTD.

ENVIRONMENTAL ASSESSMENT

HYDE PARK LANDING, LTD. - SMALL BUSINESS GRANT PROGRAM PROJECT #027-ED-32620-2013 ENVIRONMENTAL ASSESSMENT & ERR PROJECT SUMMARY	
Responsible Entity:	New York State Homes & Community Renewal – Housing Trust Fund Corporation Cooperating with the Governor’s Office of Storm Recovery (GOSR)
Certifying Officer:	Thomas J. King, Esq., Assistant General Counsel and Certifying Officer, Governor’s Office of Storm Recovery
Project Name:	Hyde Park Landing, LTD.
Funding Recipient:	Hyde Park Landing, LTD.
Federal Agency:	U.S. Department of Housing & Urban Development (HUD)
Project #:	027-ED-32620-2013
Project Sponsor:	New York State Housing Trust Fund Corporation
Program Name:	New York State Community Development Block Grant-Disaster Recovery Small Business Grant Program (April 2013)
Project Address:	6 Dock Street, Hyde Park, Dutchess County, New York
Project County:	Dutchess County
Estimated Project Cost:	\$10,113.17

Environmental Assessment Prepared By:	Tectonic Engineering & Surveying Consultants P.C. PO Box 37, 70 Pleasant Hill Road Mountainville, NY 10953

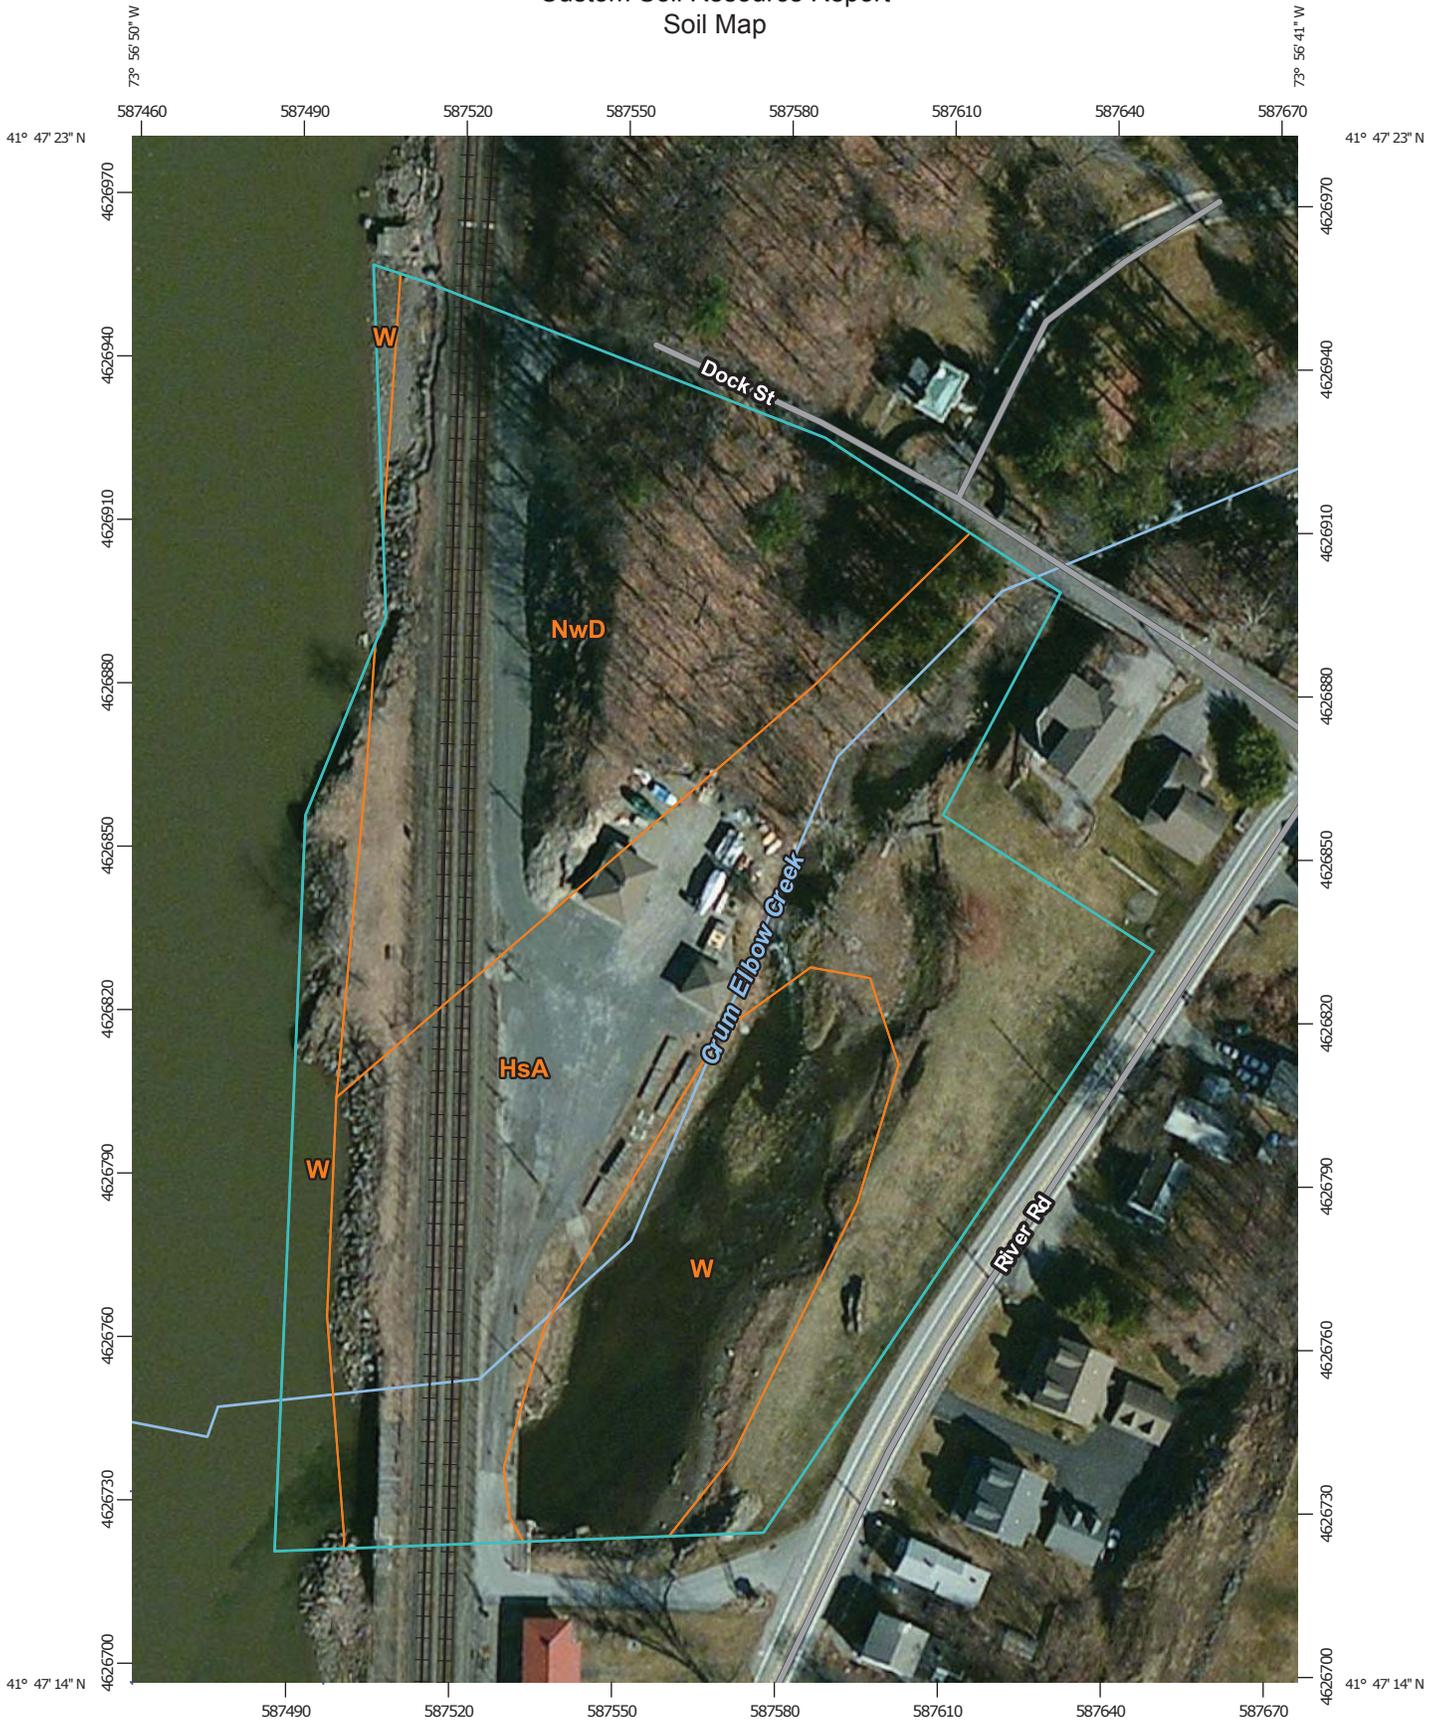
Custom Soil Resource Report Soil Map

Map Scale: 1:1,380 if printed on A portrait (8.5" x 11") sheet.

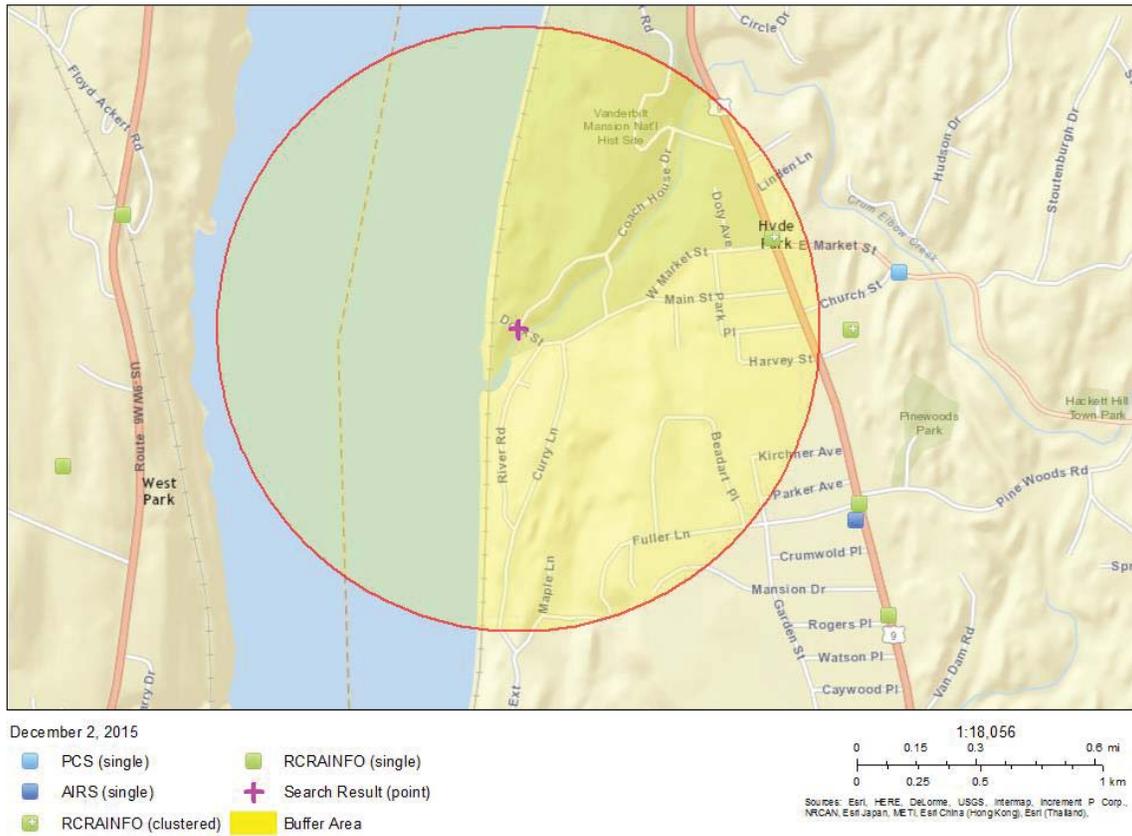
Figure 2: Hazardous waste sites and handlers (green marker), toxic release sites (blue marker), Superfund and brownfield sites (orange markers), and facilities regulated by the U.S. EPA for radiation and radioactivity (pink marker). The Subject Property is indicated by a purple cross symbol, and a 3,000 foot buffer around the Subject Property is represented by the red circle.

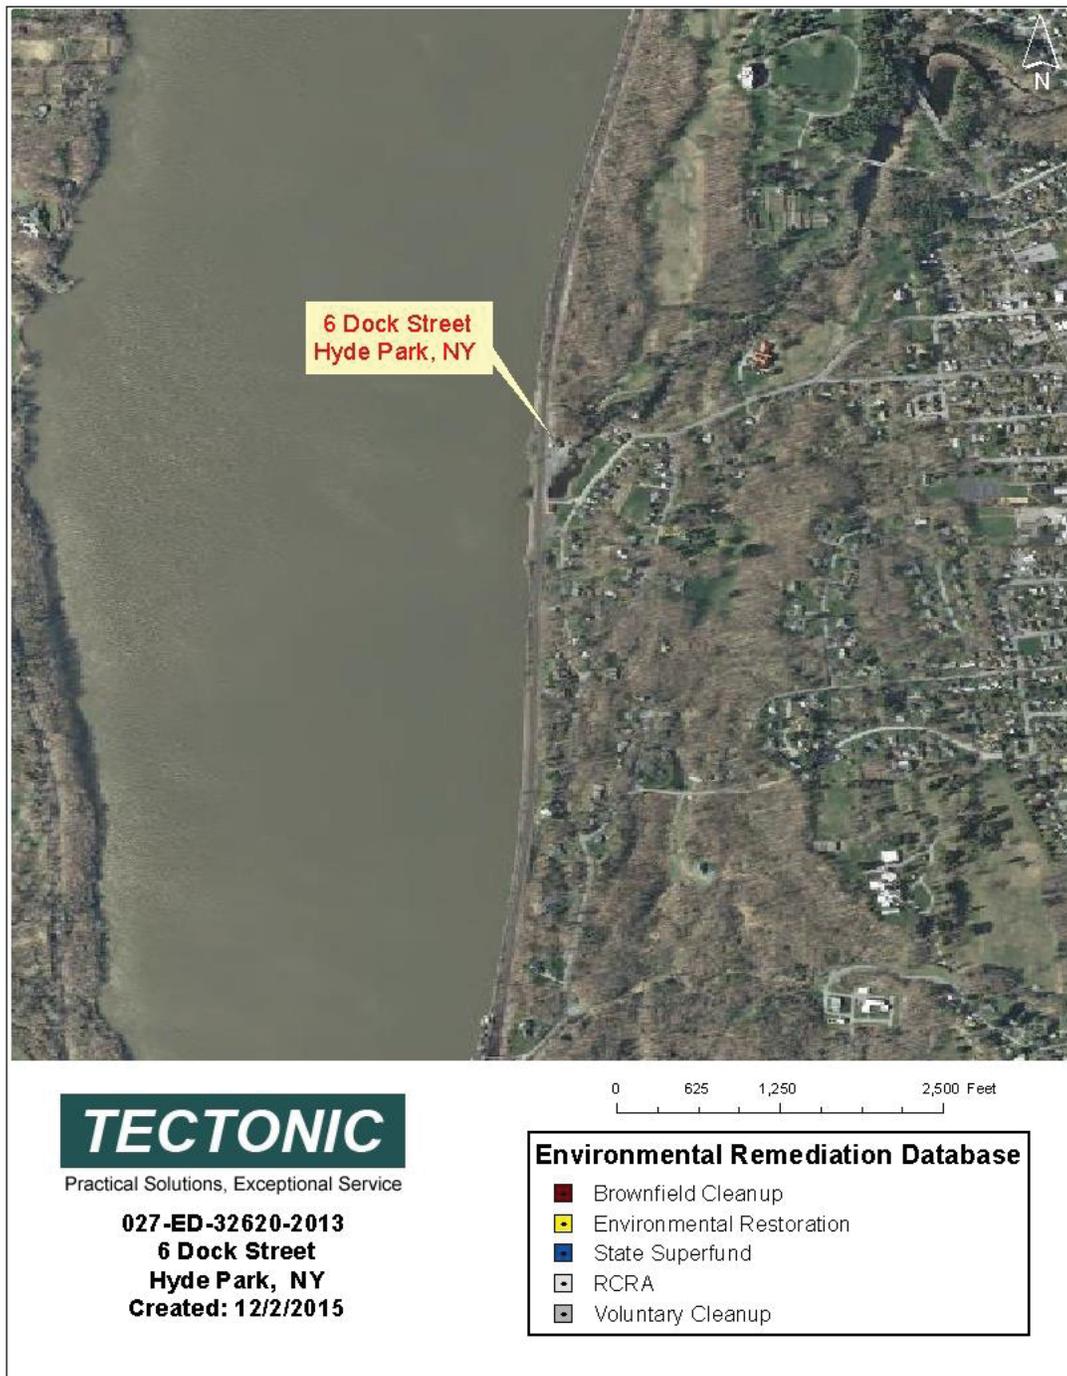
Figure 3: Environmental remediation sites listed in the NYSDEC Environmental Remediation Database. Brownfield cleanups are depicted by dark red symbols, Environmental Restoration Programs by yellow symbols, State Superfund sites by black symbols, RCRA sites by white symbols, and Voluntary Cleanup sites by gray symbols.

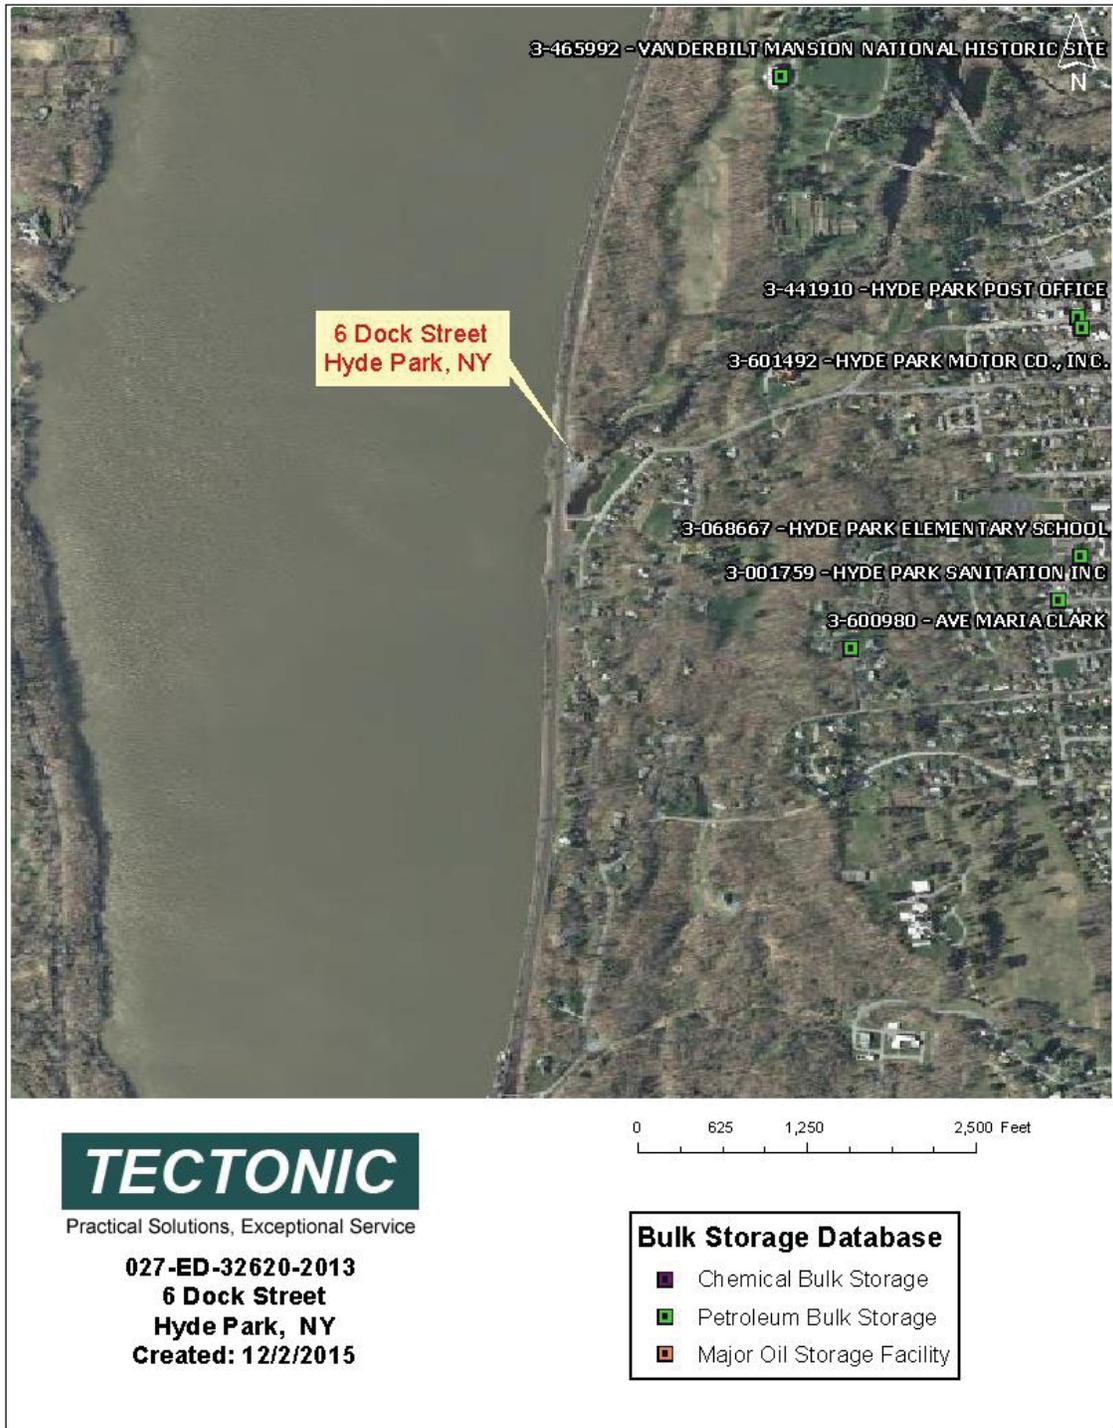
Figure 4: Properties listed on the NYSDEC Bulk Storage Database. Petroleum Bulk Storage is represented by green markers, Chemical Bulk Storage by purple markers, and Major Oil Storage Facilities by red markers.

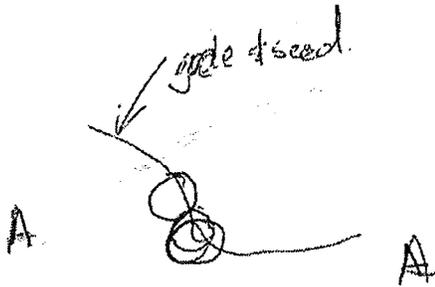
3-1382-00362/4

B stone placed for stabilization
Large embedded stone on the Bottom

C - banks need to be left alone - suggest
no mowing to allow natural vegetation

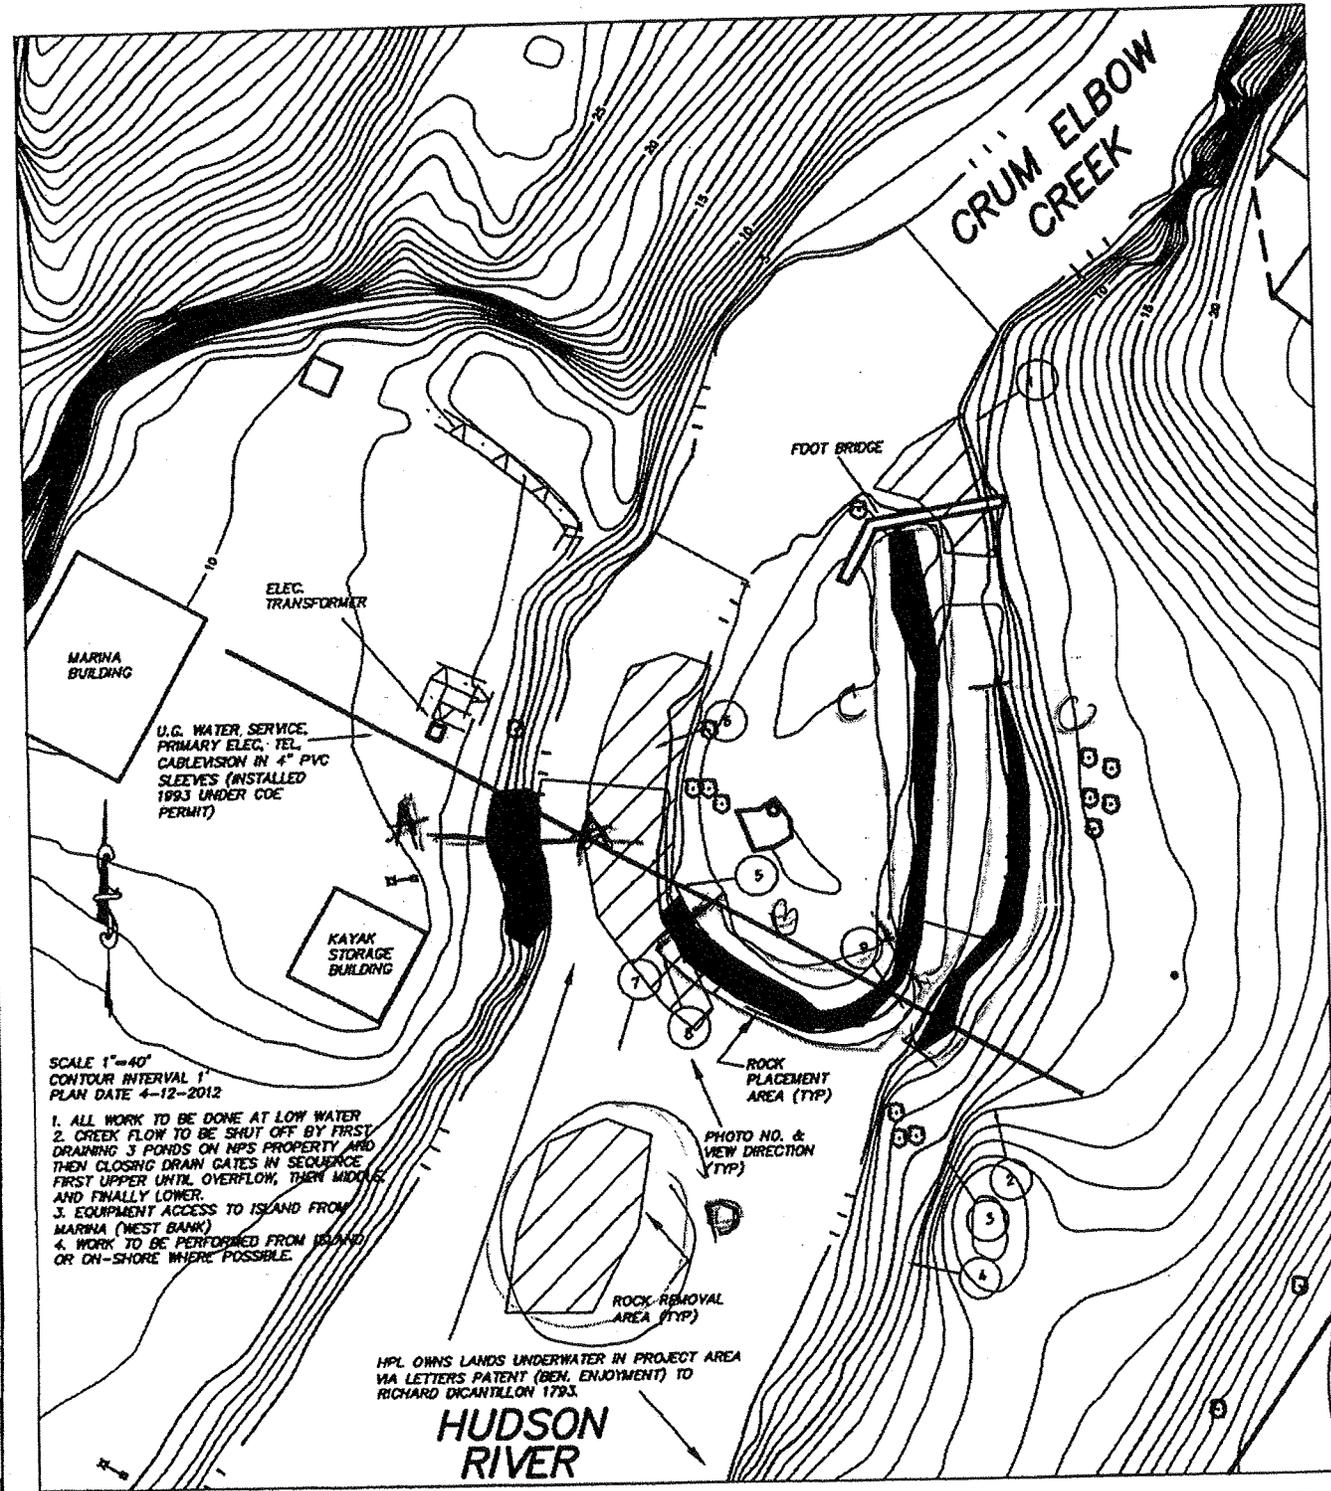
Project Drawings
For Article 15, 24 and Water Quality Certification

SCALE 1"=40'
CONTOUR INTERVAL 1'
PLAN DATE 4-12-2012

1. ALL WORK TO BE DONE AT LOW WATER
2. CREEK FLOW TO BE SHUT OFF BY FIRST DRAINING 3 PONDS ON NP'S PROPERTY AND THEN CLOSING DRAIN GATES IN SEQUENCE FIRST UPPER UNTIL OVERFLOW, THEN MIDDLE AND FINALLY LOWER.
3. EQUIPMENT ACCESS TO ISLAND FROM MARINA (WEST BANK)
4. WORK TO BE PERFORMED FROM ISLAND OR ON-SHORE WHERE POSSIBLE.

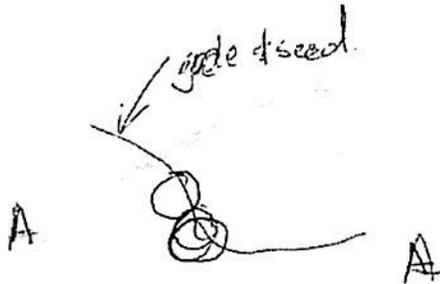
B stone placed for stabilization
Large embedded stone on the Bottom

C - banks need to be left alone - suggest
no mowing to allow natural vegetation

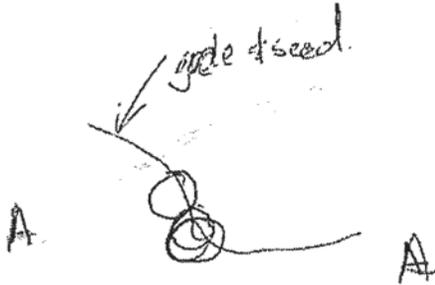
3-1382-00362/4

B stone placed for stabilization
Large embedded stone on the Bottom
