**THE HARVA COMPANY - SMALL BUSINESS GRANT PROGRAM
PROJECT #: 095-ED-32102-2013
ENVIRONMENTAL ASSESSMENT & ERR PROJECT SUMMARY**

| Project Name: | The Harva Company – Small Business Grant Program |
| Project Address: | 2922 State Route 7, Howes Cave, NY, 12092 |

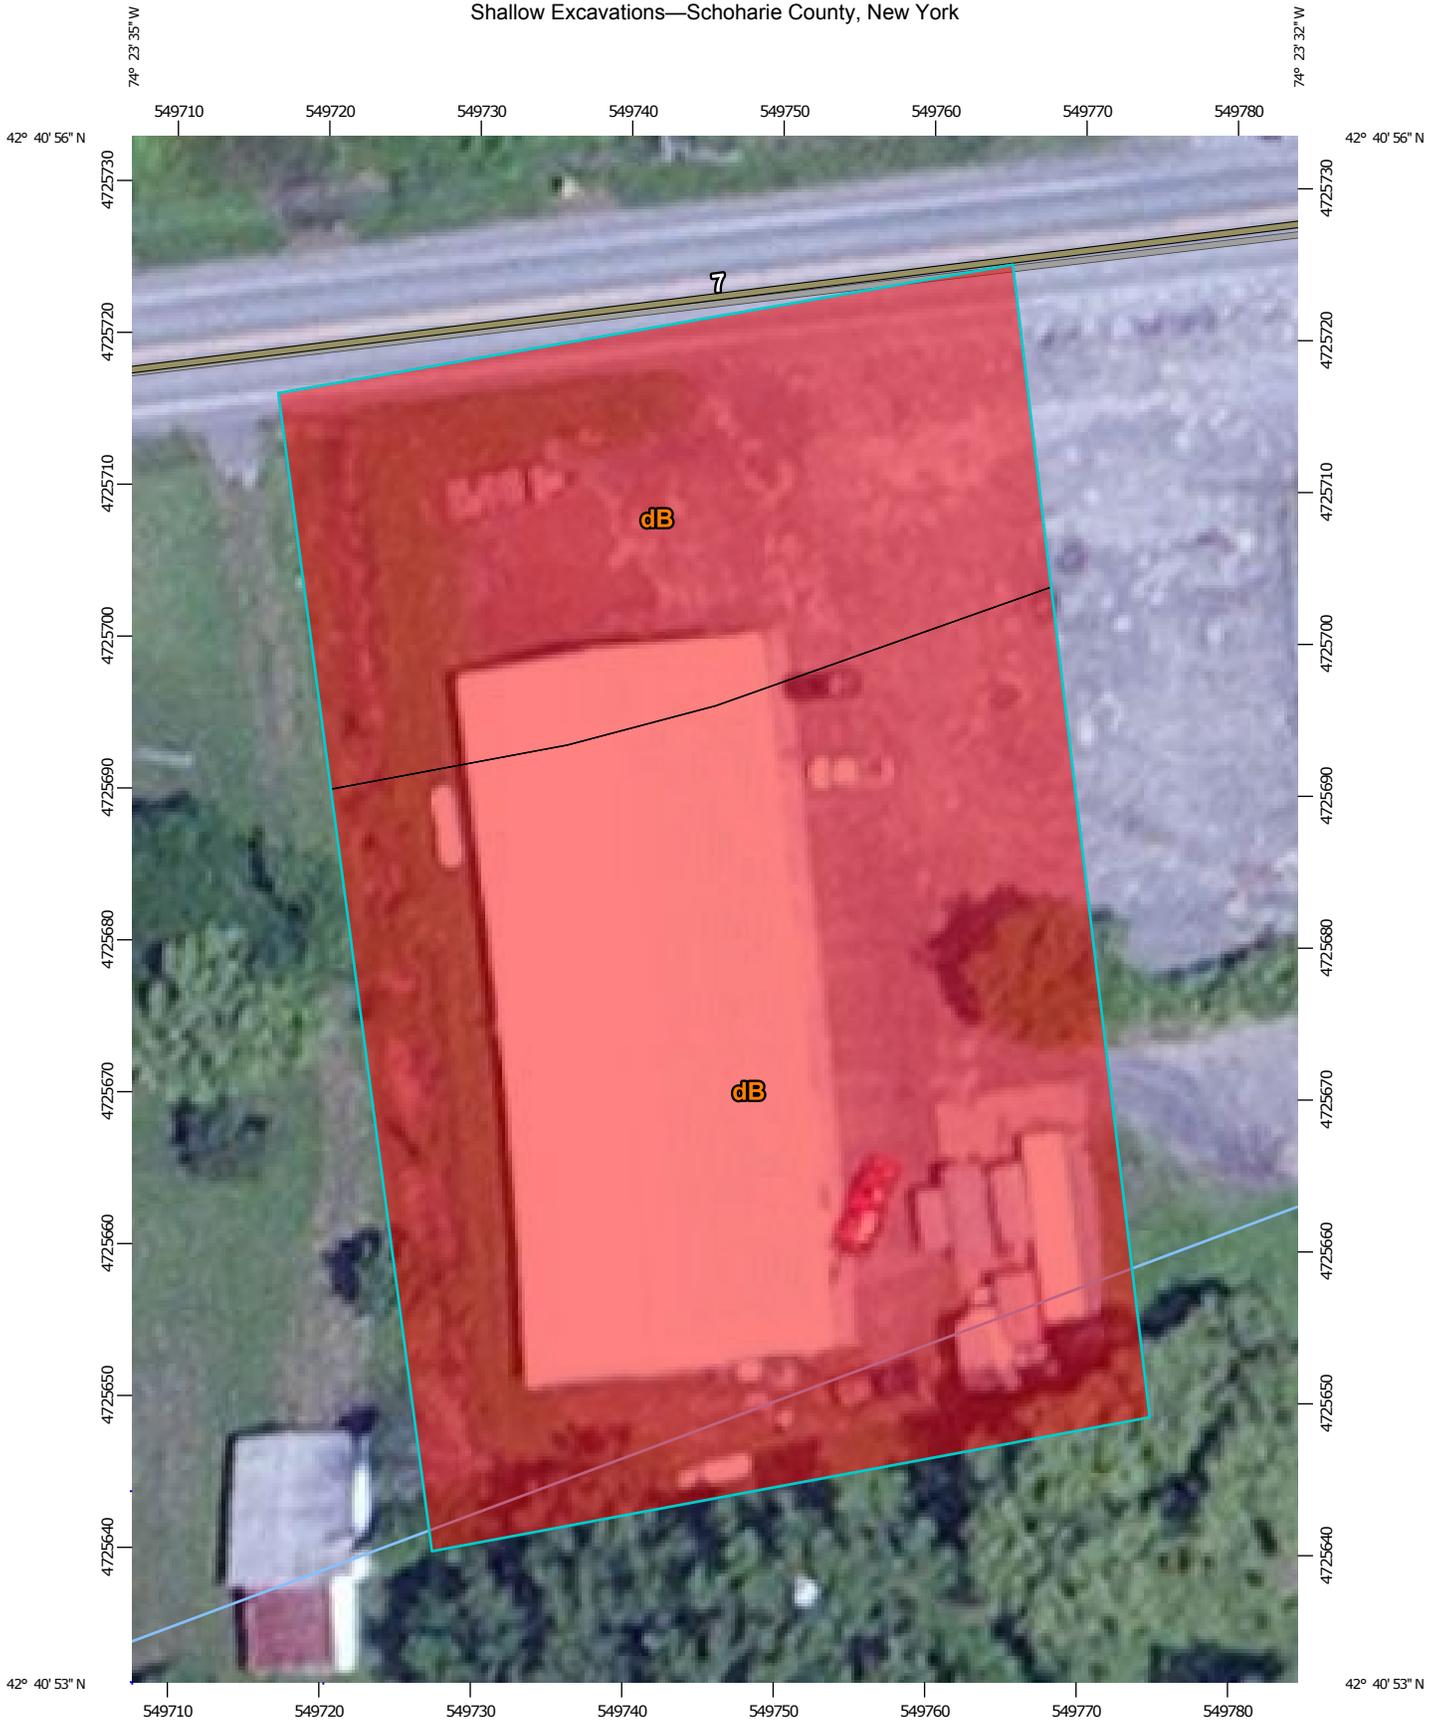
Shallow Excavations—Schoharie County, New York

Map Scale: 1:496 if printed on A portrait (8.5" x 11") sheet.

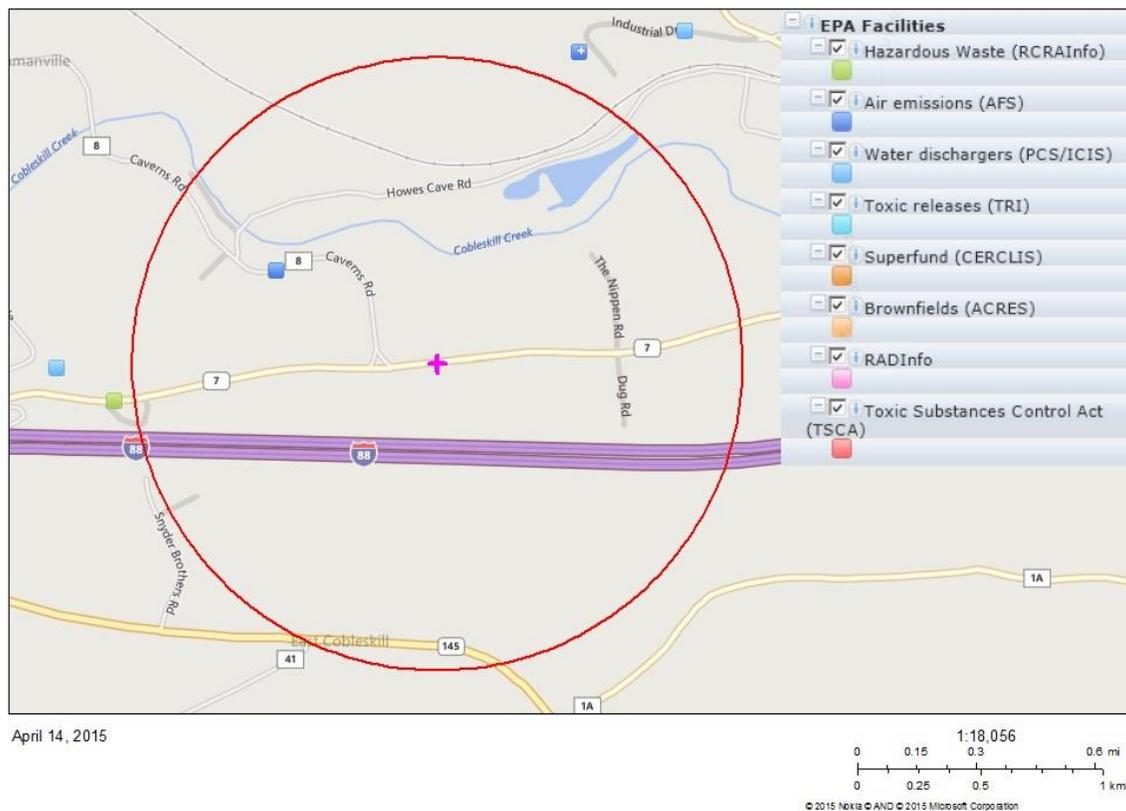
Figure 2: Hazardous waste sites and handlers (green marker), toxic release sites (blue marker), Superfund and brownfield sites (orange markers), and facilities regulated by the U.S. EPA for radiation and radioactivity (pink marker). The project property is indicated by a purple cross symbol, and a 3000 foot buffer around the Property is represented by the red circle.

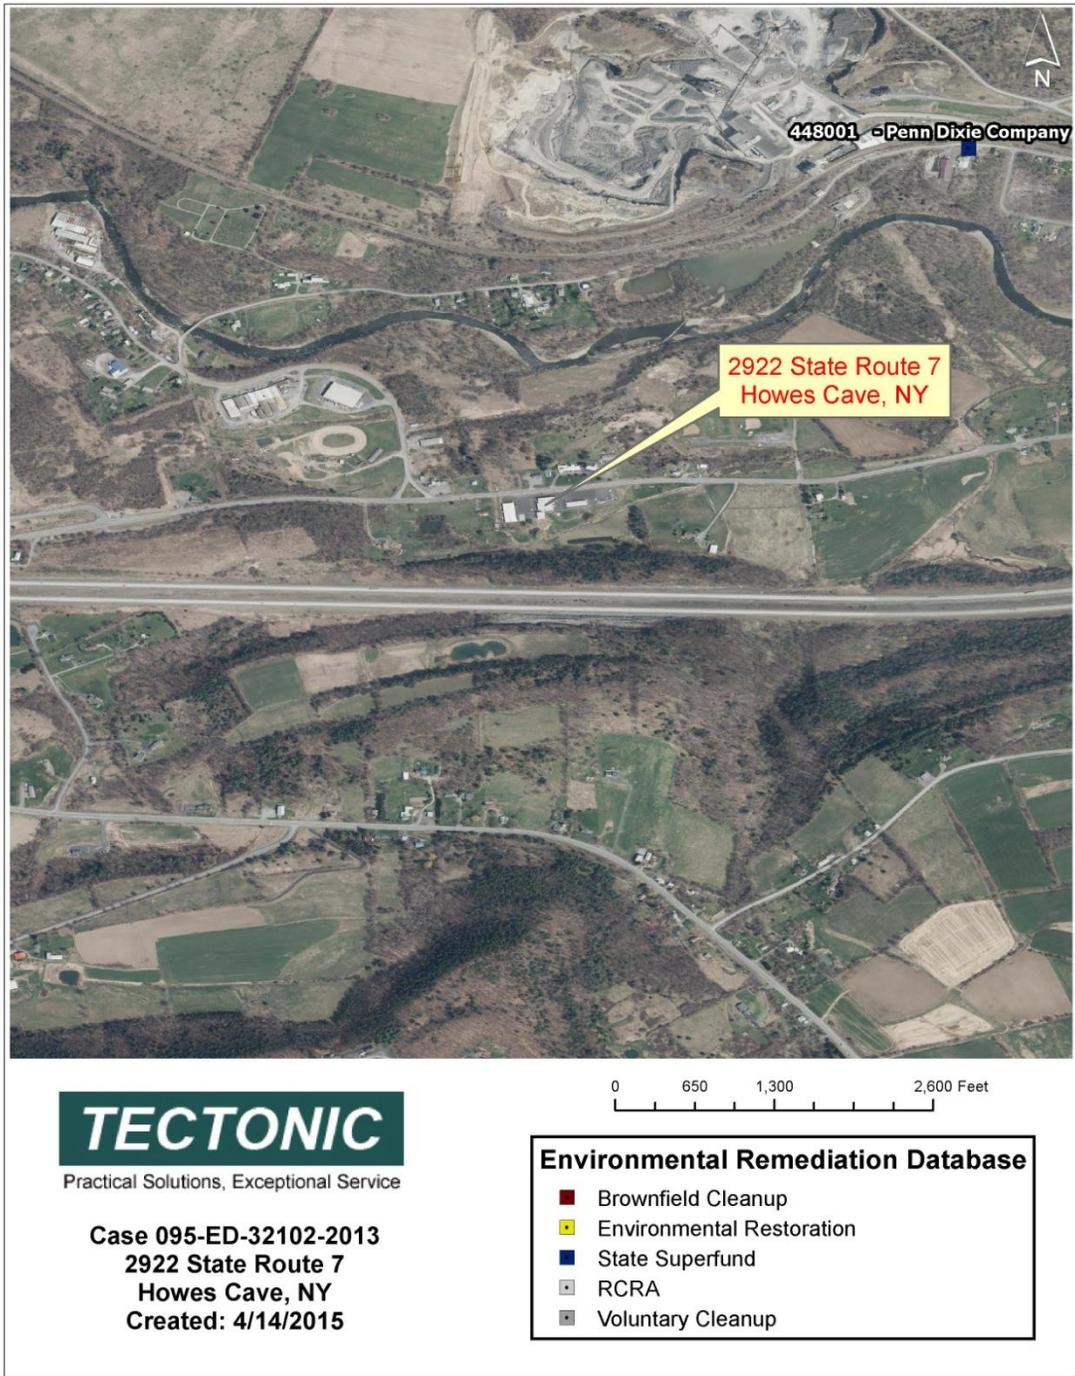
Figure 3: Environmental remediation sites listed in the NYSDEC Environmental Remediation Database. Brownfield cleanups are depicted by dark red symbols, Environmental Restoration Programs by yellow symbols, State Superfund sites by black symbols, RCRA sites by white symbols, and Voluntary Cleanup sites by gray symbols.

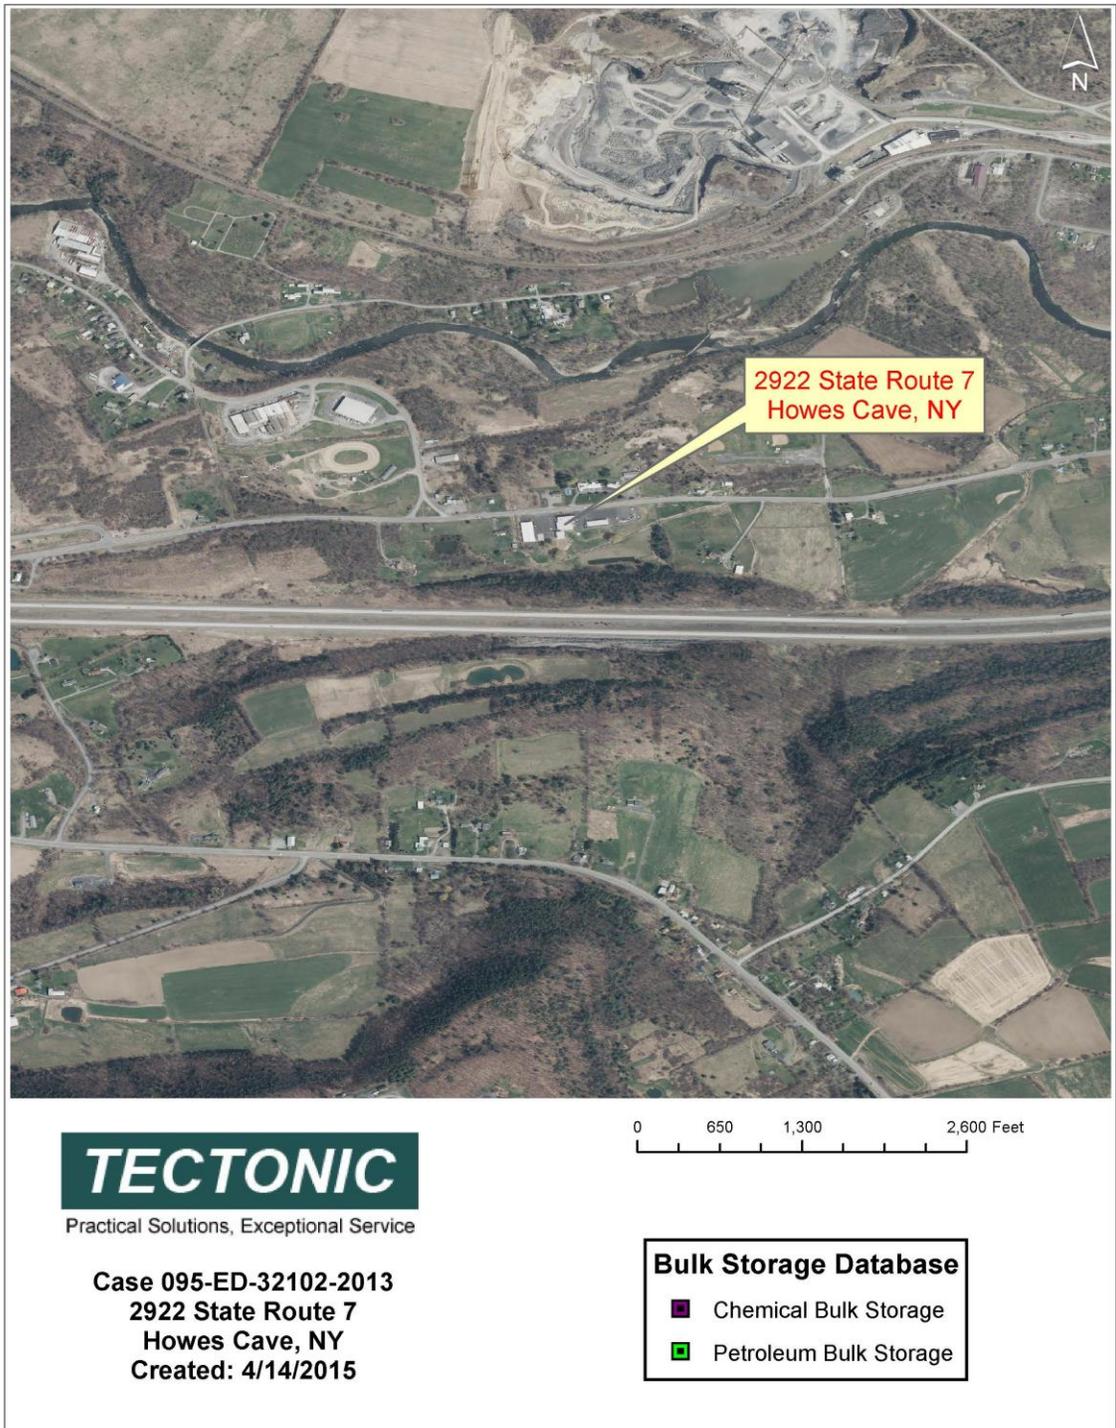
Figure 4: Properties listed on the NYSDEC Bulk Storage Database. Petroleum Bulk Storage is represented by green markers, Chemical Bulk Storage by purple markers, and Major Oil Storage Facilities by red markers.

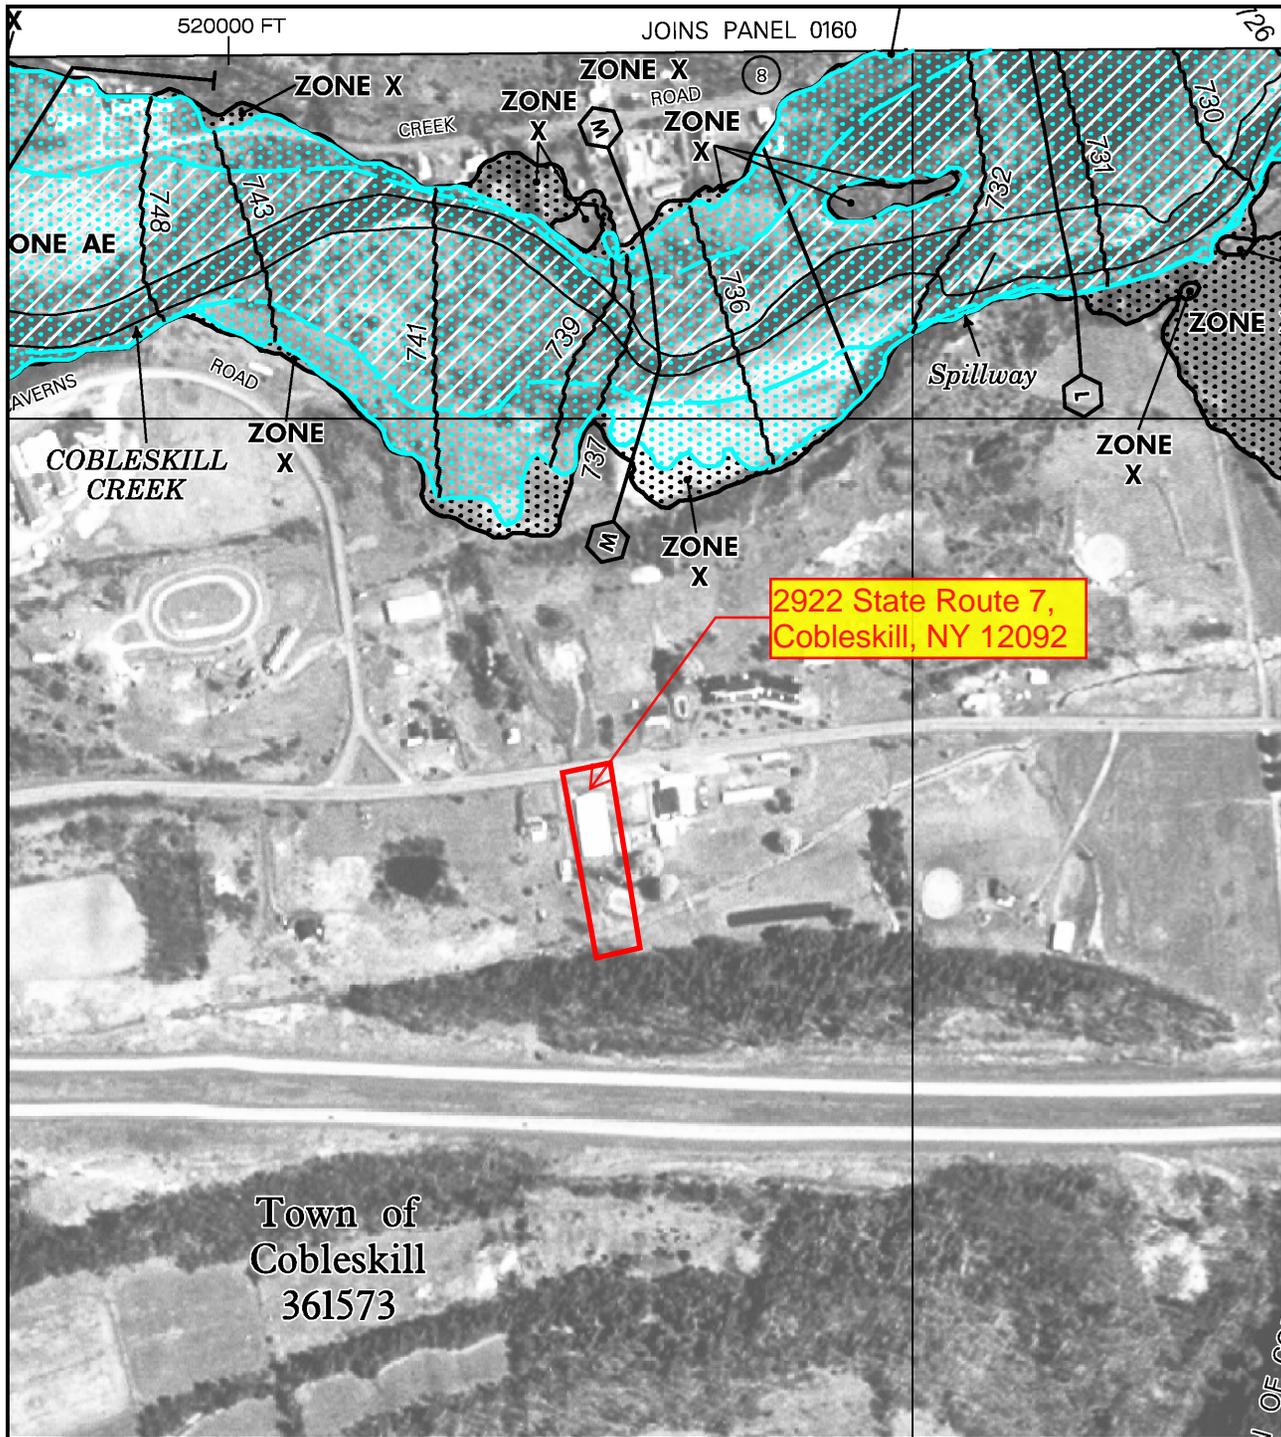
FEMA Firmette

MAP SCALE 1" = 500'

| Flood Disaster Protection Act [Flood Insurance] [§58.6(a)] | A | The activities occur in a community that is in the Regular Program of the National Flood Insurance Program (NFIP), and the community is currently in good standing. Based on the applicable Flood Insurance Rate Map shown in Attachment 7 , the property is not located within a Special Flood Hazard Area or in any type of floodplain area. No further compliance with this section is necessary. |
