Assessment Check List

Parcel ID#	Damage Address	City	Zip Code
OBBO-026a	51 Kissam Ave	Staten Is.

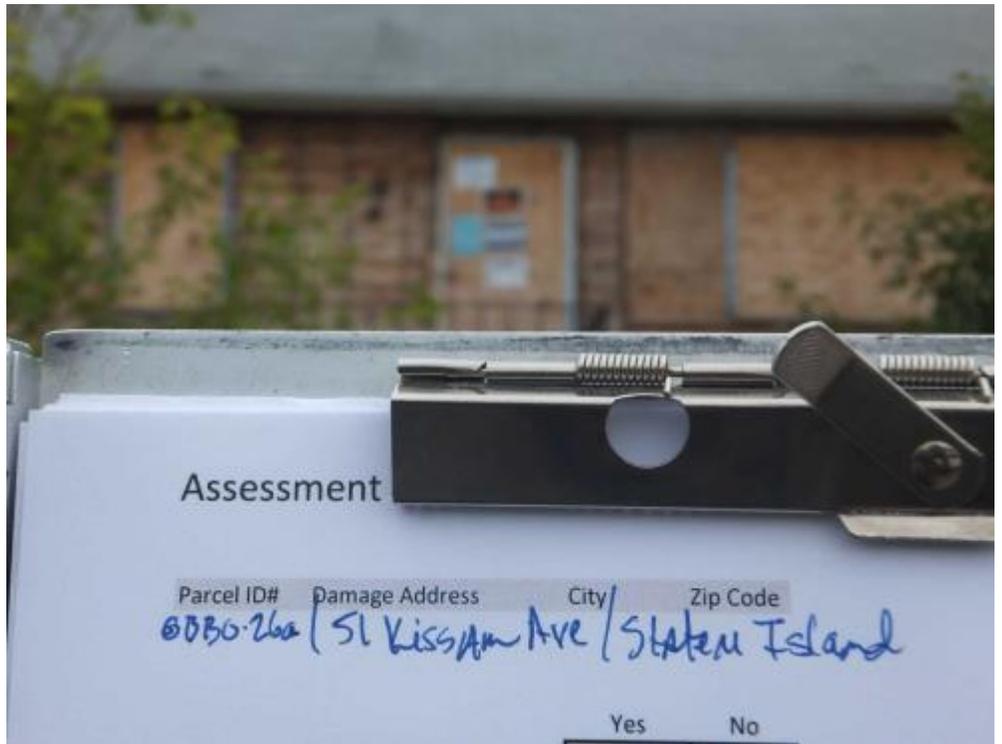
5 Front
Date Taken: 7/19/2014
Taken By: MGREEN

Front elevation shows debris in the front area and beyond the fence line.

Notes: Remove heavy brick debris from site. It appears to be the brick from the siding of the house.

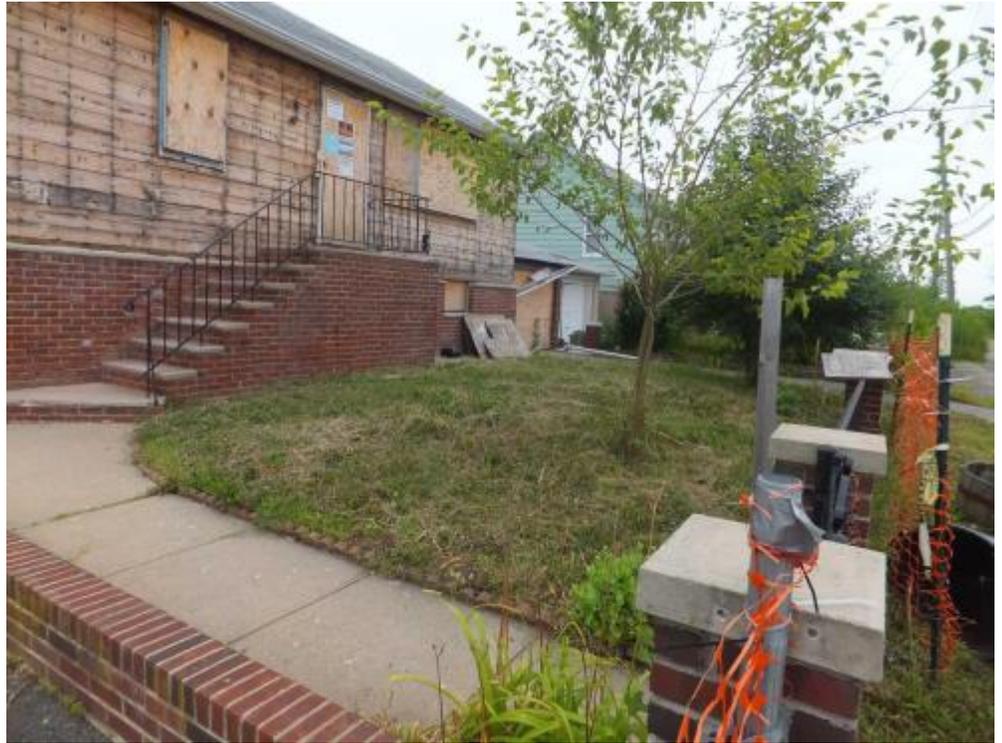
8 Right-Elevation
Date Taken: 7/19/2014
Taken By: MGREEN
Utilities have been disconnected.
