Appendix U
SHPO Consultation

RE: Nassau County Living with the Bay Project (LWTB)
Community Development Block Grant – Disaster Recovery (CDBG-DR)
Hempstead Lake State Park Project, Town of Hempstead, Nassau County, NY
SHPO Project Review No.: 17PR03487

HEMPSTEAD LAKE DAM & SOUTH POND INLET GATEHOUSES
HEMPSTEAD LAKE STATE PARK
EXISTING CONDITIONS AND PROPOSED ARCHITECTURAL
CHANGES

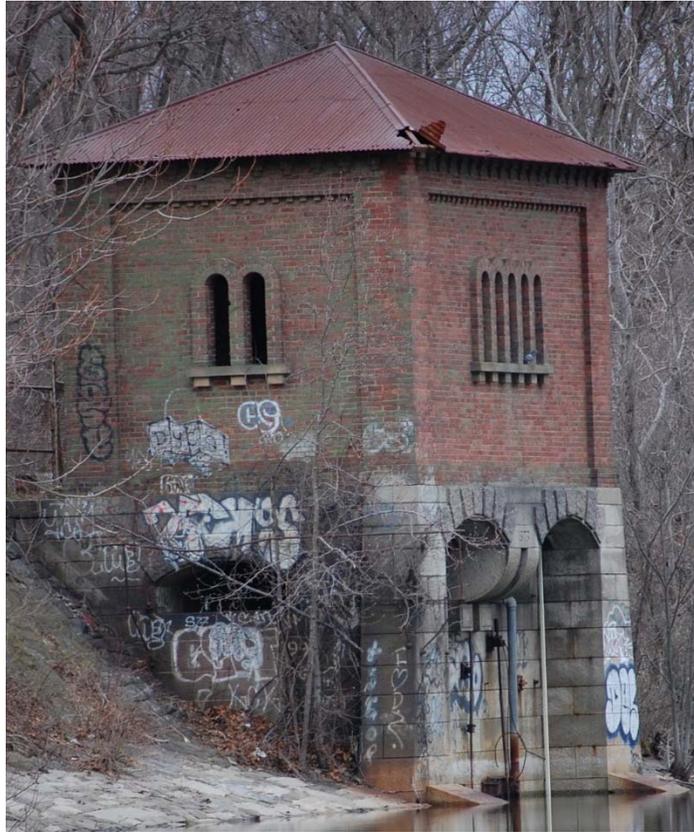
Photo 2: East and North elevation Hempstead Lake gatehouse with gates on the north elevation

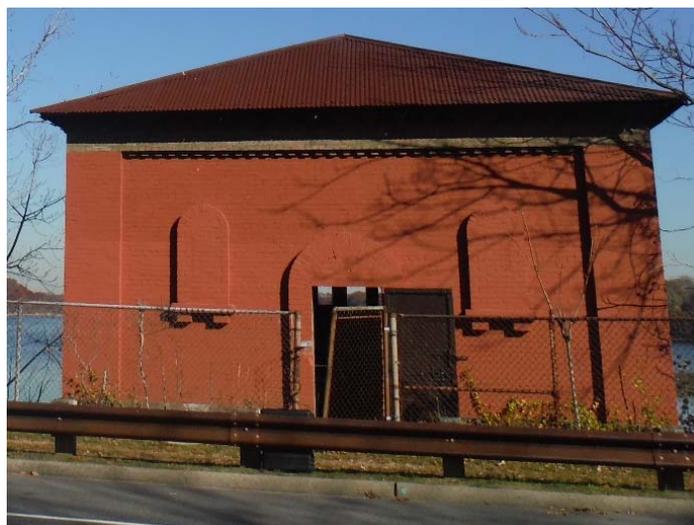
Photo 3: South elevation Hempstead Lake Dam gatehouse with bricked up windows

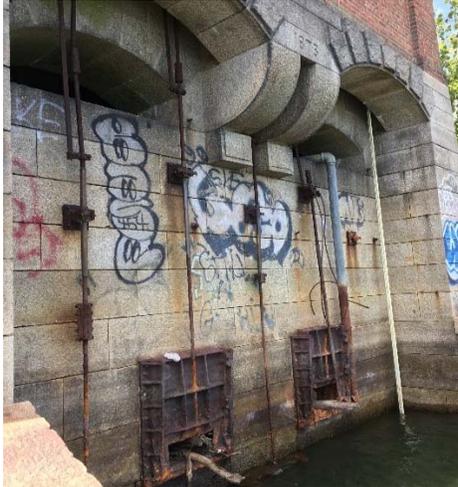
Photo 4: Hempstead Lake Dam gatehouse existing gates

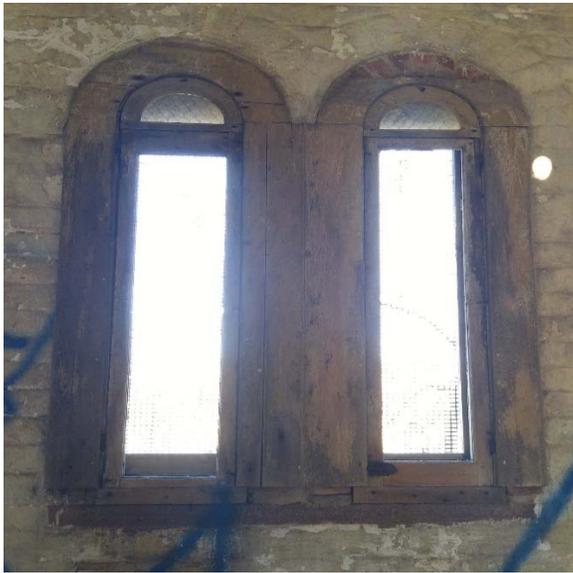
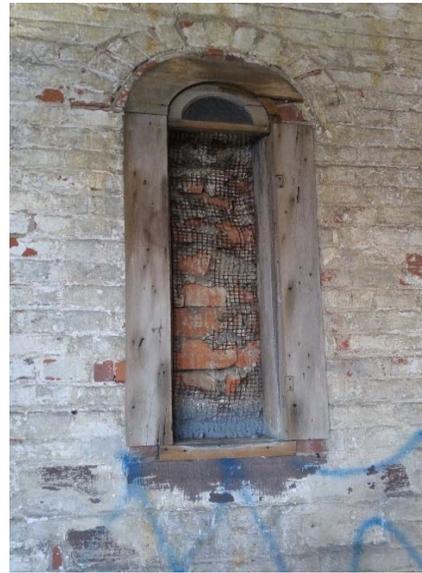
Photos 5 and 6: Hempstead Lake Dam gatehouse windows

Two options are being considered for treatment of the existing window locations of the Hempstead Lake Gatehouse. Option 1 is to restore all window openings by first removing brick work and/or wooden framing and mesh. Then new glazed panel windows (powder or vinyl coated,) would be installed at existing window locations along with exterior vandal proof mesh to keep the gatehouse and new gate controls secure as well as prevent damage to the new glazed windows. Option 2 would be to use a heavy duty mesh/bar grid within a steel frame without glazing to keep the building secure but allow more ventilation. The glazed window frame or mesh/bar combination would require anchoring to the existing brick walls and potentially the stone sill below each window. A detail of the anchoring is shown on the next page.

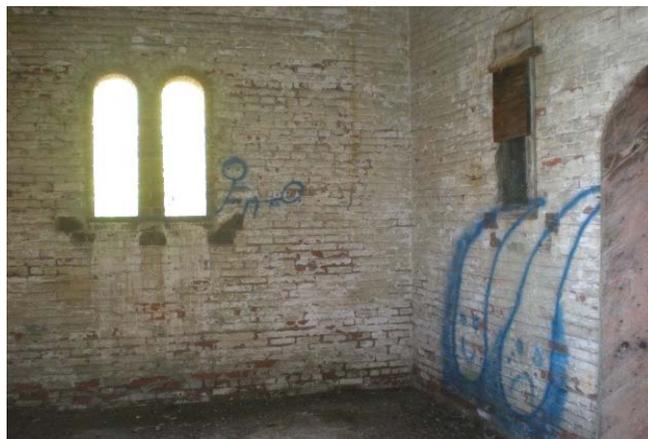
Photo 7: Interior of Hempstead Lake Dam gatehouse

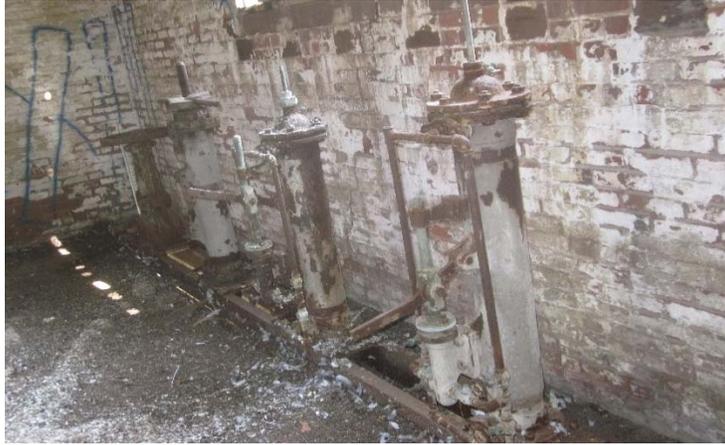
Photo 8: Hempstead Lake Dam gatehouse non-functioning gate operators

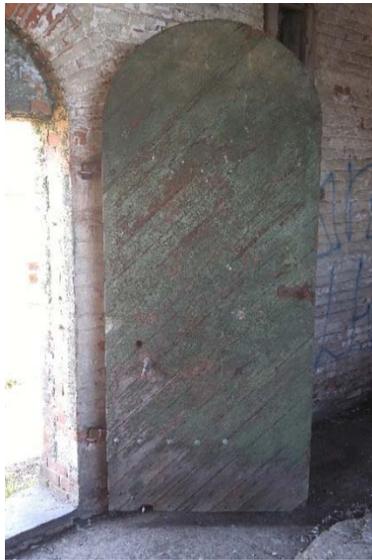
Photo 9: Hempstead Lake Dam gatehouse interior wood door

The Hempstead Lake Dam gatehouse currently has two doors at the entrance. The interior wood door (see photo 9,) and the exterior steel door (see photo 10,) are both in poor condition. There are three options for the Hempstead Lake Dam gatehouse door, all of which would involve removing the two existing doors and replacing the existing stone threshold. The preferred option is to install a new steel door and frame anchored to the brick doorway opening of the building. This new etched steel door would be similar in appearance to the existing interior wood door (see sketch below). The door would open-out instead of the current open-in configuration. This would increase the security of the door and lessen the likelihood of unauthorized persons pushing in the door. If not permissible to anchor a new frame to the brick walls of the gatehouse, option 2 would be to reuse the existing interior hinges, replace the interior wood door with an etched steel door similar in appearance to the existing wood door. The door would open-in same as the current interior door configuration. Option 3 for the Hempstead Lake Dam gatehouse door is to replace the existing interior wood door with a new wood door which would require also installing a new metal security door (see sketch below).

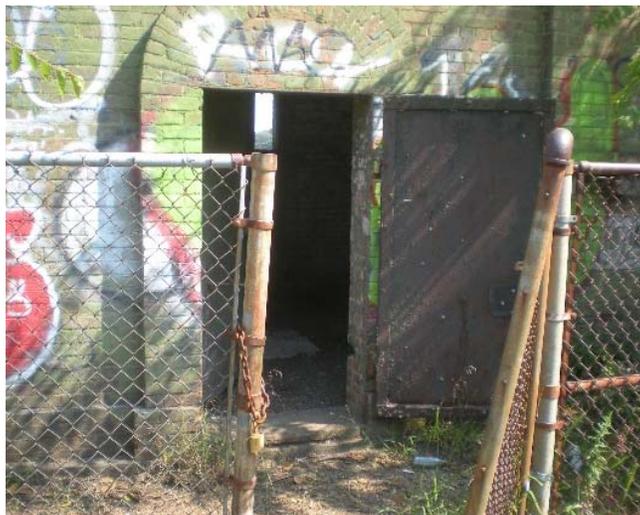
Photo 10: Hempstead Lake Dam gatehouse exterior steel door

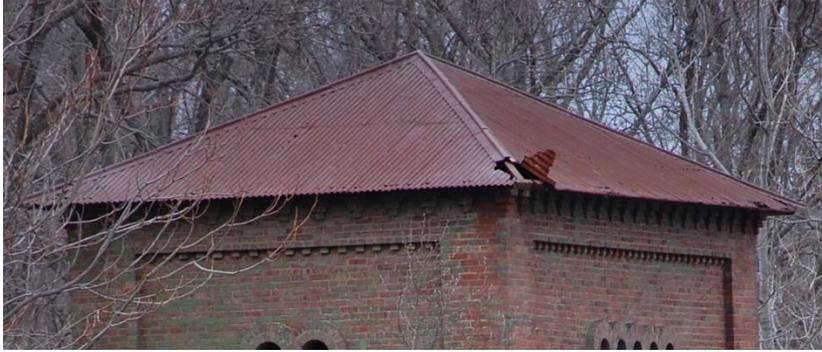
Photo 11: Exterior of Hempstead Lake Dam gatehouse roof

The existing roof at the Hempstead Lake Dam gatehouse is deteriorated with several openings allowing rain water to enter the building (see photos 11-13). The existing iron framing is in remarkable condition for a structure over 140 years old.

A new steel roof is proposed at both the Hempstead Lake Dam outlet gatehouse and the South Pond inlet gatehouse, similar in appearance to the existing roofs. The existing iron framing will be maintained and supplemented by additional steel members. The existing framing will be cleaned and painted to protect against future corrosion. New galvanized steel purlins will be installed to attach the new sinewave shaped roof panels maintaining the look of the existing roofs. The color of the new roofs would be similar to the existing color. A detail of the sinewave style roof panel is provided below.

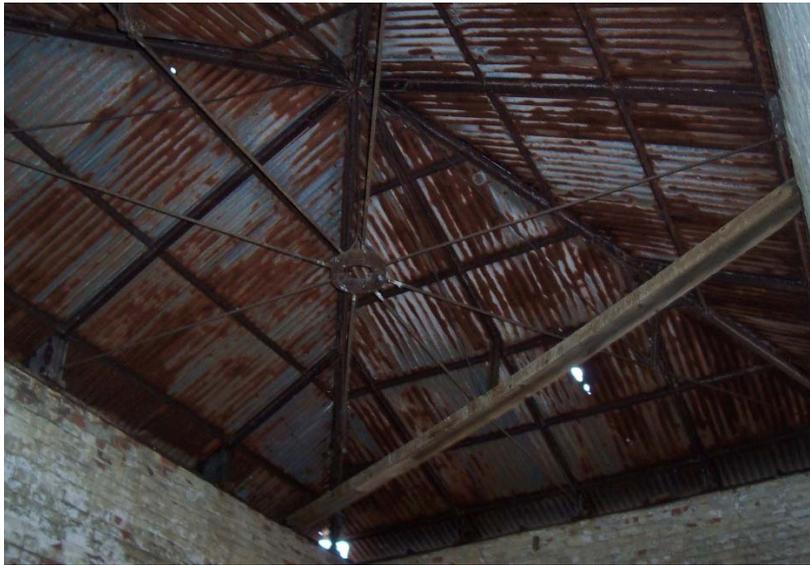
Photo 12: Interior of Hempstead Lake Dam gatehouse roof

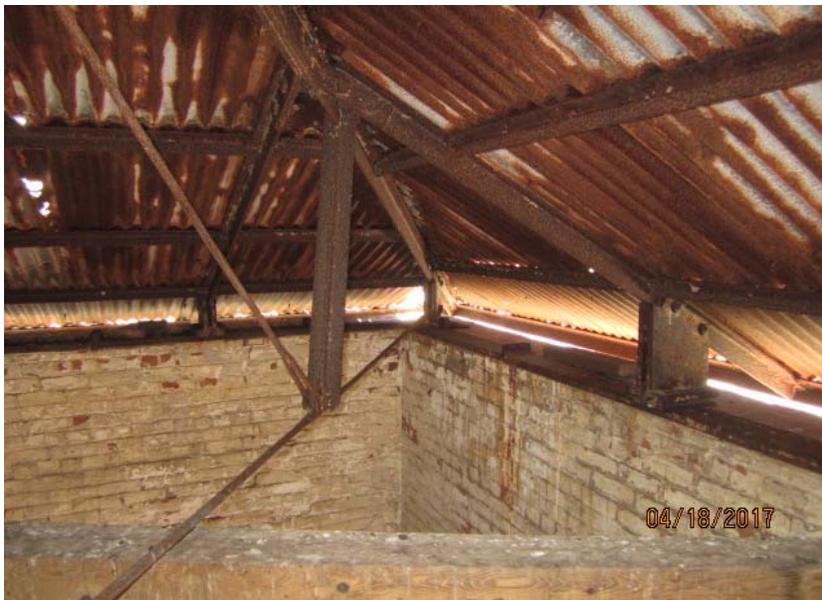
Photo 13: Interior framing and roof of Hempstead Lake Dam gatehouse

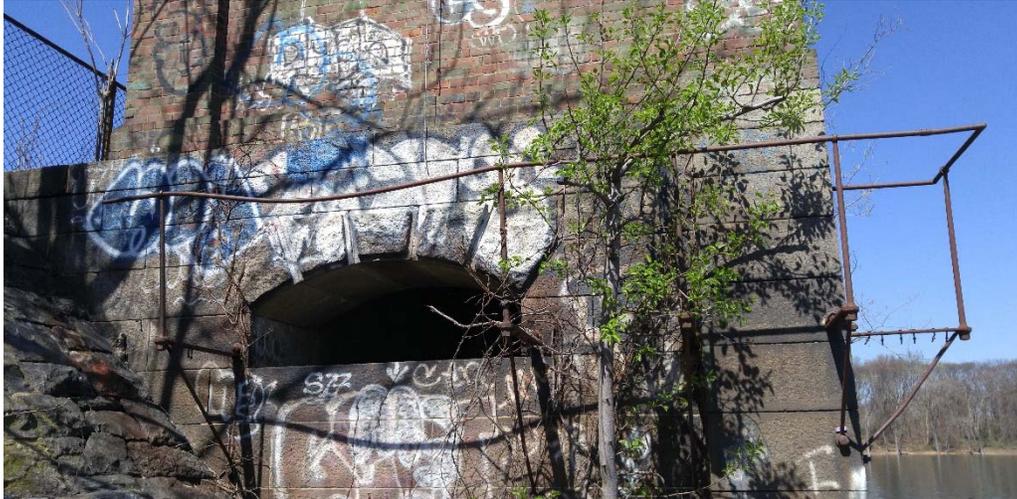
Photo 14: Remnants of Hempstead Lake dam gatehouse exterior catwalk

The remnants of the exterior catwalk is visible on the east and north sides of the Hempstead Lake Dam gatehouse (see photos 14-15). The hangers and railings are iron and it is believed the no longer present floor of the catwalk was wood planking. The catwalk served the purpose of viewing the exterior components of the gatehouse sluice gates which will also be replaced as part of this rehabilitation project.

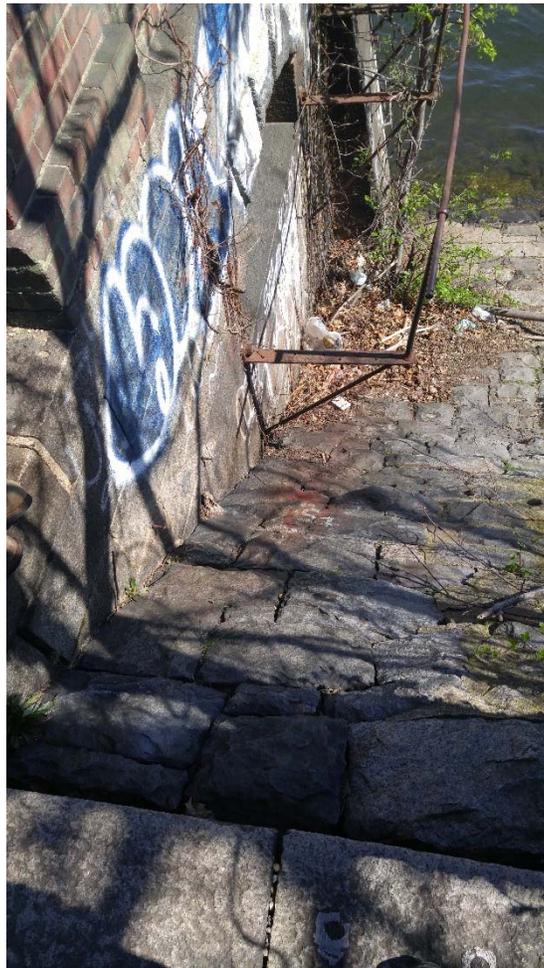
Photo 15: Remnants of Hempstead Lake dam gatehouse exterior catwalk

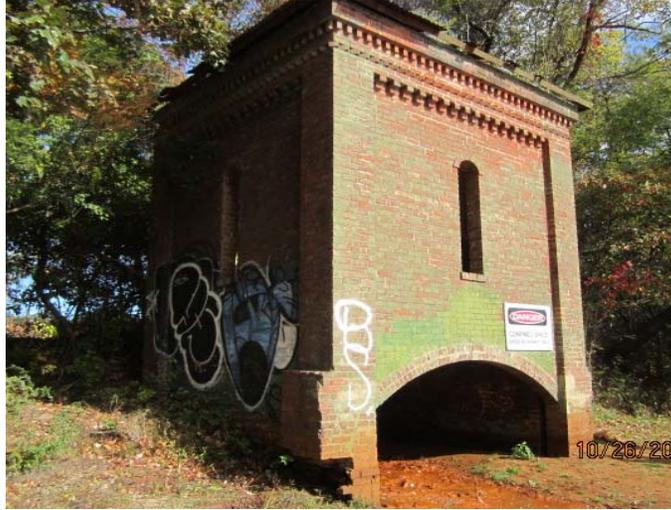
Photo 16: South Pond inlet gatehouse exterior

The South Pond inlet gatehouse currently has two window openings, one on the south elevation and one on the west elevation (see photo 16). There are no treatments proposed for these window openings. There is nothing to secure in this building as the only function of the gatehouse is to serve as the outlet of the pipe arch. The outlet of the gatehouse will remain open, so preventing birds from entering through the windows will not prevent them from gaining access.

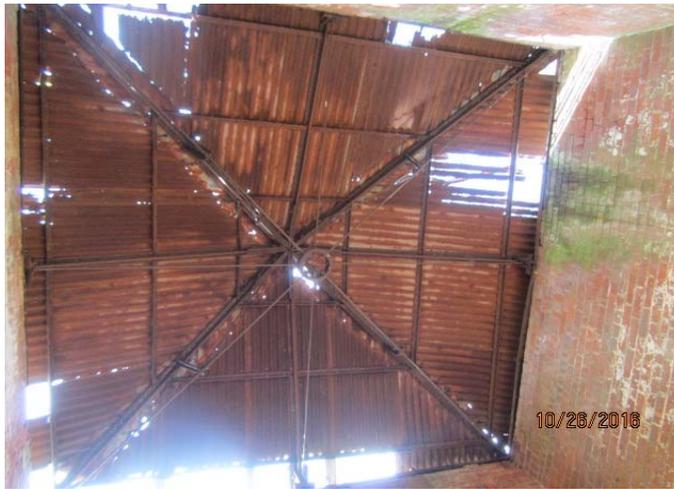
Photo 17: South Pond inlet gatehouse roof

The existing roof at the South Pond inlet gatehouse has more deterioration than the Hempstead Lake Dam gatehouse roof (see photo 17). There are several large areas of deterioration which have created large openings in the roof and if the roof panels are allowed to continue to deteriorate and finally separate from the building, a potentially very hazardous condition would be created. As with the Hempstead Lake Dam gatehouse the iron framing is in good condition.

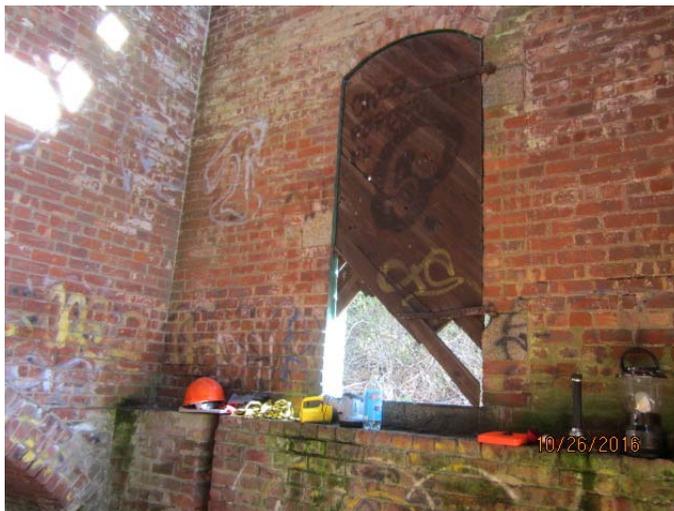
Photo 18: South Pond inlet gatehouse door opening with wood door slab remnants

The South Pond inlet gatehouse currently has the remnants of a wood door on the east elevation of the building (see photo 18). There is currently no use for this entrance. The proposed plan is to replace the deteriorated wood door with an etched steel door fixed in the opening (see sketch below). The door would not be operational as there is no need to gain access to this building. The fixed door would be in place as a deterrent for unauthorized persons attempting to climb into the building. The door location poses a safety issue as the opening is approximately 3ft above the interior and exterior ground elevations of the building.

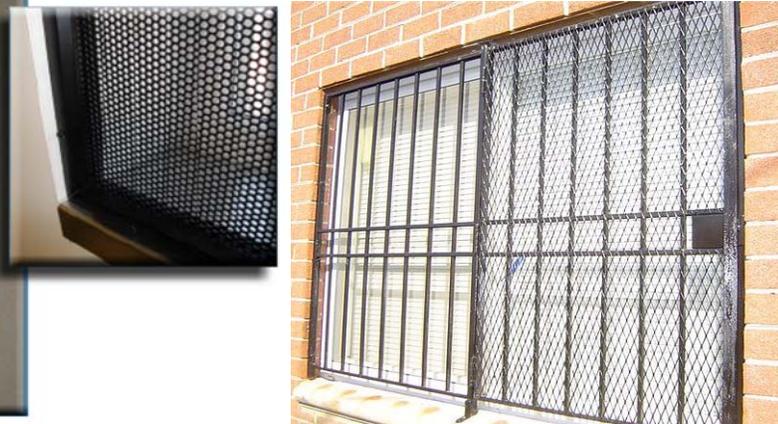
Option 2: Mesh and Bars

Potential applications for Hempstead Lake Dam gatehouse window locations

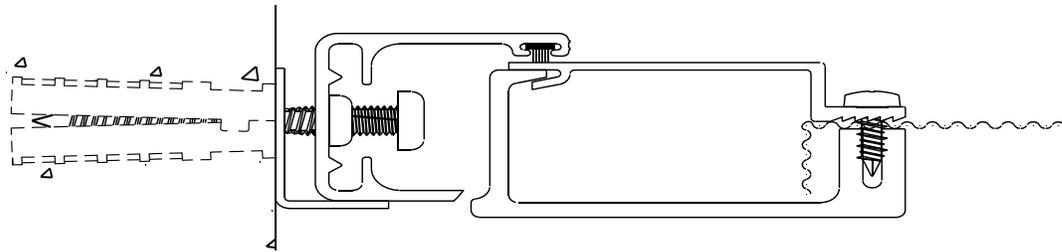
Drawing not to scale

Potential anchoring system for window frame installations

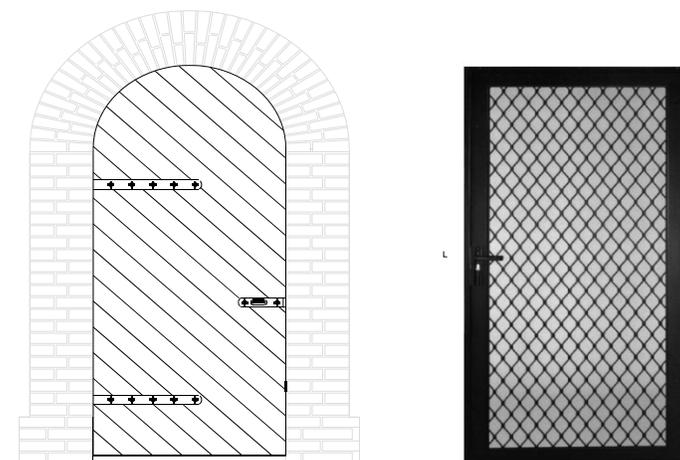
Proposed Etched Steel Door Security door if wood door is required

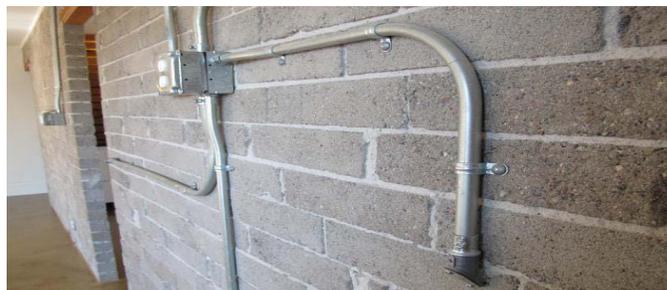
Proposed method of running conduit in the gatehouse

There is no existing electric service at either the Hempstead Lake Dam gatehouse or the South Pond inlet gatehouse. Electric service will be added to the Hempstead Lake gatehouse for an indoor light and outdoor security lighting. The new electric service would also be used to power the proposed water level monitoring equipment as well as a closed circuit television system for the gates which would be viewable from the new Hempstead Lake Education and Resiliency Center. The service would be trenched to the gatehouse from the highway lighting located in the vicinity of the gatehouse. The service would then enter the gatehouse through a hole drilled in the brick wall. The conduit runs inside the gatehouse would then be attached with brackets to the brick walls of the gatehouse, similar to the photo below.

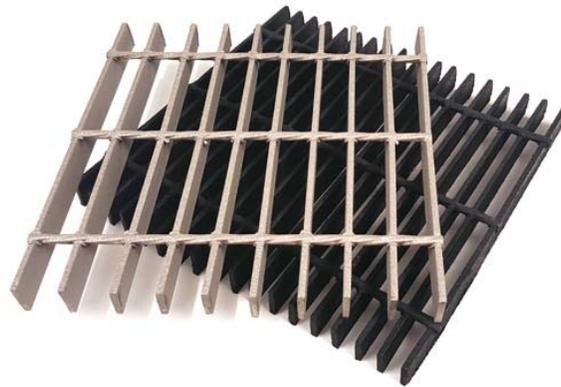
Proposed open grating for exterior catwalk

The proposal for the catwalk is to reuse the existing hangers if structurally sound, replace the existing deteriorated railings with steel railings designed to comply with current safety standards, and install an open steel grate floor for the catwalk. If the existing steel hangers are found to be insufficient, an entirely new support system will be installed. The new support system would be anchored to the exterior of the brick and stone gatehouse wall. The catwalk will be accessed from the exterior of the gatehouse near the roadway, with a fold up ladder system to deter unauthorized persons from accessing the catwalk. The grating and proposed catwalk configuration are shown below.

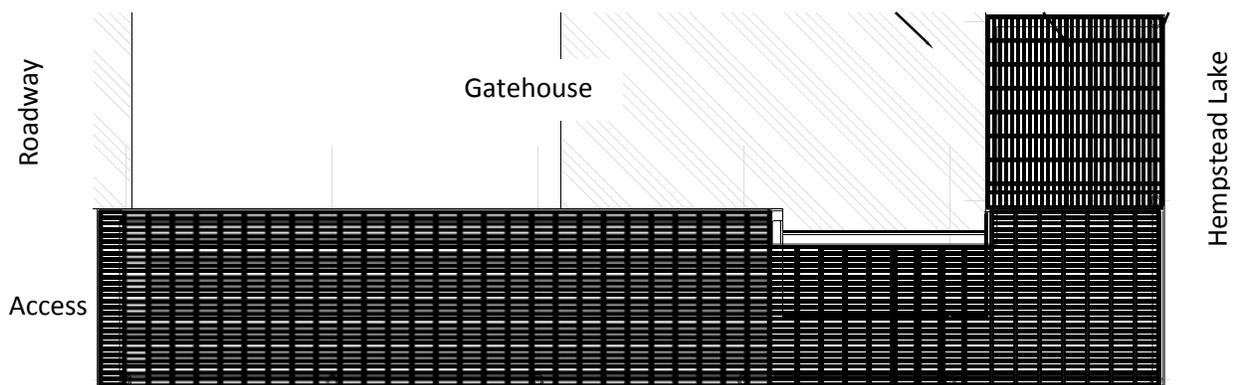
Proposed exterior catwalk east side of Hempstead Lake dam gatehouse
