Assessment Check List

Parcel ID#	Damage Address	City	Zip Code
EF-165-AQ	997 Pacific St.	Lindenhurst	11757

NOTE: IMMEDIATE ATTENTION REQUIRED- DANGEROUS STRUCTURE

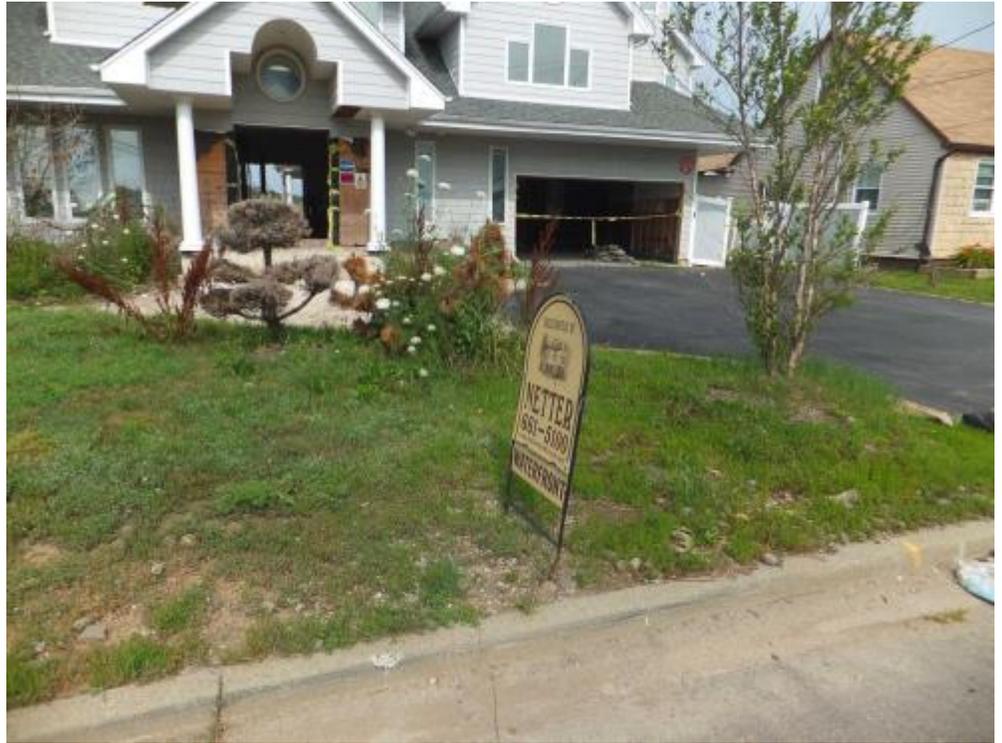
7 Front-Elevation
Date Taken: 7/14/2014
Taken By: MGREEN

House is on the market by Netter Realty.

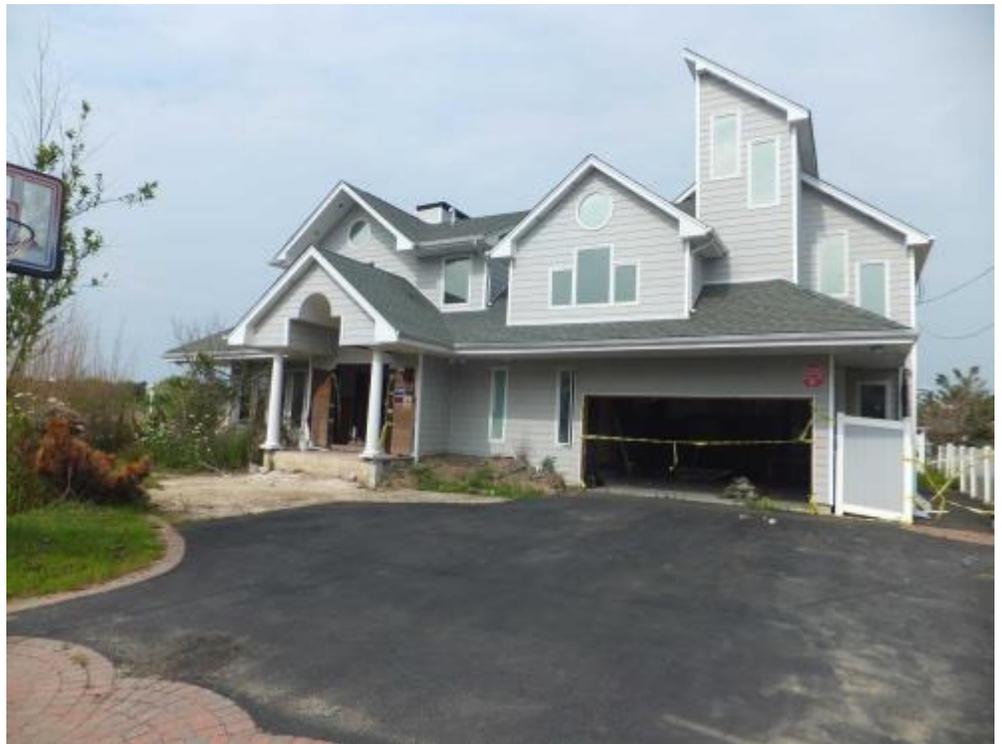
8 Front-Elevation
Date Taken: 7/14/2014
Taken By: MGREEN

Asphalt driveway

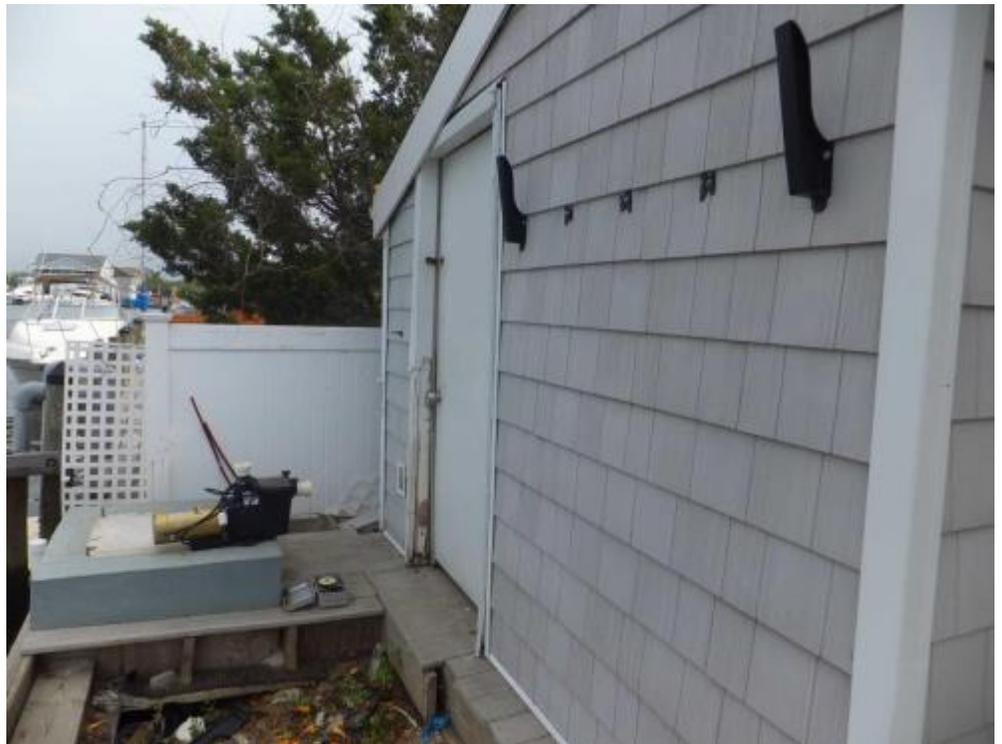
38 Rear-Storage
Date Taken: 7/14/2014
Taken By: MGREEN
Storage unit is adjacent to the sauna room.

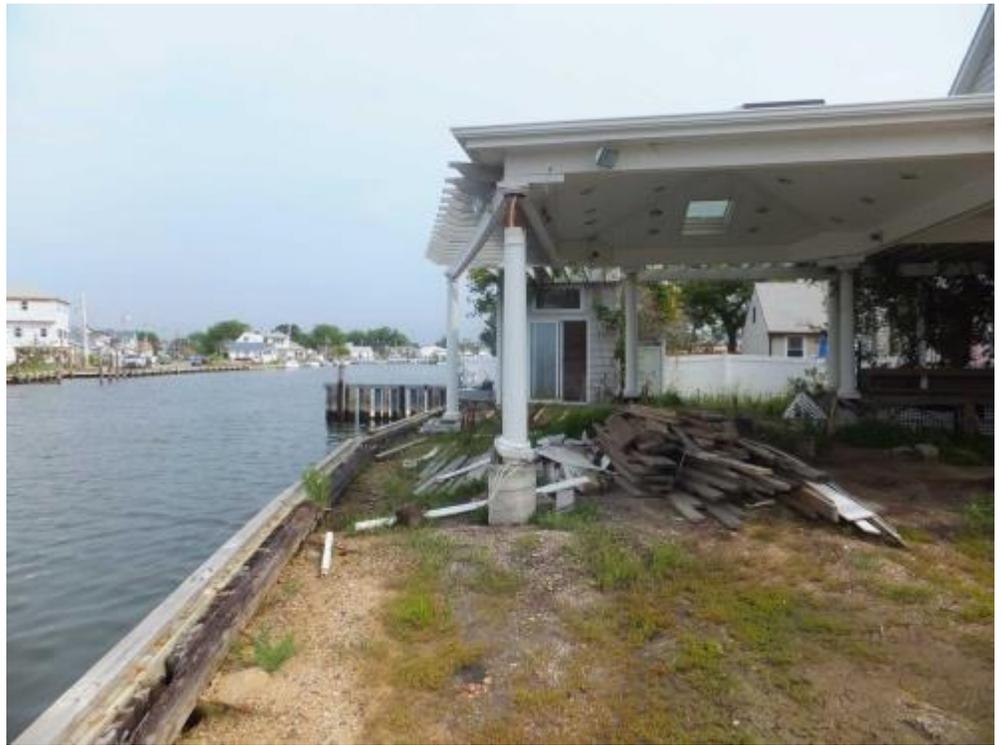
39 Rear-Yard

Overall view from left to right of the rear of the property.

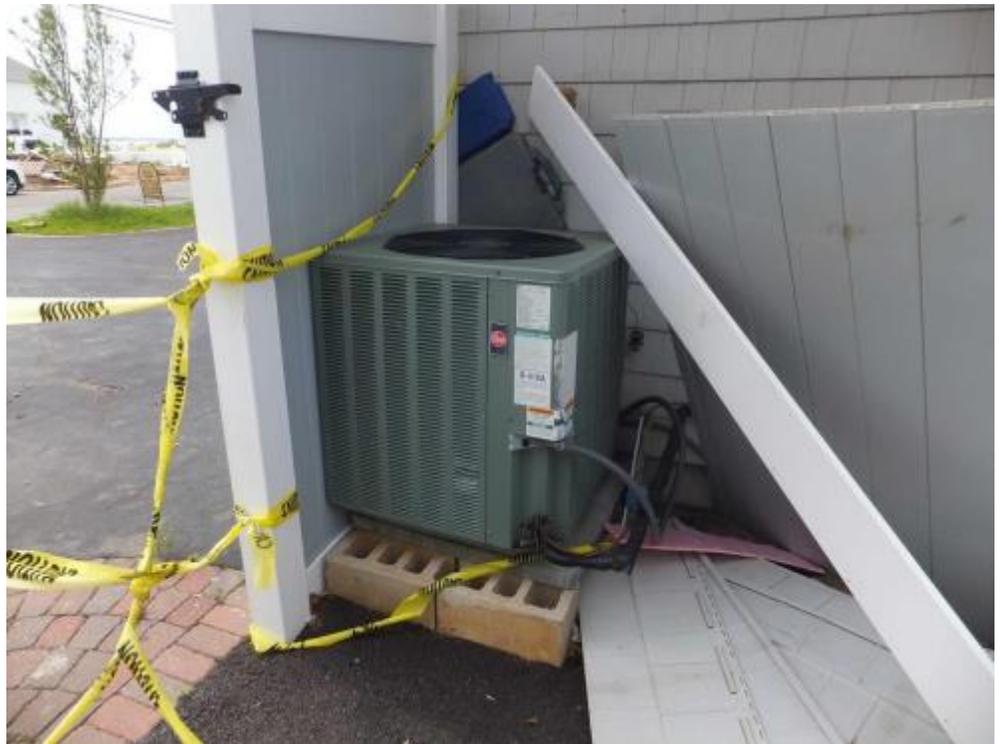
52 Right-Elevation
Date Taken: 7/14/2014
Taken By: MGREEN

Remaining AC unit.

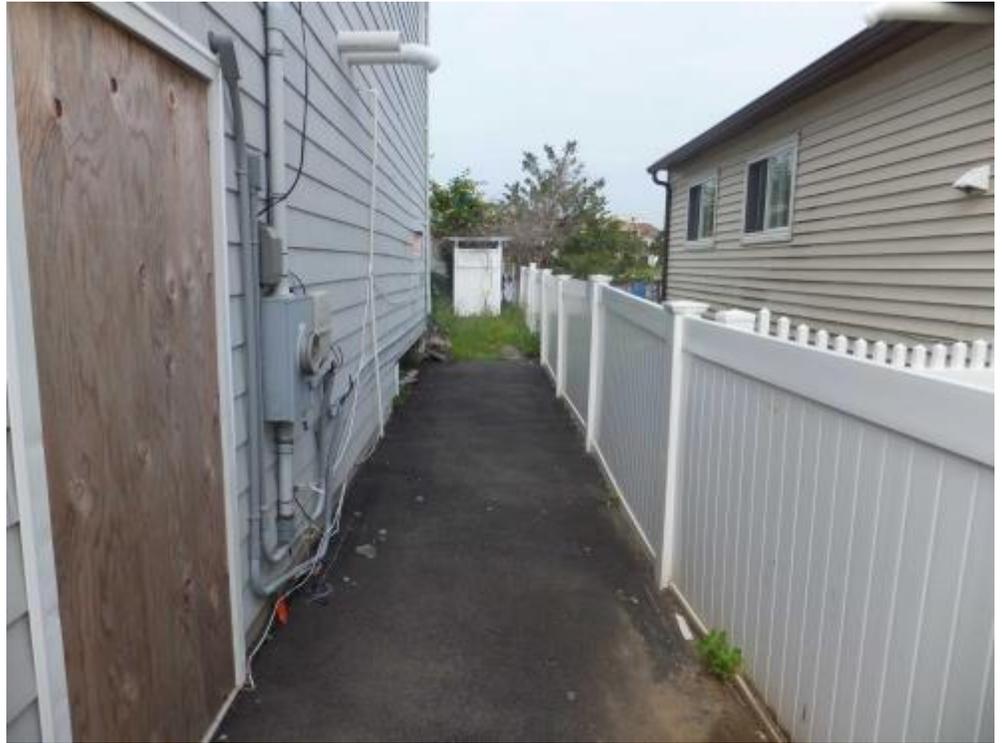
53 Right-Elevation
Date Taken: 7/14/2014
Taken By: MGREEN

Front to back view of right elevation.

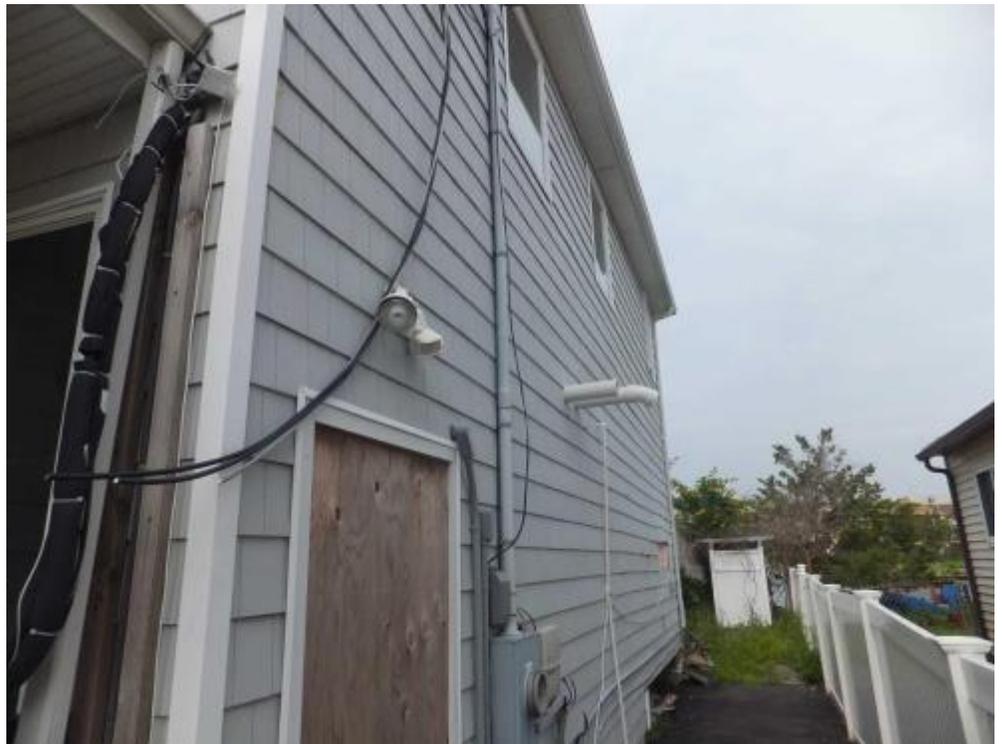
54 Right-Elevation
Date Taken: 7/14/2014
Taken By: MGREEN

Front to back view of right elevation.

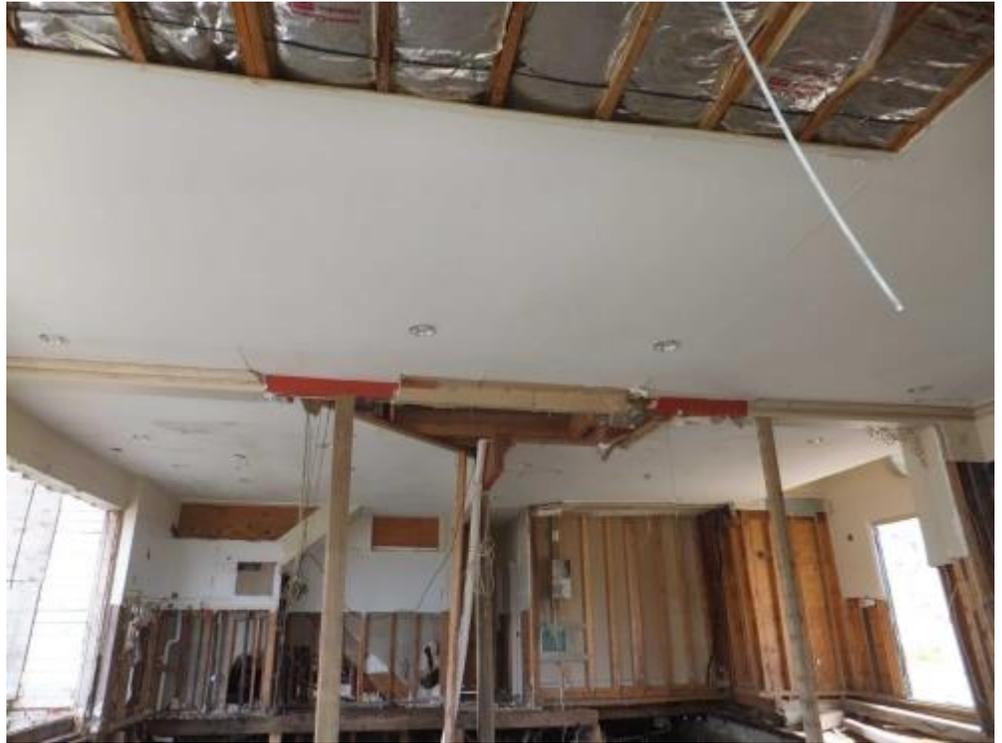
63 Interior
Date Taken: 7/14/2014
Taken By: MGREEN
Ceiling view of 1st floor.
